## Property Inspection Report

3614 Cleburne St Houston, TX 77004

Inspection Date: 12-05-2024

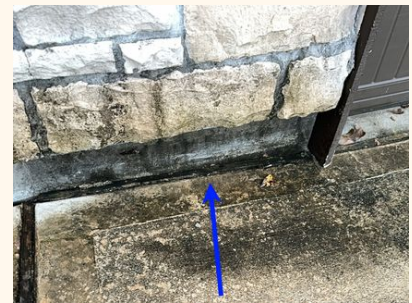
*Front*

There are form boards noted at the slab. It is recommended that all form boards be removed from around the slab and replaced with an approved backer rod and filler to help prevent water from gathering at the foundation as well as to help prevent conducive conditions for wood destroying insects as deteriorating wood is a conducive condition for wood destroying insects. Mainly at -

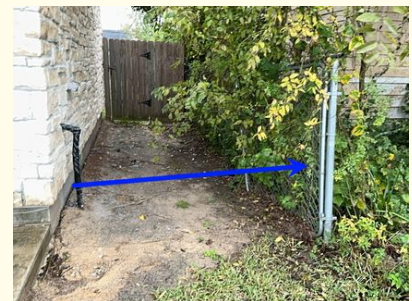
All trees should be located no closer than 15' from structure to help prevent foundation movement. You may want to keep larger trees trimmed to help slow further root growth and future foundation movement as removing older trees may cause voids under the slab from dying root systems.

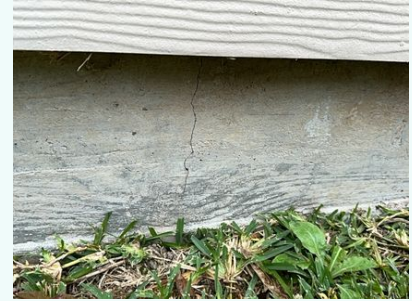
*Right*

There are hairline cracks visible in the perimeter of the foundation. These cracks are typical of a poured concrete slab and are often caused by shrinkage or from the concrete drying too quickly in the post-pour process. Recommend monitoring for continued movement and if further movement occurs, contact a foundation specialist for further evaluation. Mainly at -

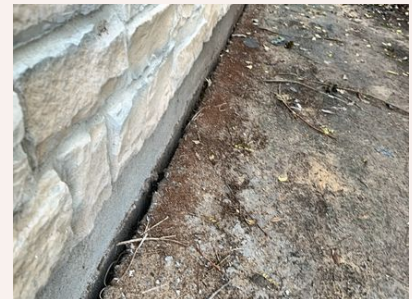
The soil is very dry around the perimeter of the foundation and has separated from the edges of the slab. This should be corrected in order to help prevent future foundation problems. Water should never be poured into the cracks or voids next to the slab. It is a good idea to run a soaker hose approximately 18" away from the foundation to water the ground slowly.

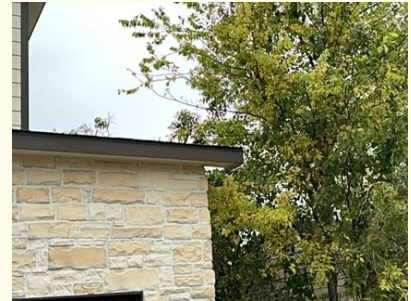
Tree limbs should be kept trimmed at least 5' from roof to help prevent damage to the roof during windy conditions.

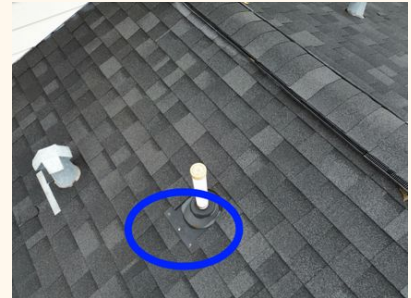
There were exposed nails noted on the roof. It is recommended that all exposed nails and fasteners on roof be sealed at all penetrations, ridges and roof to wall connections.

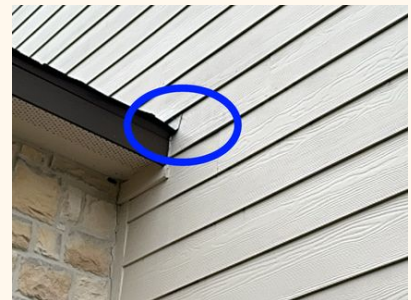
The roof is missing the kick out flashing at the end of the roof to sidewall connection. Kick-out flashing is meant to help prevent water from running down or into the wall causing possible water penetration and deterioration. Mainly at -

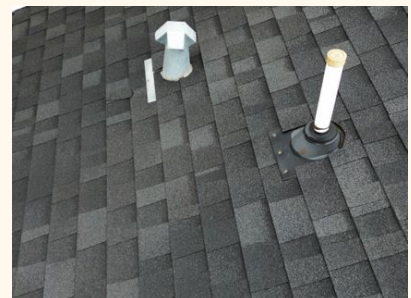
One or more of the vents and or flashing is unpainted, recommend painting all unpainted vents and flashing to help prevent damage due to UV rays or rust.

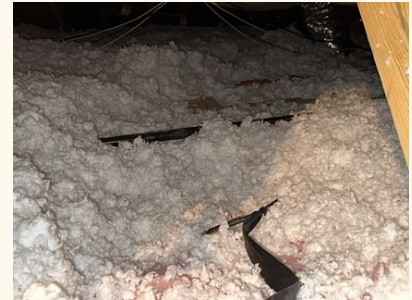
The insulation has been heavily compressed by storage, age and/or varmints in some areas of the attic and does not meet today's energy requirements, recommend upgrading to today's standards of at least R30.

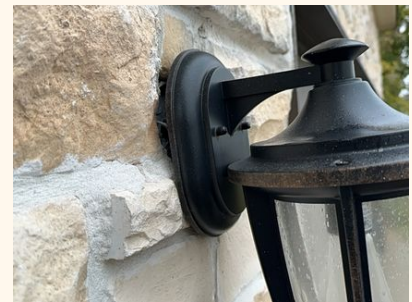
Seal all electrical lighting fixtures at wall connection to help prevent water penetration. It is a good idea to leave a small opening at the bottom to allow any water penetrating to escape.

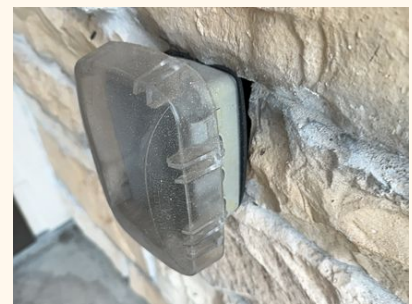
*Porch*

The exterior receptacle is not sealed at box and/or wall connection, recommend sealing all exterior receptacles to help prevent water entry into box or wall. Mainly at -

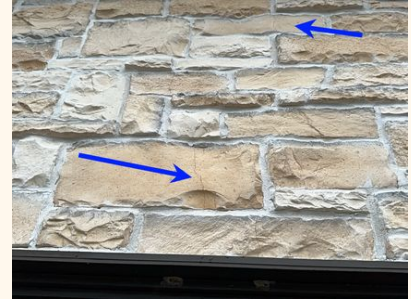
Settlement cracks were noted in the stonework. Mainly at -

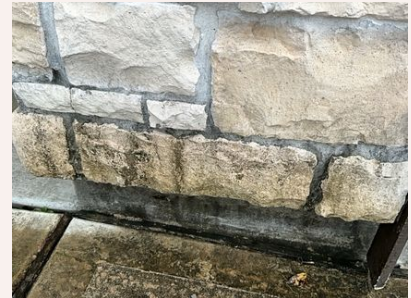
There are signs of growth on exterior brickwork/siding, recommend cleaning to help prevent deterioration.

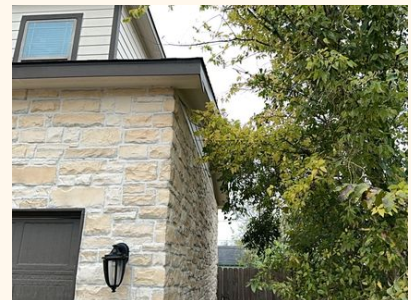
Recommend trimming vegetation so that it is not in contact with the house. Vegetation in contact with the structure can hold moisture against the structure and promote damage to building materials and conducive conditions for wood destroying insects.

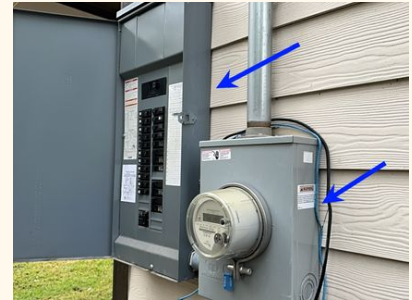
It is recommended that Electric Panels, Meter Boxes and Disconnects be sealed between the box and the Exterior cladding to help prevent water penetration.

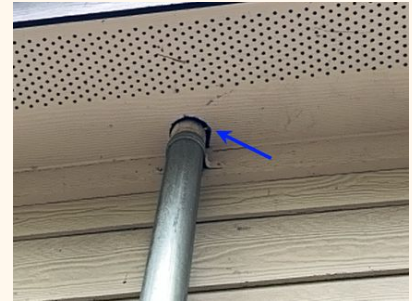
Seal gaps and holes in soffit to help prevent water penetration and rodent intrusion. Mainly at -

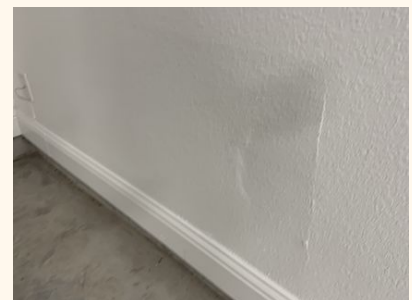
*Garage*

There is damage to the drywall, recommend repairs as needed. Mainly at -

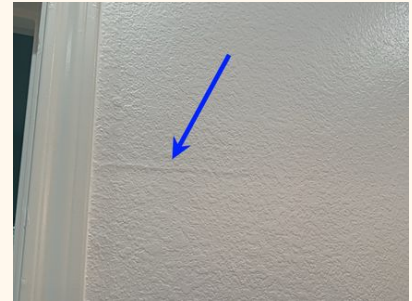
*Wall outside of front bedroom*

Settlement cracks were noted at the tape joint in the drywall. The following locations were noted:

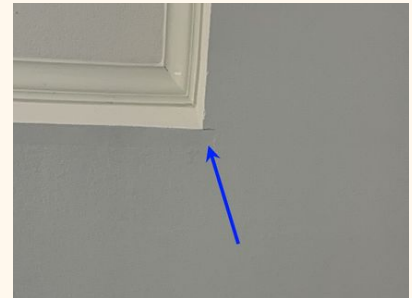
*Primary bedroom*

Settlement cracks were noted at the corner bead/tape joint in the drywall. Mainly at -

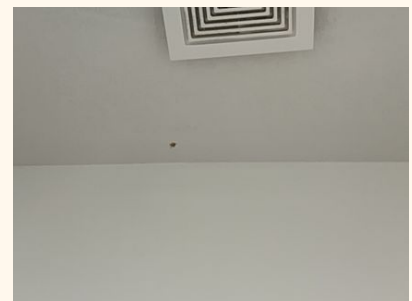
*Shared bath*

Nail pops were noted in the ceiling. These are generally considered cosmetic only, unless otherwise noted. Mainly at -

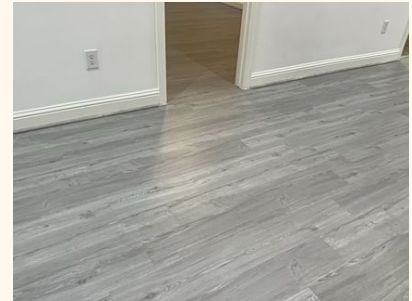
Uneven or sloping floors were noted. Sometimes in older homes minor slopes may be due to construction methods at that time, however if floors are sloping more than normal it is recommended that some follow up investigation be made. Sloping floors can be caused by foundation movement or from structural issues usually on upper floors. Floors were noted to be sloped. Mainly at - throughout

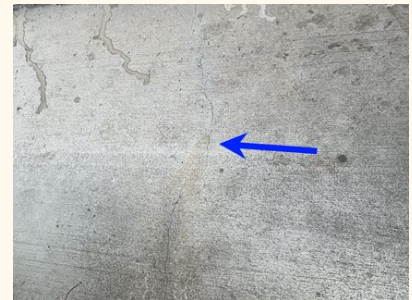
*Porch*

Cracks were noted in the pavement. These are cosmetic in nature at this time. Recommend sealing to help prevent further deterioration. Mainly at -

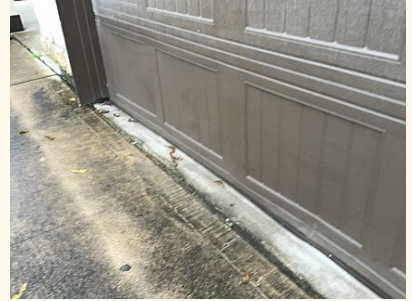
Garage door is dented.

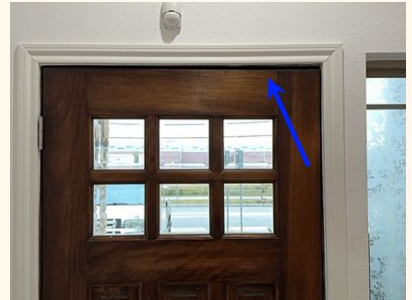
*Front door*

The door is not square in jamb. Mainly at -

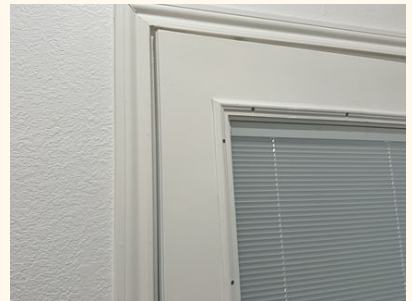
*Rear door*

The door hits the frame when closing. Mainly at -

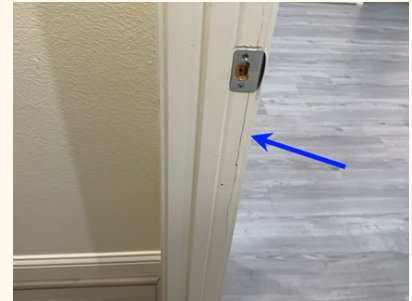
Pantry

The door jamb/frame is cracked or damaged. Recommend repairs to help prevent unwanted entry. Mainly at -

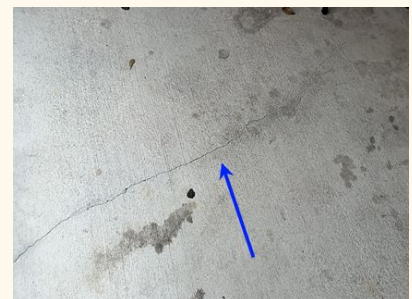
Minor settlement cracks are noted on the patio.

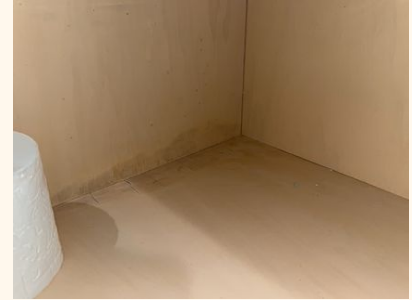
*Upstairs shared bath*

**🔧 (SS-37) Recommended Repair:** There are signs of water damage in the cabinet under sink. Mainly at -

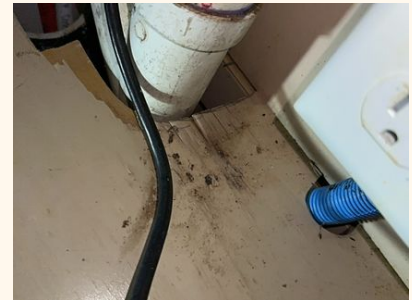
*Kitchen*

**🔧 (SS-38) Recommended Repair:**  
There are mold like stains under the sink. Mainly at -

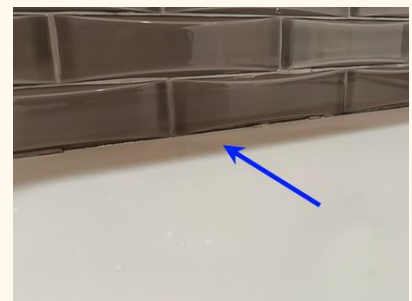
*Kitchen*

**🔧 (SS-39) Recommended Repair:**  
Seal counter top at wall connection to help prevent moisture penetration in the event of a spill. Mainly at -

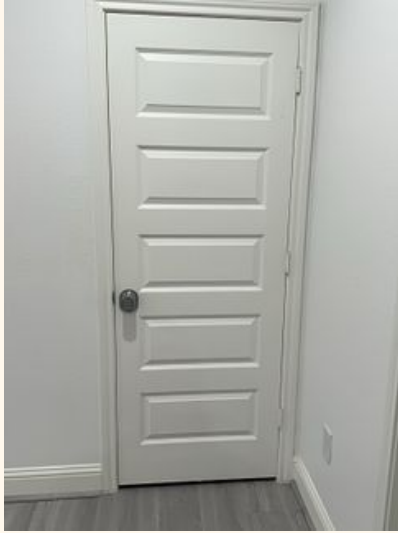
*Second floor hallway*

**🔧 (SS-40) Recommended Repair:** Some areas have limited access due to a locked door. Mainly at -

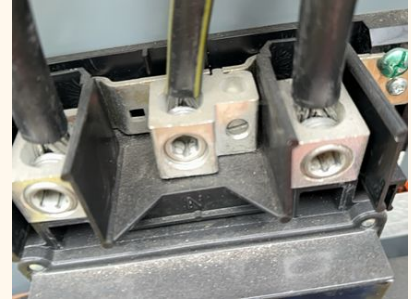
There is no antioxidant on main aluminum feeds to the panel box. This should be used to help prevent overheating.

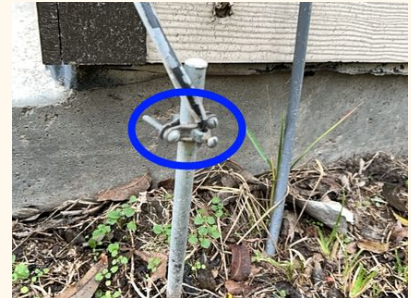
There is an improper ground rod clamp, it is recommended that ground wires be secured with the proper acorn style clamp for proper protection.

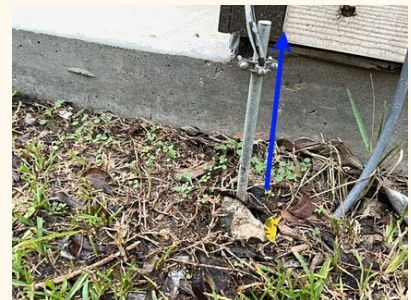
There are indications that the ground rod is not at the proper depth. The ground rod should be 8' deep. (This means it should be down to ground level since most ground rods are 8' in length)

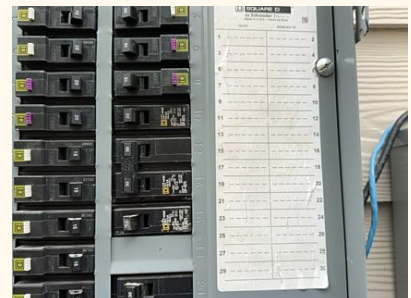
The breakers in the main electrical panel are not labeled.

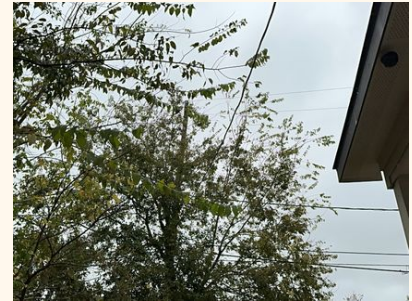
Electrical feeds were running through the trees, recommend trimming limbs from wires.

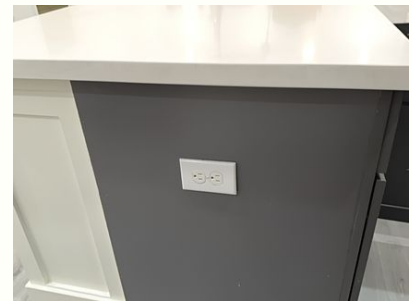
As of 2023, kitchen island receptacles are no longer allowed to be installed in the exposed vertical surfaces below the countertop. Per the NEC 210.52(C)(2) Island and Peninsular Countertops and work surface receptacles, if installed, shall be located in one or more of the following areas. (1) On or above, but not exceeding 20 inches above, a countertop or work surface. (2) In a countertop using receptacle outlet assemblies listed for use in countertops. (3) In a work surface using receptacle outlet assemblies listed for use in work surfaces or listed for use in countertops.

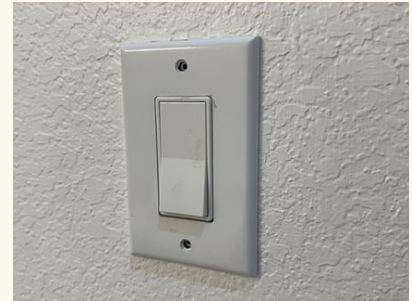
*Front right bedroom bath*

Switch plate missing fasteners. Mainly at -

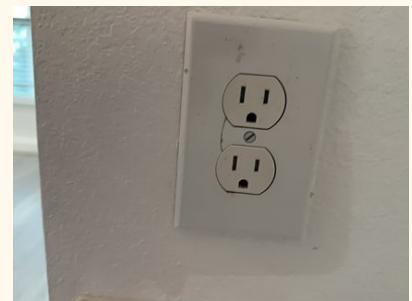
*Bar area*

Receptacle plate is broken or missing, recommend replacing covers to help prevent electrical shock. Mainly at - various locations

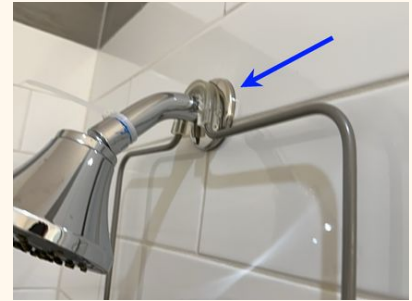
All tub shower faucets and spouts should be sealed to help prevent water penetration behind the fixture.

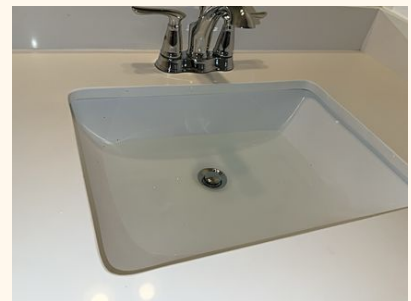
*Upstairs shared bath*

**🔧 (PS-9) Recommended Repair:**  
The bath sink drains very slow. Mainly at -

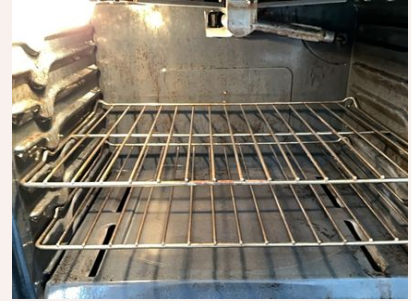
*Oven is dirty, recommend cleaning.*

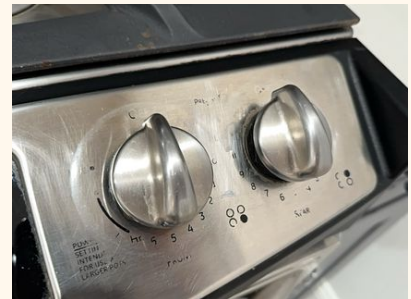
*The knobs on the cooktop are worn and unreadable.*

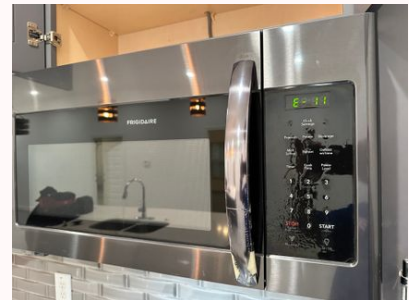
The microwave is not operating at time of inspection. (Error code given when testing)

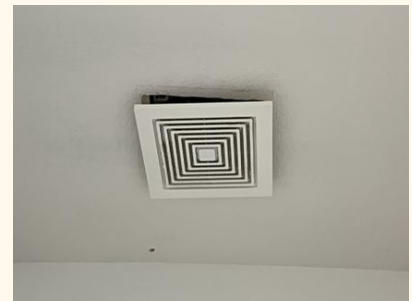
*The bath or laundry exhaust fan cover is loose to the ceiling.*

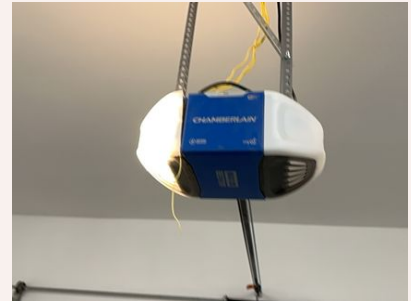
Light is not functioning, recommend changing bulb to verify fixture.

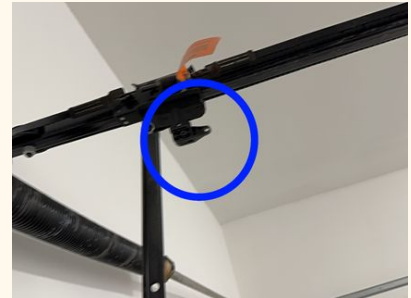
Track disengaging pull string missing.

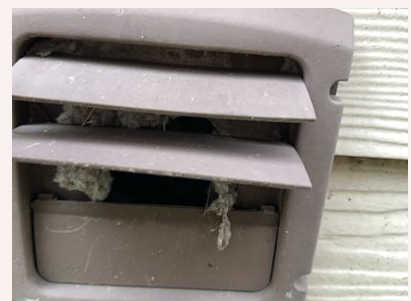
Recommend dryer vent cleaning to restore dryer duct to an operable condition. Dryer ducts becoming clogged can inhibit the dryer's performance as well as become a potential fire hazard in the home.

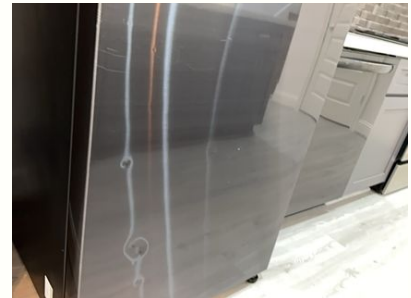
Refrigerator door dented/damaged.
