INSPECTION REPORT

**Property Address
4829 Golden Forest Dr
Houston, TX 77091
September 2, 2024**

PROPERTY INSPECTION REPORT FORM

Joey Gumataotao <i>Name of Client</i>	09/02/2024 <i>Date of Inspection</i>
4829 Golden Forest DrHouston, TX 77091 <i>Address of Inspected Property</i>	
Angel Medina <i>Name of Inspector</i>	24264 <i>TREC License #</i>

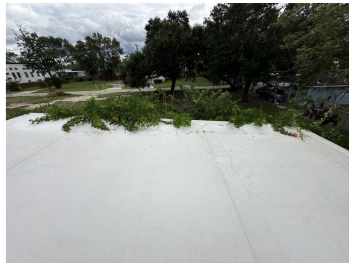
- **Tree Branches and Limbs - Extending over the roof covering**

Tree branches and limbs were observed extending over the roof. Overhanging branches and limbs can potentially cause damage to the roof covering, fascia, soffit, and eave materials. The weight and movement of these branches may lead to physical damage, such as scratches or punctures in the roofing material, and can also obstruct proper water drainage. Consult with a tree service company to trim the branches and limbs away from the roof. This will help prevent damage to the roofing materials and surrounding structures, ensuring the long-term integrity and performance of the roof. Regular tree maintenance is advised to avoid future issues and maintain a clear distance between trees and roofing.

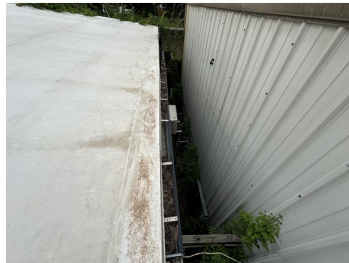
Observed that the guttering system had accumulated leaves and debris. This build-up of asphalt shingle granules can impede the flow of water and hinder the system's ability to provide proper drainage. Additionally this condition increases the vulnerability of the underlying layers of the roof covering to water intrusion. Recommend cleaning out the guttering system to remove the leaves and debris, ensuring unrestricted water flow and effective drainage.

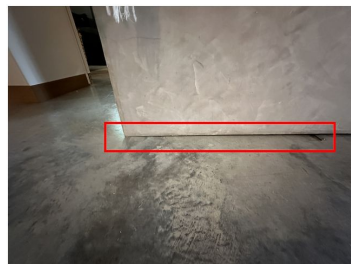
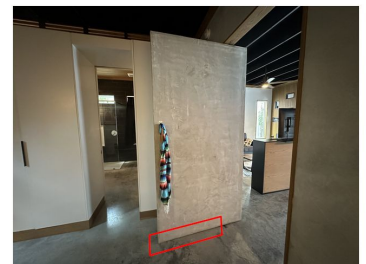
Interior Double Doors - Misaligned

The interior door was found to be misaligned, causing rubbing at the floor. This misalignment can lead to issues with the door closing properly, potentially affecting their functionality and appearance. It is recommended to adjust the alignment of the door to ensure they close properly and align correctly. This adjustment will help prevent rubbing, reduce gaps, and improve both the operation and aesthetic of the door.

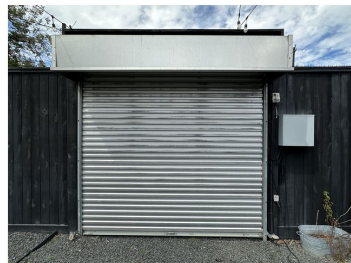
Overhead Door

The overhead door could not be opened because the remote control was not functioning. This prevents access and use of the overhead door. It is recommended to replace or repair the remote control to restore its functionality. If the issue persists, consult with a professional garage door technician to diagnose and resolve any underlying problems with the door opener system.

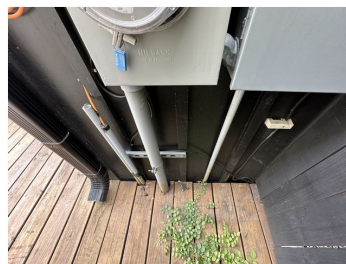
- **Grounding Rod - Not verified**

The inspector was unable to visually verify the installation of the ground electrode rod (grounding rod). It appeared that the ground rod and clamp were driven below the ground level. The ground electrode rod should be installed with the top at least 2 inches above ground level, and the ground rod clamp should be visible to ensure proper grounding and easy inspection. The current installation poses a safety hazard until corrected. Consult with a qualified, licensed electrician for a thorough evaluation and necessary corrections. Ensuring the proper installation of the grounding rod is essential for electrical safety and compliance with standards.

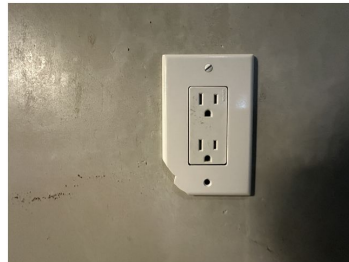
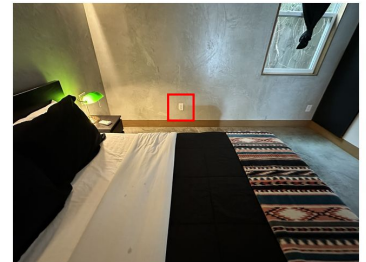
● **Receptacle Cover - Damaged (Broken)**

The receptacle cover plate was damaged (broken) at the corner. For safety reasons, it is recommended to replace the cover plate.

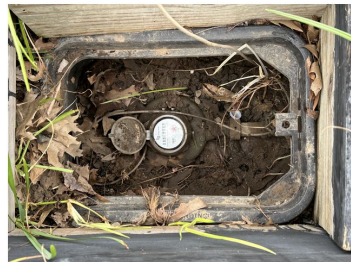
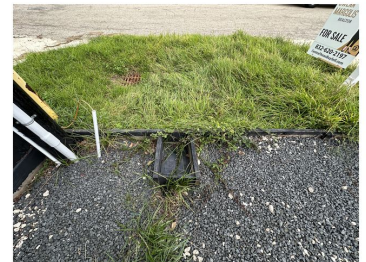
The inspector observed mud inside the water meter box, obstructing the view of the water pipes. The presence of mud inside the water meter box prevented the inspection of the pipes and connections, making it impossible to assess for potential leaks or other issues. This obstruction can hide existing problems that may require attention, leading to undetected issues that could worsen over time. Consult with a landscape professional to perform a thorough cleaning of the inside of the water meter box. This will allow for a proper inspection of the pipes and connections to ensure there are no leaks or other issues. Regular maintenance of the water meter box is also advised to prevent future obstructions.

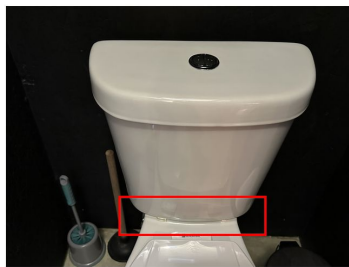
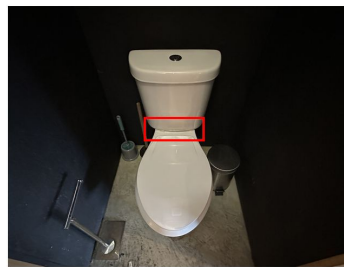
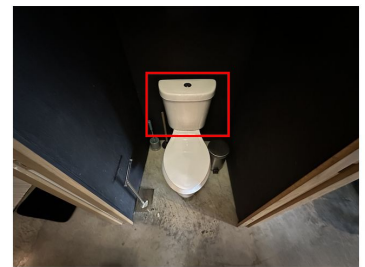
● **Toilet Tank - Loose at the bowl connection**

The toilet tank was loose at the bowl connection. This instability was noticeable, indicating that the tank was not securely attached to the toilet bowl. The loose connection presents a potential risk of water seepage between the tank and the toilet, which can lead to leaks. If left unaddressed, this condition may result in water damage to the surrounding areas, including the floor and underlying structures, as well as increase the likelihood of mold growth. Consult with a qualified, licensed plumber for a thorough evaluation of the toilet tank connection. Necessary corrections should be made to secure the tank properly and prevent any potential leaks.

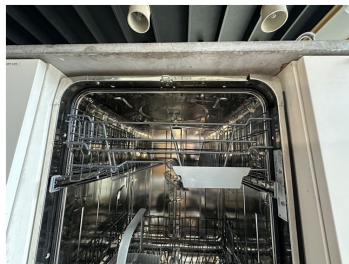
- **Dishwasher - Not securely fasten (anchored)**

The dishwasher was not securely fastened (anchored) under the cabinet opening, as the appropriate hardware was missing or improperly installed. This lack of secure anchoring can lead to instability, causing the appliance to shift during operation. Such movement poses a safety hazard, as the dishwasher could potentially tip or become dislodged, which may also result in functionality issues, such as improper alignment with plumbing connections or difficulty in opening and closing the door. It is advised to properly secure the dishwasher using the recommended anchoring hardware. Ensuring that the dishwasher is firmly attached to the cabinet will enhance safety by preventing any unintended movement and will also ensure the appliance functions correctly within its intended installation.

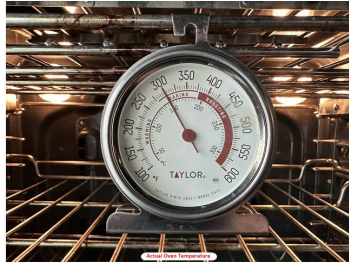
- **Oven - Discrepancy in oven temperature**

The oven was set to a test temperature of 350 degrees Fahrenheit. However, the actual temperature of the oven was measured at 265 degrees Fahrenheit. According to general standards, ovens should maintain a temperature within a range of 25 degrees Fahrenheit of the set temperature. The observed discrepancy of 85 degrees suggests that the oven is not functioning correctly and may be incapable of reaching or maintaining the desired cooking temperature. It is recommended to consult with a qualified professional appliance company to assess the oven's performance and conduct any necessary repairs or replacement. Ensuring the oven operates within acceptable temperature parameters is important for safe and efficient cooking.

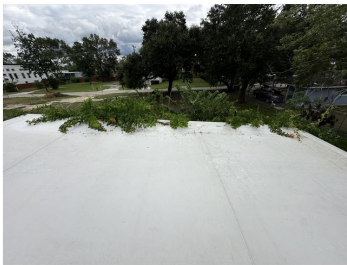
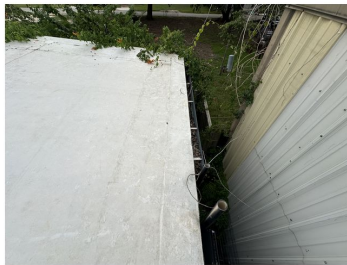
Tree branches and limbs were observed extending over the roof. Overhanging branches and limbs can potentially cause damage to the roof covering, fascia, soffit, and eave materials. The weight and movement of these branches may lead to physical damage, such as scratches or punctures in the roofing material, and can also obstruct proper water drainage. Consult with a tree service company to trim the branches and limbs away from the roof. This will help prevent damage to the roofing materials and surrounding structures, ensuring the long-term integrity and performance of the roof. Regular tree maintenance is advised to avoid future issues and maintain a clear distance between trees and roofing.

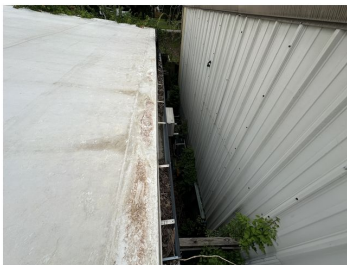
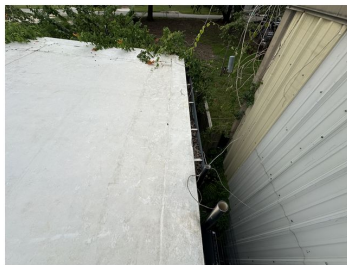
- **Guttering System - Accumulation leaves and debris**

Observed that the guttering system had accumulated leaves and debris. This build-up of asphalt shingle granules can impede the flow of water and hinder the system's ability to provide proper drainage. Additionally this condition increases the vulnerability of the underlying layers of the roof covering to water intrusion. Recommend cleaning out the guttering system to remove the leaves and debris, ensuring unrestricted water flow and effective drainage.

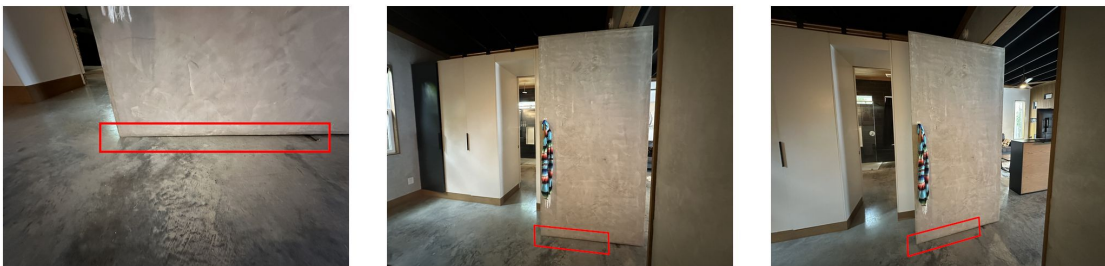
● **Interior Double Doors - Misaligned**

The interior door was found to be misaligned, causing rubbing at the floor. This misalignment can lead to issues with the door closing properly, potentially affecting their functionality and appearance. It is recommended to adjust the alignment of the door to ensure they close properly and align correctly. This adjustment will help prevent rubbing, reduce gaps, and improve both the operation and aesthetic of the door.

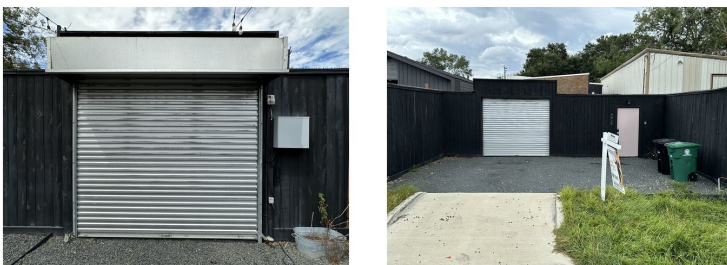
● **Overhead Door**

The overhead door could not be opened because the remote control was not functioning. This prevents access and use of the overhead door. It is recommended to replace or repair the remote control to restore its functionality. If the issue persists, consult with a professional garage door technician to diagnose and resolve any underlying problems with the door opener system.

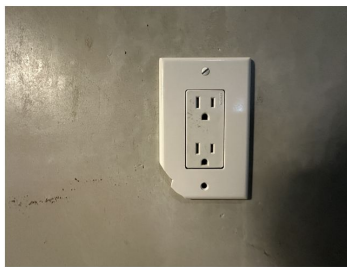
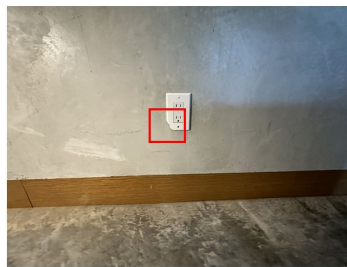
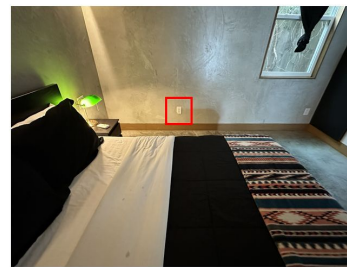
- **Receptacle Cover - Damaged (Broken)**

The receptacle cover plate was damaged (broken) at the corner. For safety reasons, it is recommended to replace the cover plate.

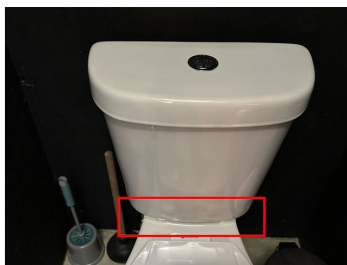
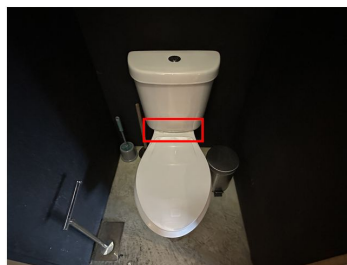
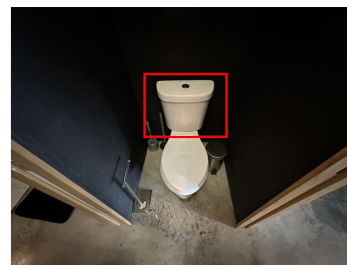
- **Toilet Tank - Loose at the bowl connection**

The toilet tank was loose at the bowl connection. This instability was noticeable, indicating that the tank was not securely attached to the toilet bowl. The loose connection presents a potential risk of water seepage between the tank and the toilet, which can lead to leaks. If left unaddressed, this condition may result in water damage to the surrounding areas, including the floor and underlying structures, as well as increase the likelihood of mold growth. Consult with a qualified, licensed plumber for a thorough evaluation of the toilet tank connection. Necessary corrections should be made to secure the tank properly and prevent any potential leaks.

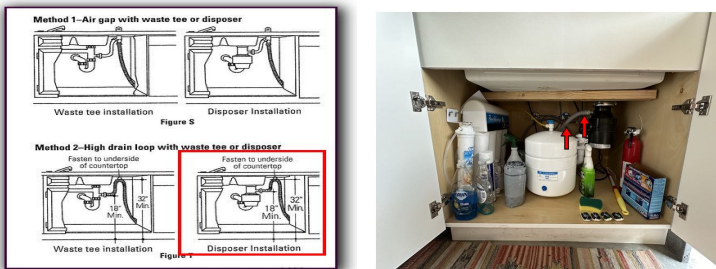
- **Dishwasher Drain Hose - Improperly installed**

The dishwasher drain hose was improperly installed, lacking the necessary high loop that prevents backflow. The hose was not securely attached to the underside of the countertop, which is essential for ensuring proper drainage. The improper installation of the drain hose poses a risk of backflow or anti-siphoning, potentially allowing wastewater to flow back into the dishwasher. This situation can lead to contamination of clean dishes and create unsanitary conditions in the kitchen. Over time, such issues can also lead to damage to the dishwasher and plumbing system. It is recommended to consult with a qualified, licensed plumbing contractor to further evaluate the installation of the dishwasher drain hose and perform the necessary repairs or replacements.

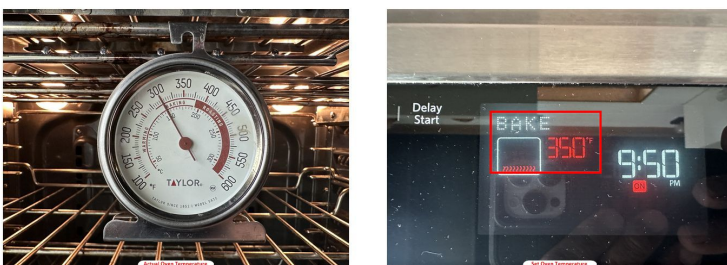
- **Oven - Discrepancy in oven temperature**

The oven was set to a test temperature of 350 degrees Fahrenheit. However, the actual temperature of the oven was measured at 265 degrees Fahrenheit. According to general standards, ovens should maintain a temperature within a range of 25 degrees Fahrenheit of the set temperature. The observed discrepancy of 85 degrees suggests that the oven is not functioning correctly and may be incapable of reaching or maintaining the desired cooking temperature. It is recommended to consult with a qualified professional appliance company to assess the oven's performance and conduct any necessary repairs or replacement. Ensuring the oven operates within acceptable temperature parameters is important for safe and efficient cooking.

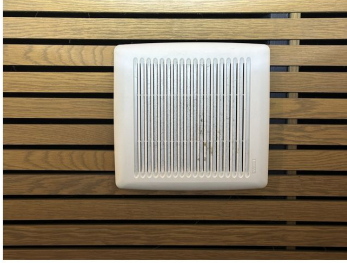
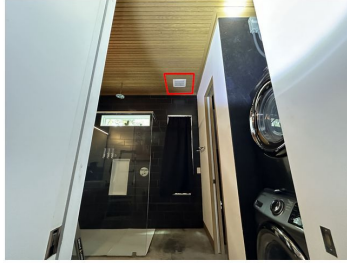
- **Mechanical Exhaust Fan Vent Cover - Dirty fan grilles**

The exhaust vent cover fan grilles had accumulated a significant amount of dust and lint. The presence of dust and lint can impede the airflow through the grilles, which can lead to compromised ventilation. Additionally, the accumulation of dust and lint on the fan blades can result in reduced efficiency and pose a potential risk of overheating the fan motor. Recommend cleaning the exhaust vent cover and removal of any accumulated dust and lint from the fan blades.
