INSPECTION REPORT

**Property Address
2809 Rosedale St
Houston, TX 77004
September 5, 2024**

Angel Home Inspections

PROPERTY INSPECTION REPORT FORM

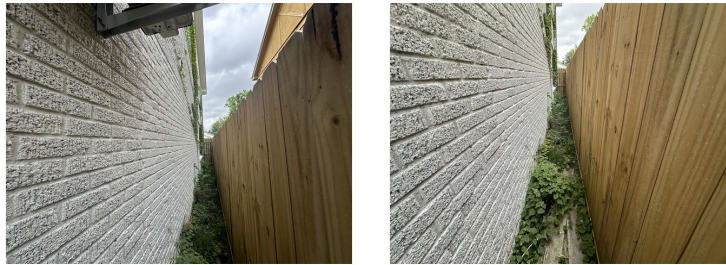
Foliage was observed growing on the exterior walls of the structure. This plant growth can trap moisture against the walls, leading to potential deterioration of materials like siding, fascia, and soffit. Over time, this moisture can cause structural damage and create an inviting environment for pests. The overgrown foliage also obstructs visual inspection of the exterior surfaces, making it difficult to identify any underlying issues or defects. Recommend trimming all bushes, shrubs, plants, and vines back at least 18 inches from the walls to help protect the structure and maintain its integrity.

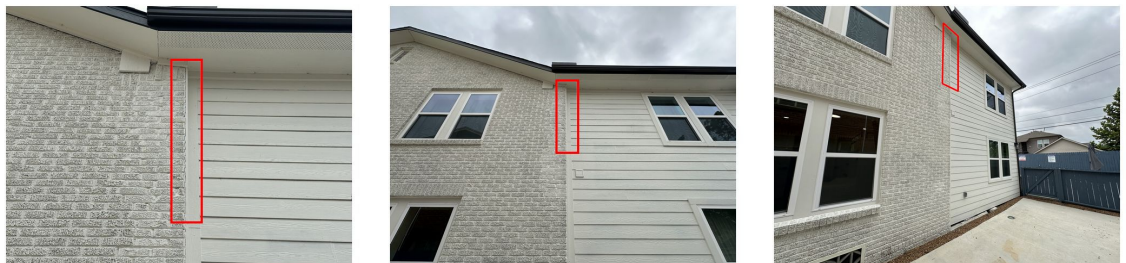
- **Exterior Wall - Gap between trim board and wall**

Sealant was observed to be missing between the trim board and the exterior wall. This gap can allow water intrusion, which may lead to moisture damage and wood rot over time. Proper sealing is essential to prevent water from penetrating the area and compromising the integrity of the trim and underlying wall structure. Recommend applying a high-quality exterior sealant to fill the gap and protect the structure from potential water damage.

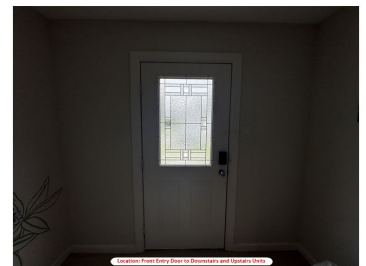
• **Floor - Weather-Stripping at threshold - Loose**

The weather-stripping on the door threshold was observed to be loose. This can create gaps that allow drafts, moisture, and pests to enter, reducing the energy efficiency of the home and potentially causing damage over time. Proper weather-stripping ensures a tight seal, helping to maintain indoor temperatures and protect against external elements. It is recommended to repair or replace the loose weather-stripping to restore a secure seal and improve the overall efficiency of the door.

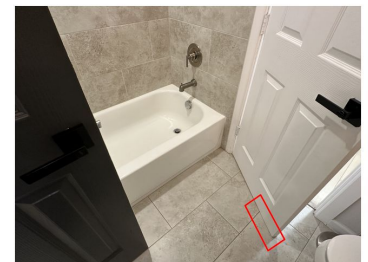
The interior door was observed rubbing along the bottom rail on the floor, making it difficult to open or close and causing irregular operation. This issue suggests that the hinges may require readjustment or replacement. Recommend adjusting or replacing the hinges, to restore the door's smooth functionality and ensure proper operation.

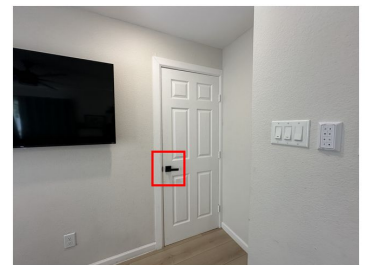
- **Door - Will not latch properly**

The door did not latch properly when closed. A noticeable misalignment was observed between the latch mechanism and the strike plate, preventing the door from securing effectively in its closed position. Recommend adjusting either the door latch or the strike plate to achieve proper alignment. This may involve repositioning the strike plate or making slight adjustments to the door hinges. If these adjustments do not resolve the issue, consult with a qualified carpenter or handyman for further evaluation and corrective measures to ensure the door latches securely and operates smoothly.

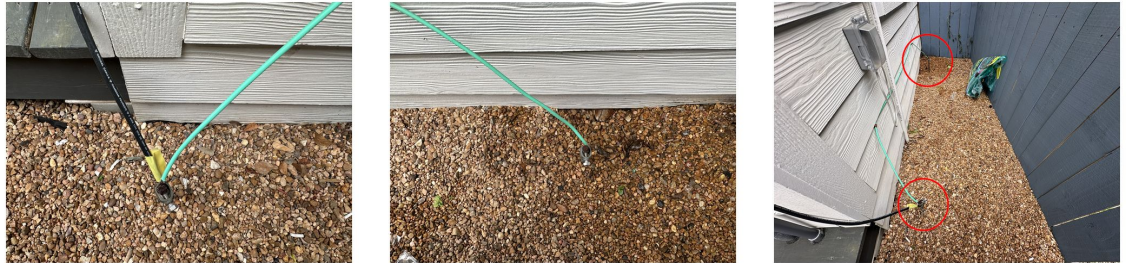
- **Main Breaker Box Grounding**
Location: Exterior Wall - Right Side (Facing Rear of Home)

further evaluation and any necessary corrections to ensure compliance with the recommended depth and visibility of the grounding rod and clamp connection, addressing any potential safety issues.

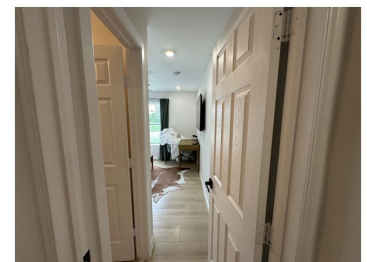
Additional Note: In accordance with fire alarm code requirements, it is mandatory to have smoke alarms installed inside every sleep room, even for existing homes. Furthermore, smoke alarms should be placed outside each sleeping area and on every level of the home as a minimum standard. Therefore, it is strongly recommended to reinstall the smoke alarms to comply with fire alarm code and maintain a safe living environment.

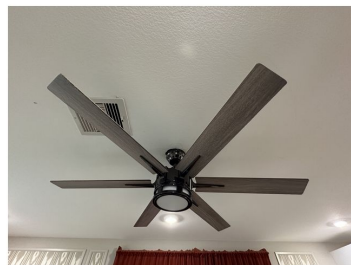
- **Ceiling Fan and Light Fixture - Inoperative**
Location: Downstairs Unit - Family Room

The ceiling fan and light fixture were inoperative during the functionally test. This issue could be related to an electrical problem, electrical connection problems, faulty wiring, malfunctioning component within the fixtures themselves, or a faulty switch. This inoperability can affect the effectiveness of air circulation and comfort within the space. Consult with a qualified, licensed electrician evaluate the cause of the inoperability and perform any necessary repairs or replacement to restore proper functionality and ensure the fan and light operate safety and effectively.

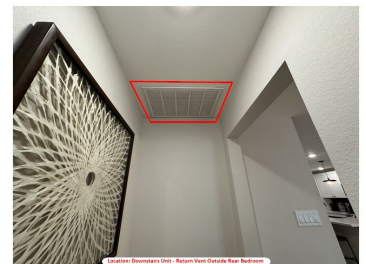
The filters at the return vents of the HVAC system were dirty filled with dust. This accumulation of contaminants restricts airflow, forcing the HVAC system to work harder to maintain desired temperatures. The reduced airflow can negatively impact the system's performance and efficiency, leading to compromised indoor air quality, increased energy consumption, and higher utility bills. Additionally, prolonged use of dirty filters can shorten the operational life of the HVAC system and lead to costly maintenance issues. It is recommended to replace the air filters to ensure optimal airflow, energy efficiency, and indoor air quality. It is advisable to replace the filters every 1-3 months, depending on usage and environmental factors.

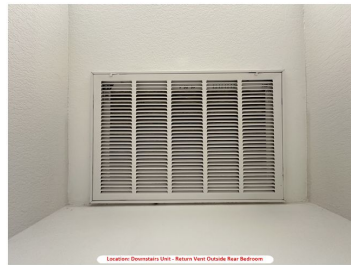
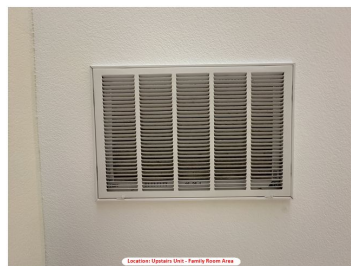
● **Return Vent Grilles - Dirty**

The grilles on the return vents for the HVAC system were found to be dirty, containing dust and lint particles that are pulled into the system. These contaminants are drawn into the HVAC system which can adversely affect performance by straining the air handler fan motor, potentially leading to motor burnout, overheating, and system failure. It is recommended to clean the return vents to improve the HVAC system's efficiency, prolong its operating life, contribute to energy savings, and reduce maintenance costs. **Note:** The photos provided serve as a visual representation (examples) of all return vent covers that require cleaning.

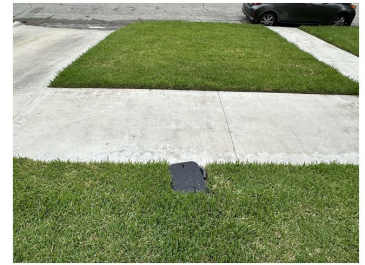
The inspector observed mud inside the water meter box, obstructing the view of the water pipes. The presence of mud inside the water meter box prevented the inspection of the pipes and connections, making it impossible to assess for potential leaks or other issues. This obstruction can hide existing problems that may require attention, leading to undetected issues that could worsen over time. Recommend removing the mud from the meter box, ensuring that the pipes and connections are visible and accessible. This will allow for a proper inspection of the pipes and connections to ensure there are no leaks or other issues. Regular maintenance of the water meter box is also advised to prevent future obstructions.

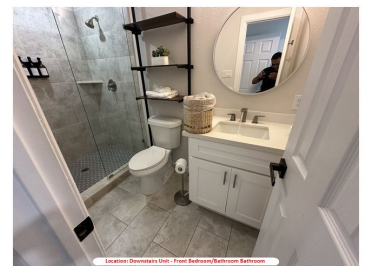
● **Toilet Tank - Loose at the bowl connection**

The toilet tank was loose at the bowl connection. This instability was noticeable, indicating that the tank was not securely attached to the toilet bowl. The loose connection presents a potential risk of water seepage between the tank and the toilet, which can lead to leaks. If left unaddressed, this condition may result in water damage to the surrounding areas, including the floor and underlying structures, as well as increase the likelihood of mold growth. Consult with a qualified, licensed plumber for a thorough evaluation of the toilet tank connection. Necessary corrections should be made to secure the tank properly and prevent any potential leaks.

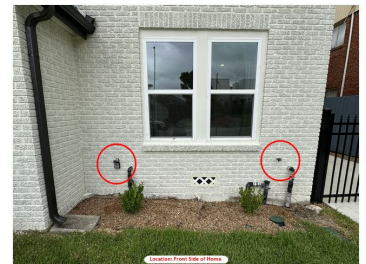
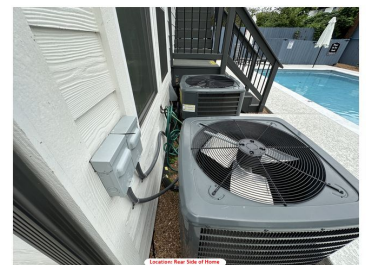
● **Hose Bibs/Spigot Vacuum Breakers (Backflow Preventers) - Missing**
Locations: Front and Rear Side of Home

Note: The anti-siphon devices were not required at the time the structure was built, it is important to report this as a deficiency in accordance with TREC (Texas Real Estate Commission) standards of practice.

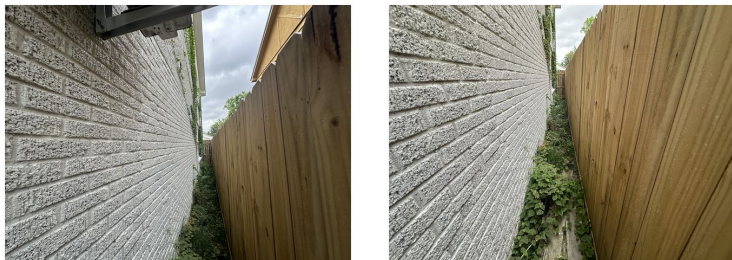
Foliage was observed growing on the exterior walls of the structure. This plant growth can trap moisture against the walls, leading to potential deterioration of materials like siding, fascia, and soffit. Over time, this moisture can cause structural damage and create an inviting environment for pests. The overgrown foliage also obstructs visual inspection of the exterior surfaces, making it difficult to identify any underlying issues or defects. Recommend trimming all bushes, shrubs, plants, and vines back at least 18 inches from the walls to help protect the structure and maintain its integrity.
