CONFIDENTIAL INSPECTION REPORT

Mogul 1046 Wedgewood LLC

*1046 N Wedgewood Dr
Mesa, AZ 85203*

Tuesday, October 1, 2024

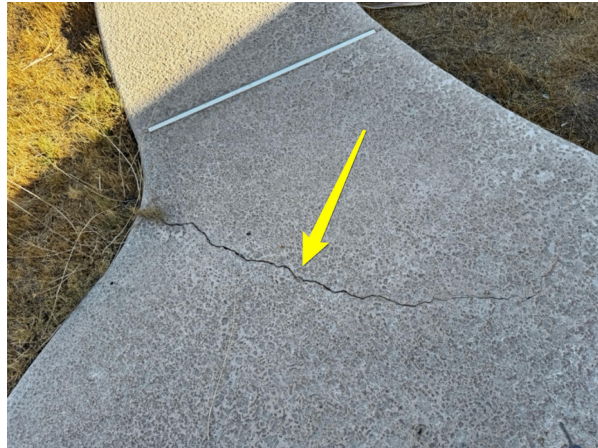
NOTE 11: Typical cracks were observed at the driveway, patio and walkway slabs - Review.

Example: crack

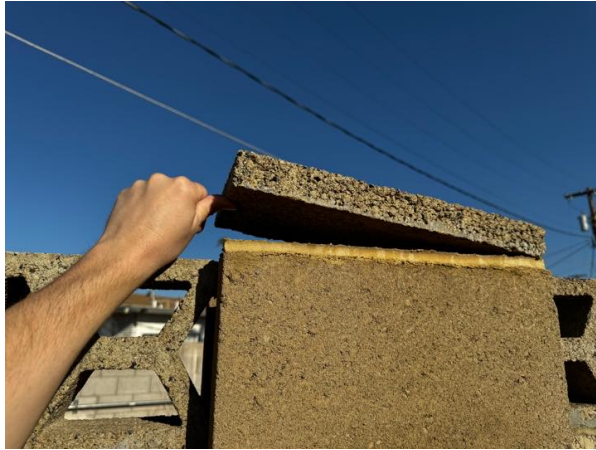
NOTE 13: Typical cracks/damage and evidence of displacement were observed at the block fence - Review.

Example: crack/damage/displacement

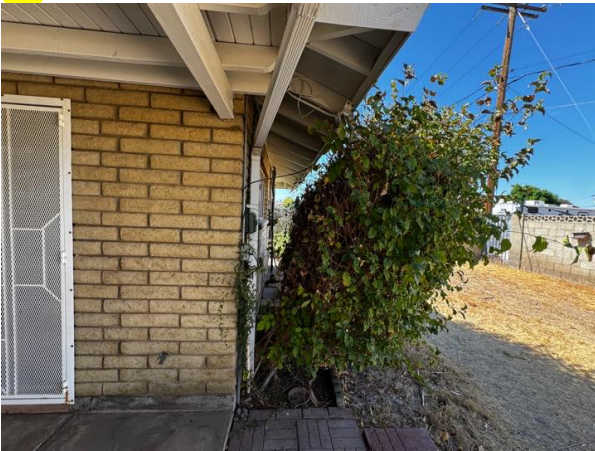
NOTE 22: Vegetation should be trimmed away from the structure - Attention.

Example: vegetation in contact with structure

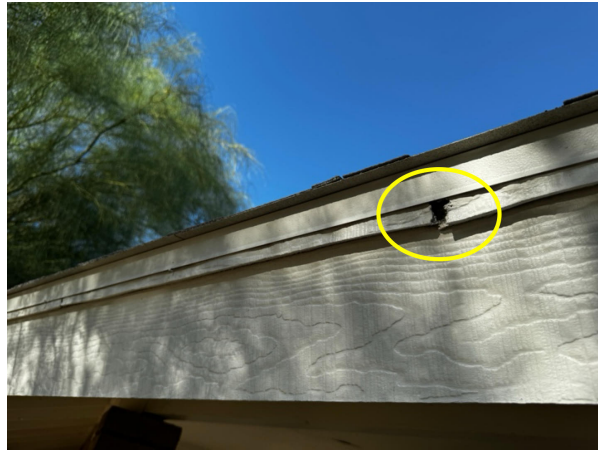
NOTE 24: Typical damage was observed at the eave areas - Review.

Example: damaged trim

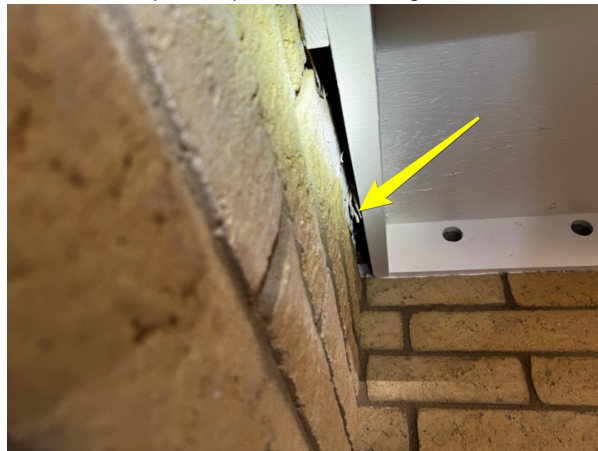
NOTE 25: There are gaps/openings at the eave areas that should be corrected to prevent pests from entering -Attention.

Example: gap/opening

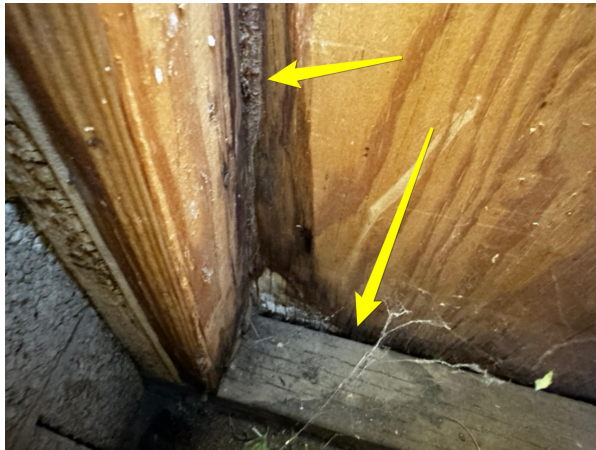
NOTE 31: Damage/deterioration and evidence of past roof leaks were observed at the storage room - Review.

Example: staining/deterioration

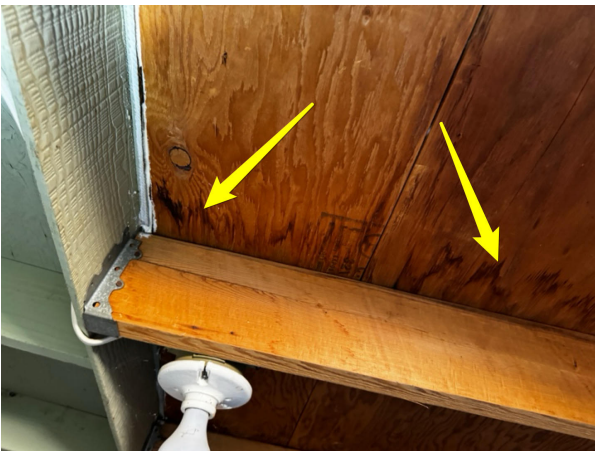
Example: moister staining

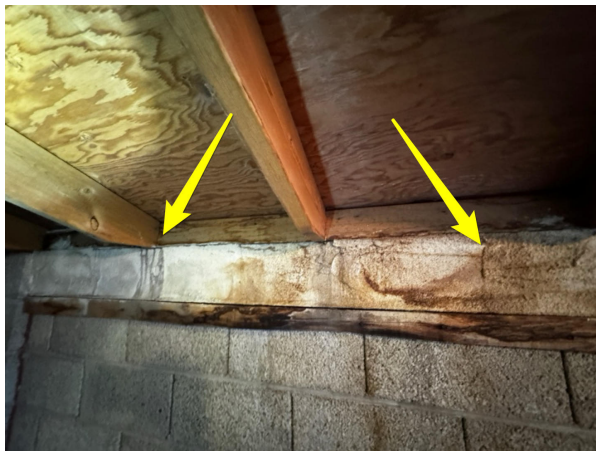
Example: moister staining

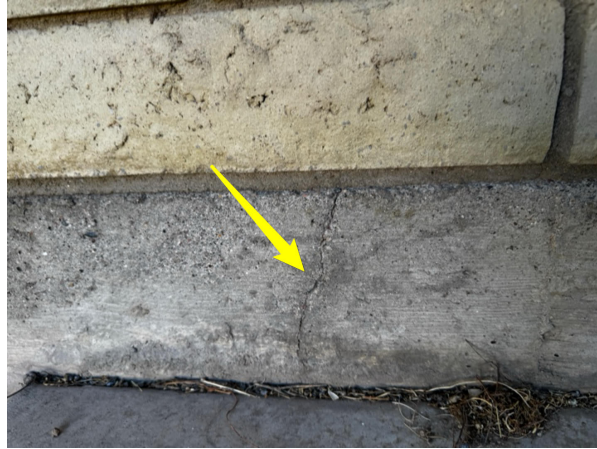
NOTE 32: Typical cracks and surface damage were observed at the foundation walls - Review.

Example: crack

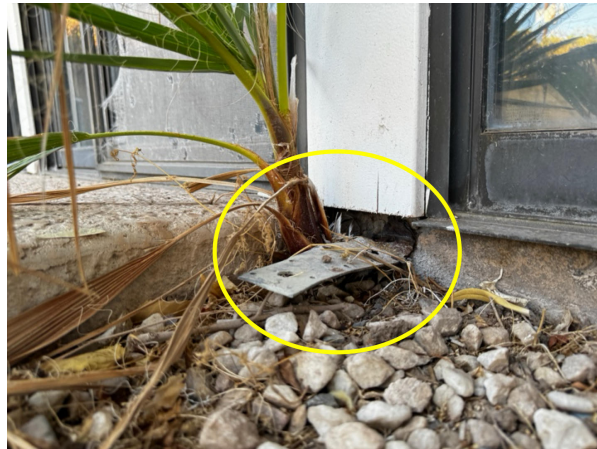
NOTE 33: Damage was observed at wall anchor areas of the foundation wall. Consult a specialist for further evaluation to determine the options for repair - Review. (e.g. rear addition)

Example: unsecured wall anchor

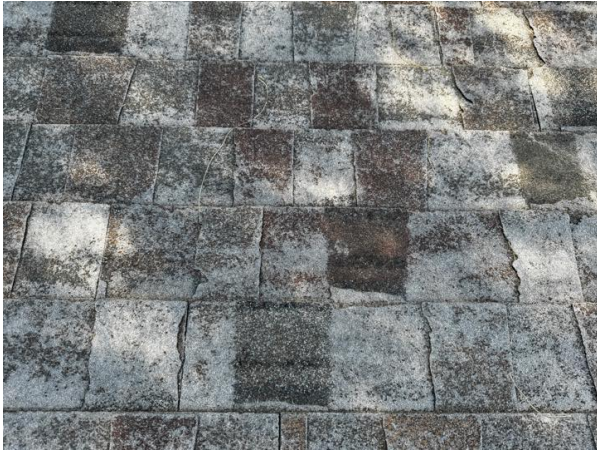
NOTE 37: The composition shingle roof appears to be at or near the end of its service life. Significant granule loss and material deterioration were observed. It should be further evaluated by a licensed roofer to determine options and cost of replacement - Review.

Example: deterioration/damage

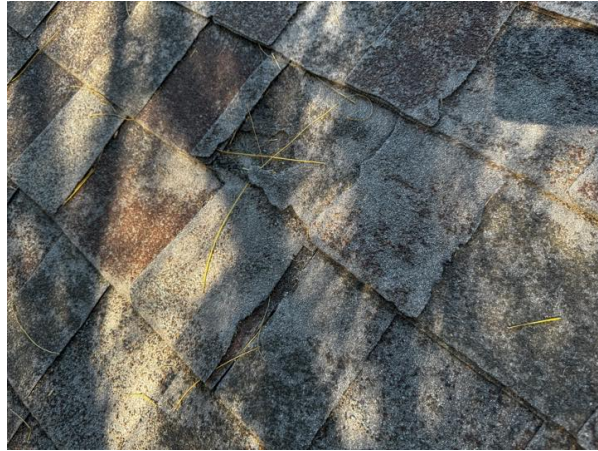
Example: deterioration/damage

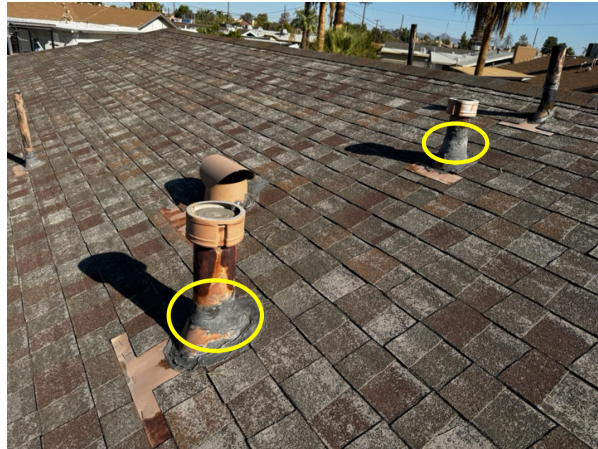
NOTE 38: Storm collars are not installed on the gas appliance vents at the roof level. These collars seal around the vent pipe at the top of the roof flashing and are required under current standards to prevent moisture infiltration; consider adding - Attention.

Example: storm collars not installed

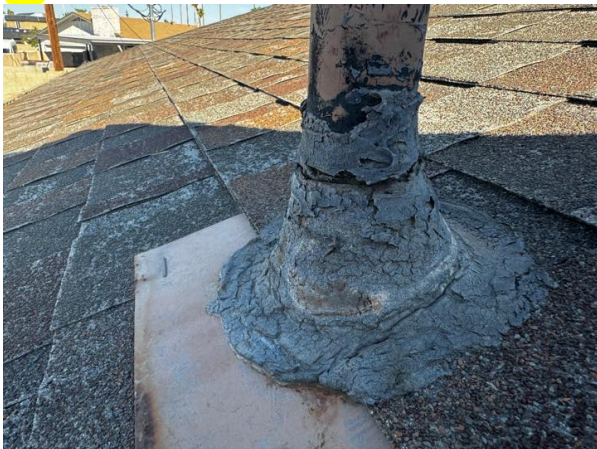
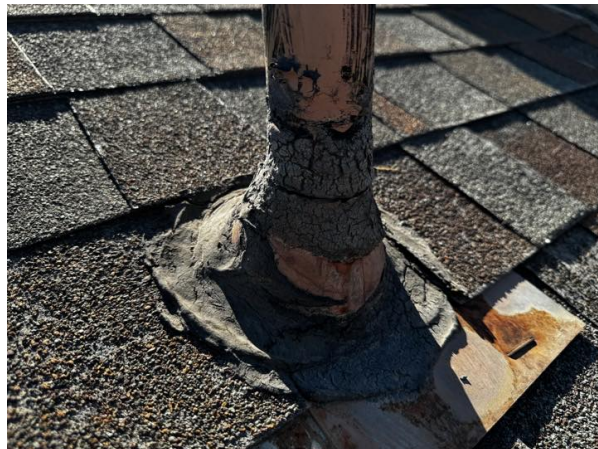
NOTE 39: Separations at roof flashings need to be sealed to prevent water entry - Attention (e.g. plumbing vents)

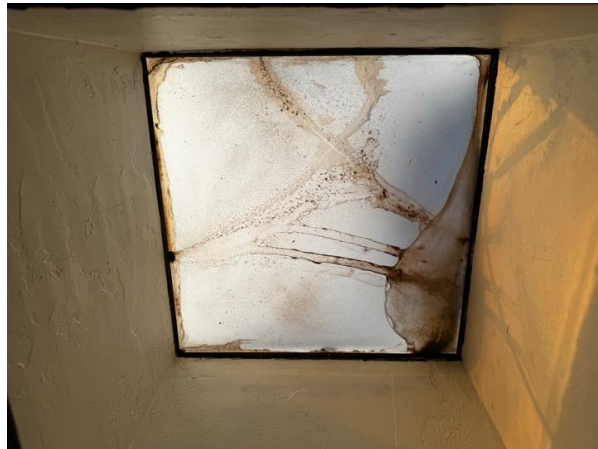
NOTE 45: The skylight lens is cracked/damaged and should be replaced - Attention.

Evidence of past leaking

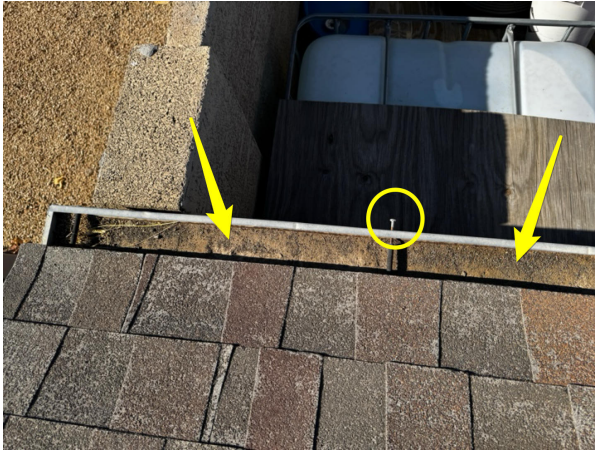
Example: gutter full of debris & loose anchor

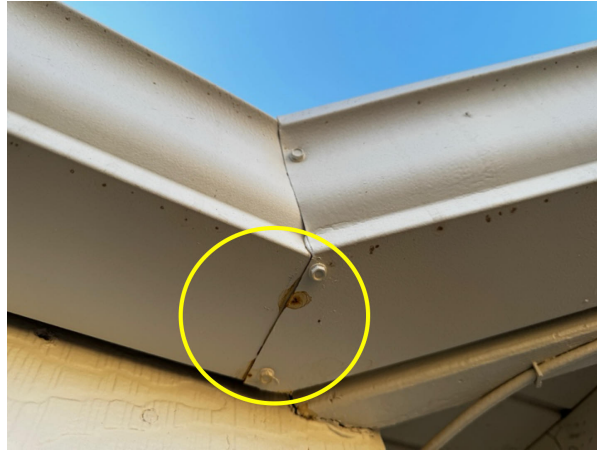
Example: evidence of leaking at seam

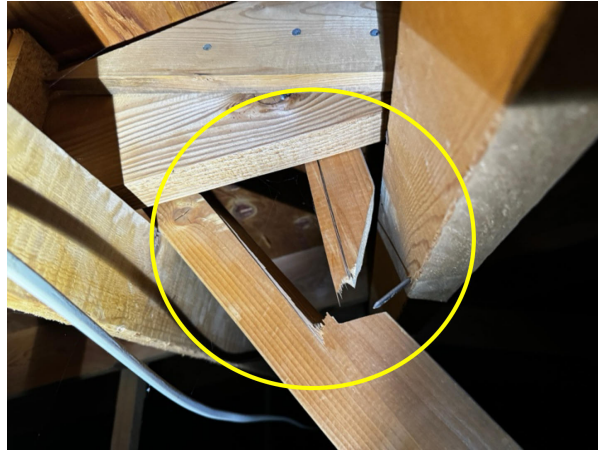
NOTE 50: A purlin within the attic is damaged/loose. Consult a licensed contractor to repair/repair as required - Attention. (e.g. above living room)

Example: loose framing

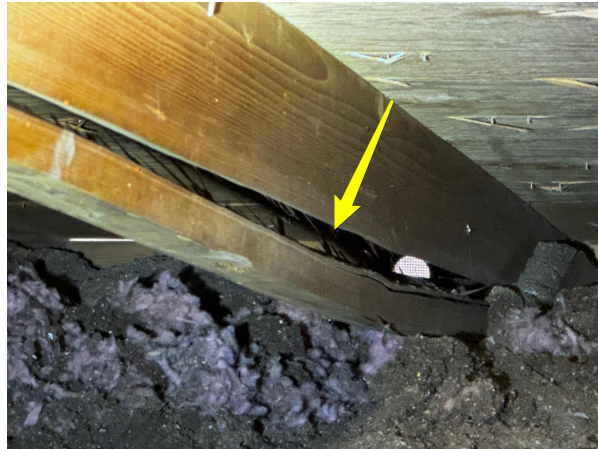
NOTE 51: A rafter within the attic is cracked/damaged. Consult a licensed contractor to repair/repair as required - Attention. (e.g. near front entry)

Example: cracked rafter

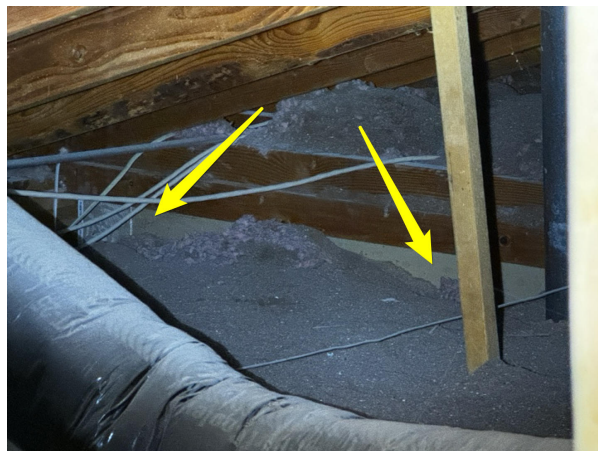
NOTE 56: Insulation within the attic is low and missing/displaced in areas. Additional material is needed for energy efficiency reasons and to comply with current building standards - Attention.

Example: missing insulation

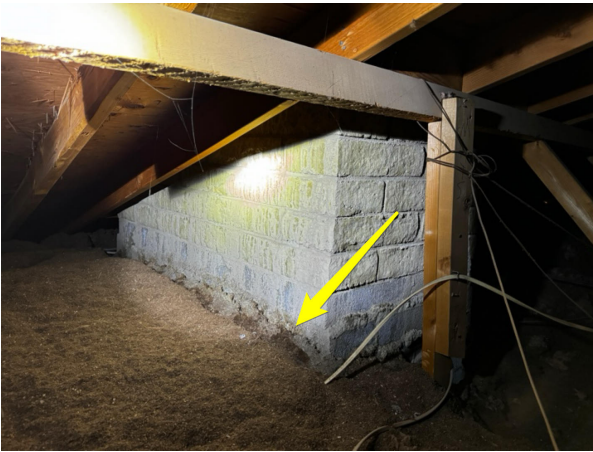
NOTE 58: There is moisture staining within the attic. You should obtain roof leak history/repair documents or have a licensed roofer evaluate the condition further - Review. (e.g. chimney penetration)

Example: moisture staining

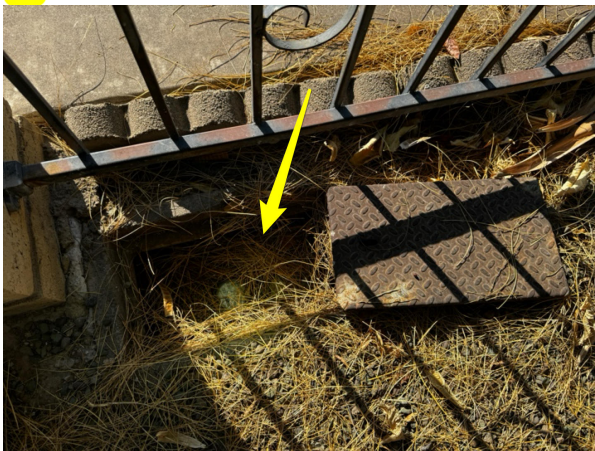
NOTE 63: The water meter box is filled with debris. Correction is recommended to provide access to the shut off valve - Attention.

Debris in meter box

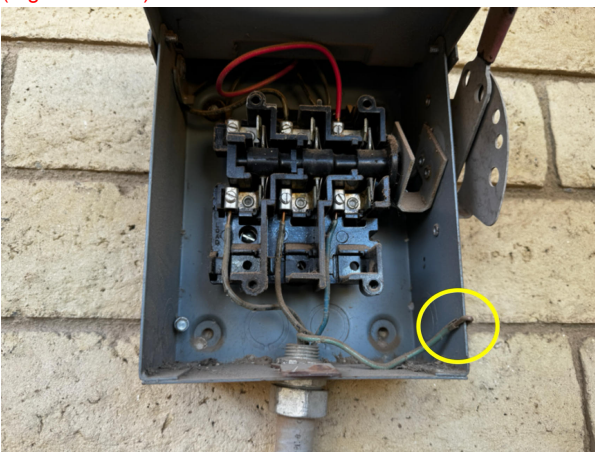
NOTE 107: A ground wire is not properly attached to the air conditioner electrical disconnect enclosure and should be corrected - Attention. (e.g. north unit)

Improper installation

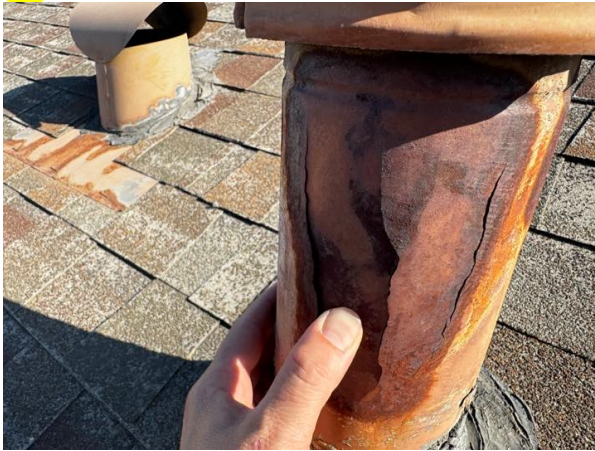
NOTE 116: The furnace vent pipes are rusted at the roof level. The south side flue is damaged and needs to be replaced - Attention.

Example: rusted/damaged flue

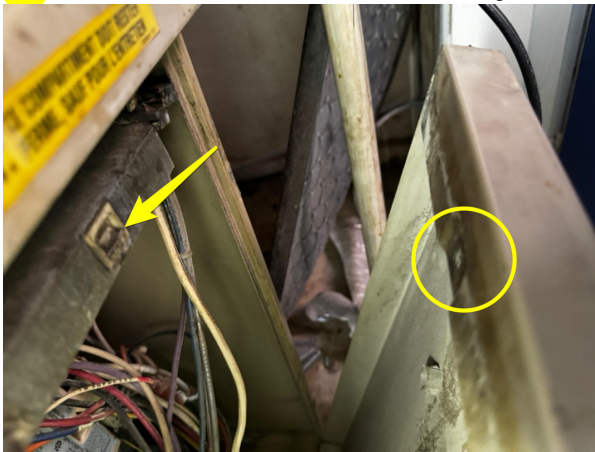
NOTE 117: A fastener at the furnace cover is damaged/missing - Attention. (e.g. north unit)

Loose cover

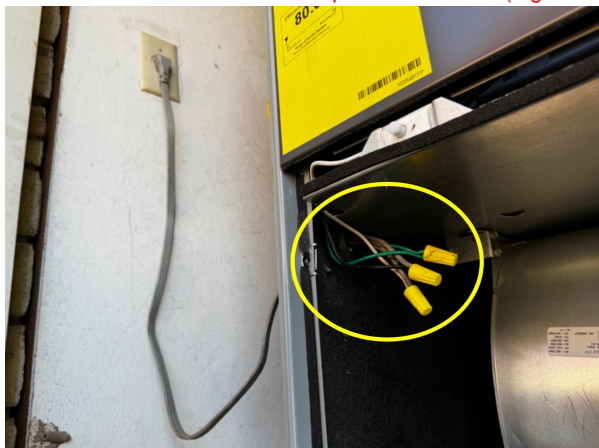
NOTE 118: The electrical connections at the furnace have been improperly made outside of an enclosed junction box. Consult a licensed HVAC technician to correct as required - Attention. (e.g. south unit)

Exposed wiring connections

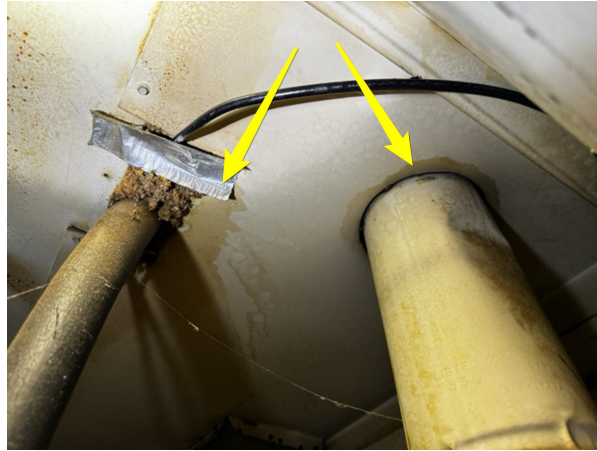
Example: moisture staining

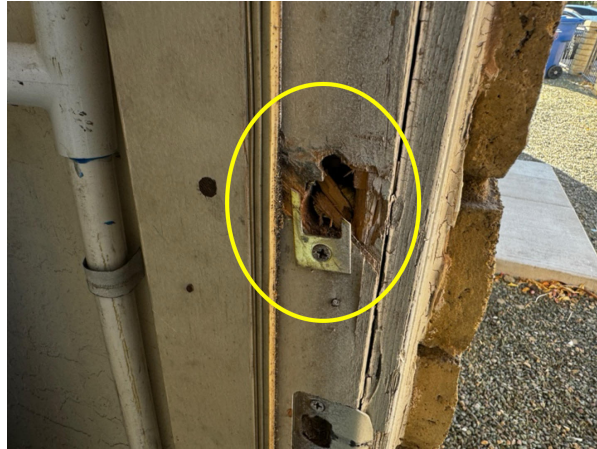
Example: damage at exterior closet door jamb

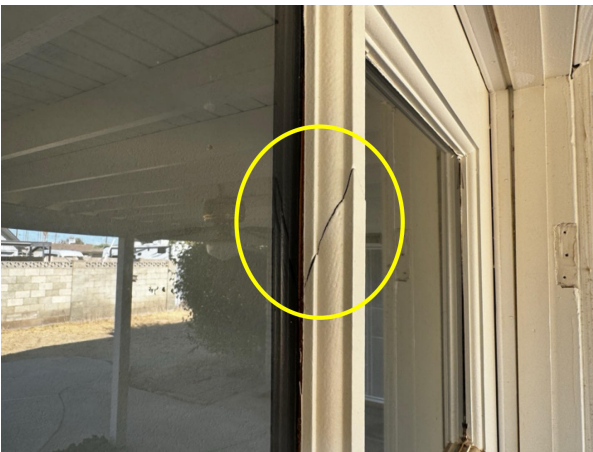
Example: damage at rear patio door trim

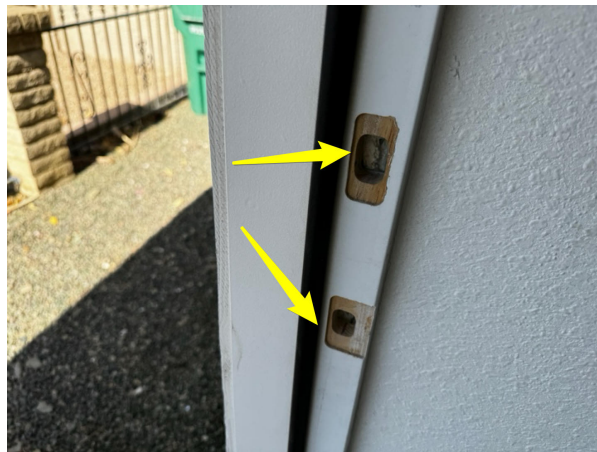
Example: missing strike plates at Room #9 door

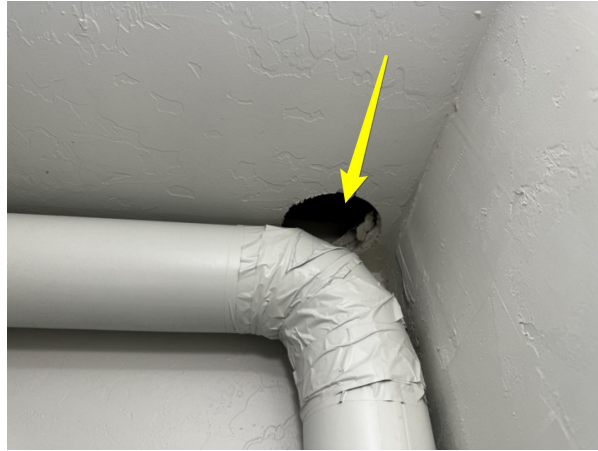
Example: hole in ceiling near dryer vent

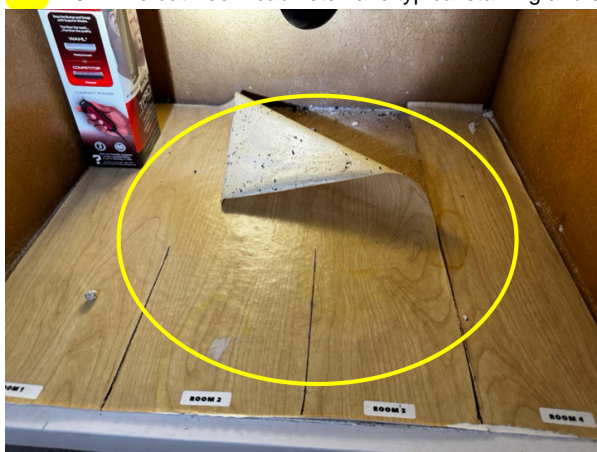
NOTE 187: The bathroom cabinets have typical staining and cosmetic damage - Review.

Example: staining/deterioration at north side hallway bathroom

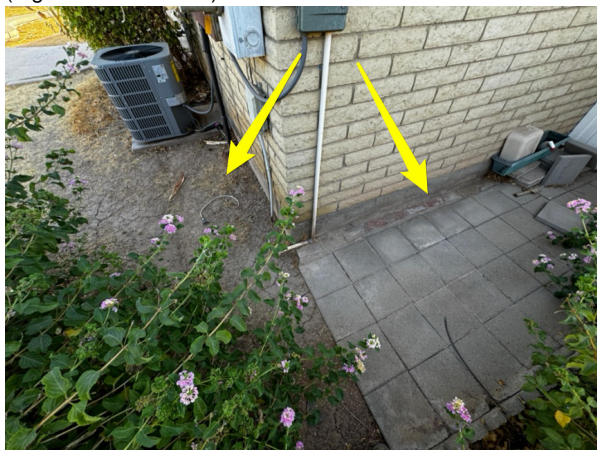
NOTE s-10: Site drainage is poor at areas. Alterations are recommended to control water flow and keep it away from the structure - Attention. (e.g. rear of structure)

Example: evidence of water ponding

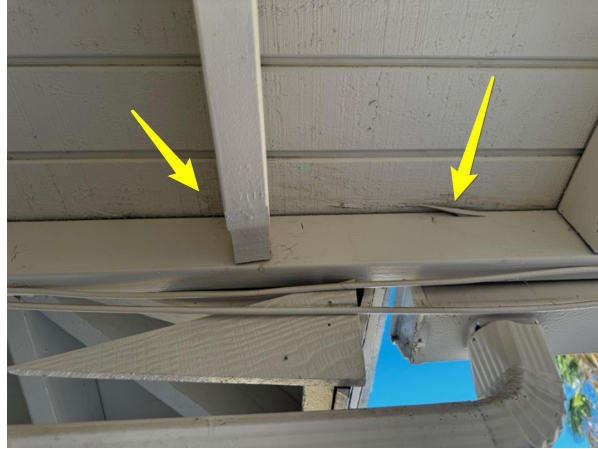
Example: moisture staining

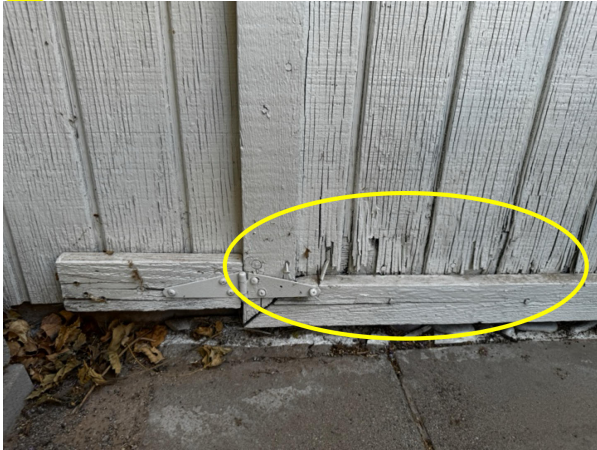
NOTE s-31: Damage/deterioration and evidence of past roof leaks were observed at the storage room - Review.

Example: damage/deterioration

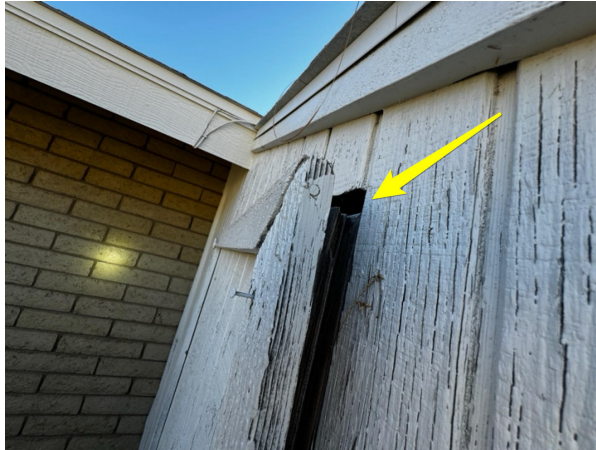
Example: door does not close/latch properly

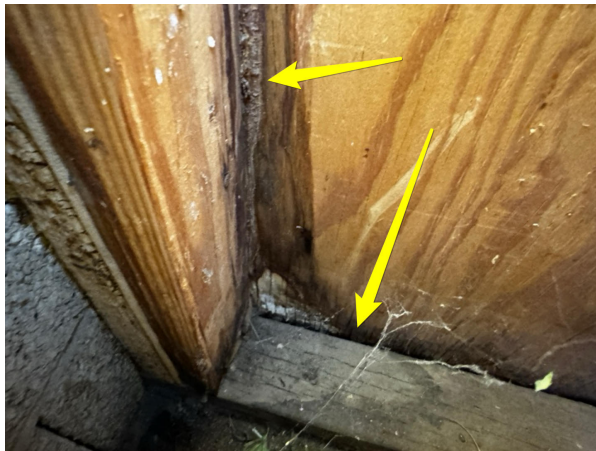
Example: staining/deterioration

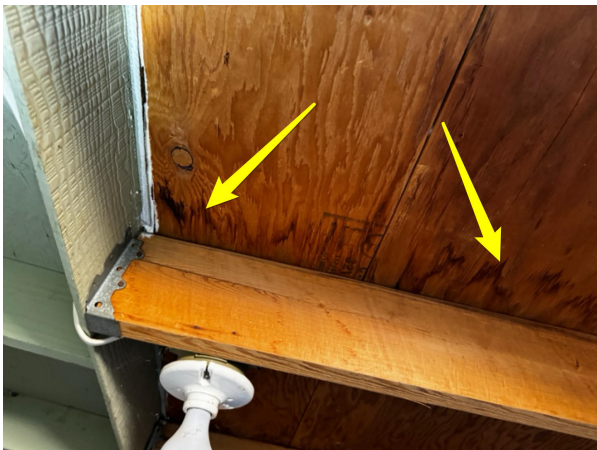
Example: moister staining

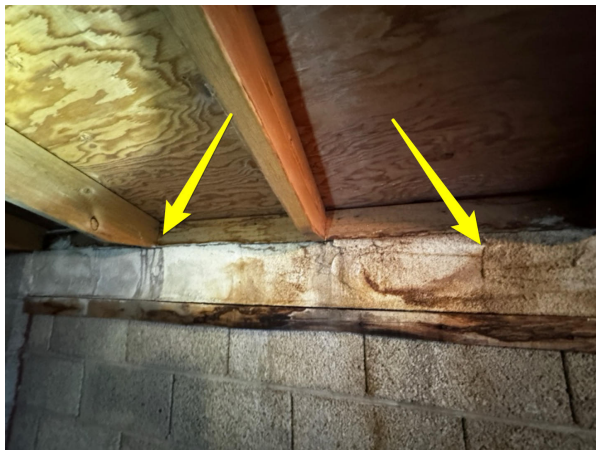
Example: moister staining

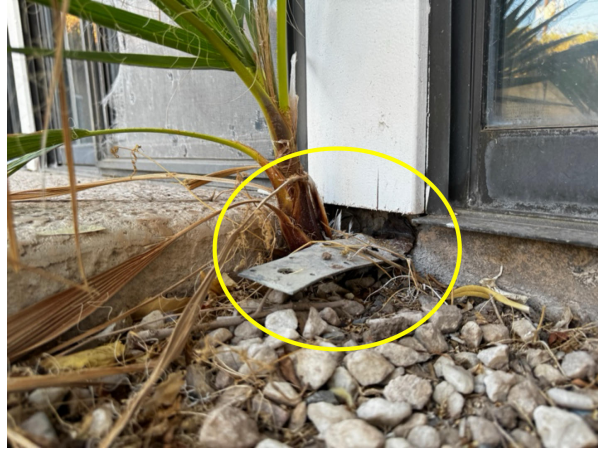
Example: unsecured wall anchor

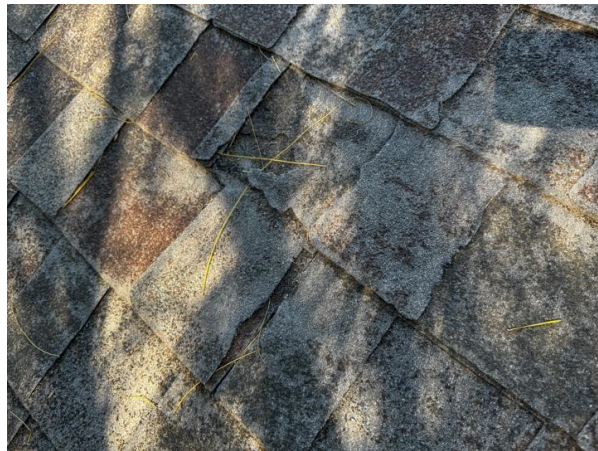
Example: deterioration/damage

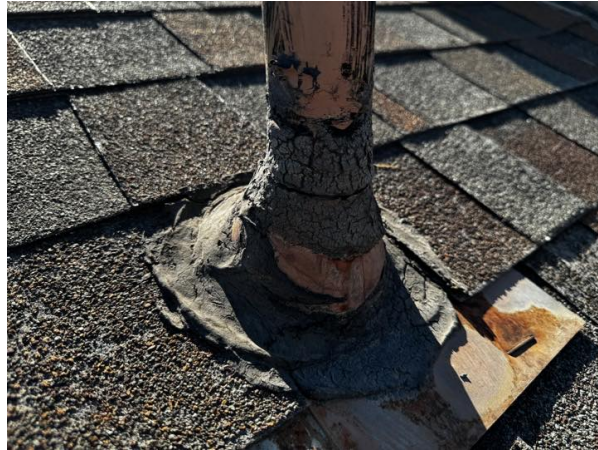
NOTE s-39: Separations at roof flashings need to be sealed to prevent water entry - Attention (e.g. plumbing vents)

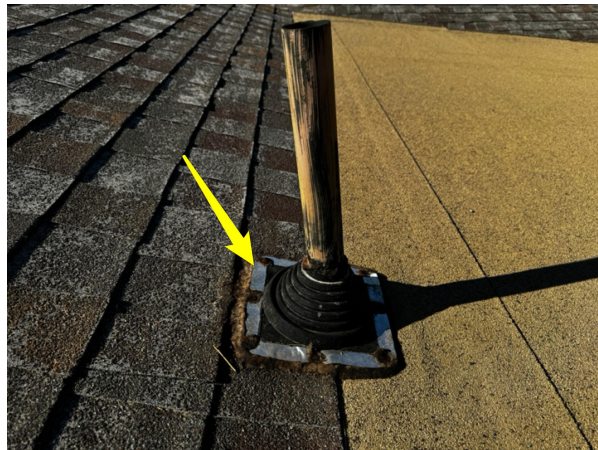
NOTE s-40: Roof flashing detail at penetrations is improper. Further evaluation by a licensed roofer is needed for repair - Attention.

Example: plumbing vent roof jack improperly installed atop shingles

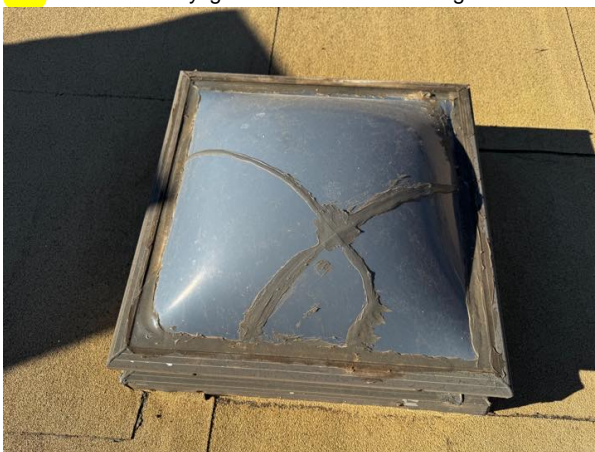
NOTE s-45: The skylight lens is cracked/damaged and should be replaced - Attention.

Damaged lens

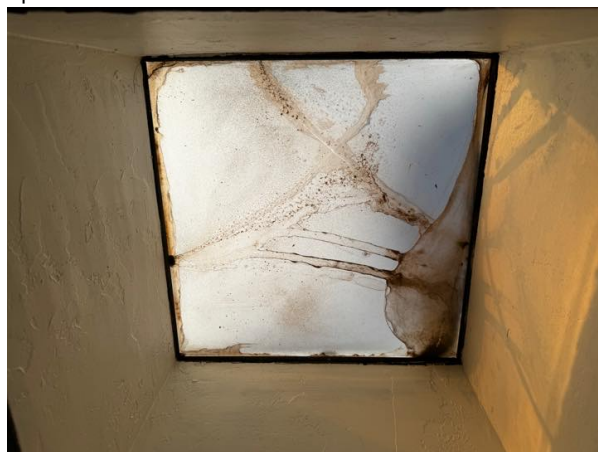
Evidence of past leaking

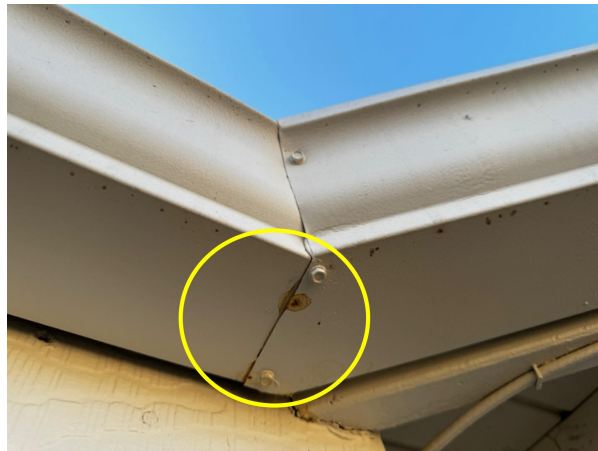
Example: evidence of leaking at seam

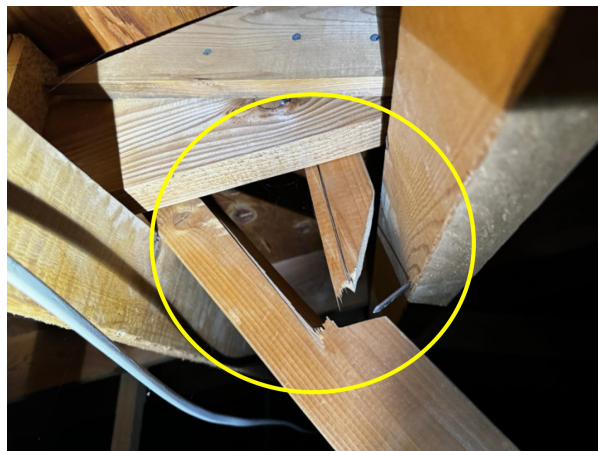
Location

Example: loose framing

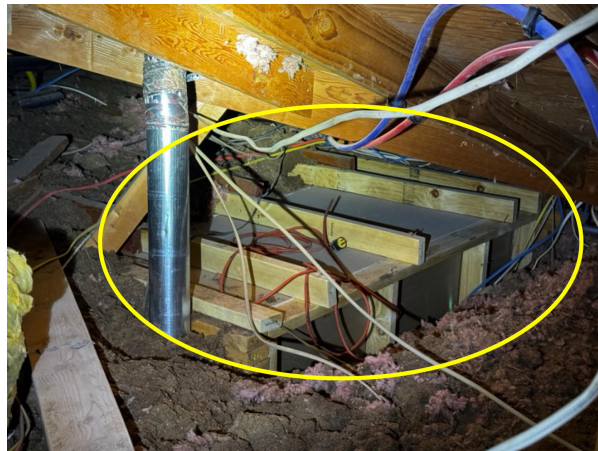
Example: missing insulation

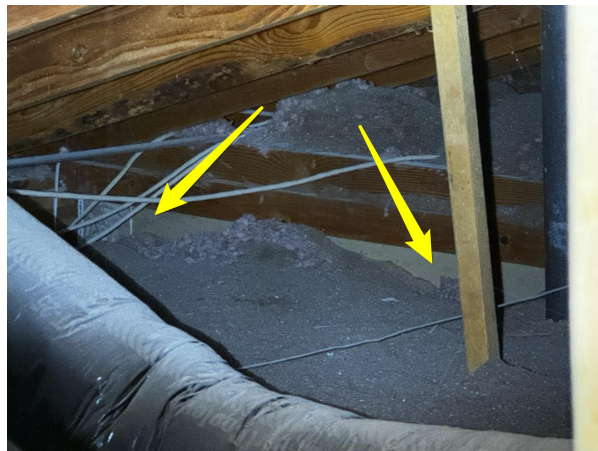
Example: missing insulation

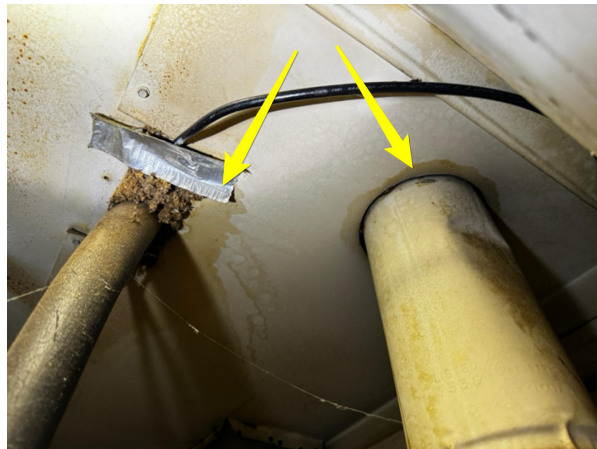
Example: moisture staining

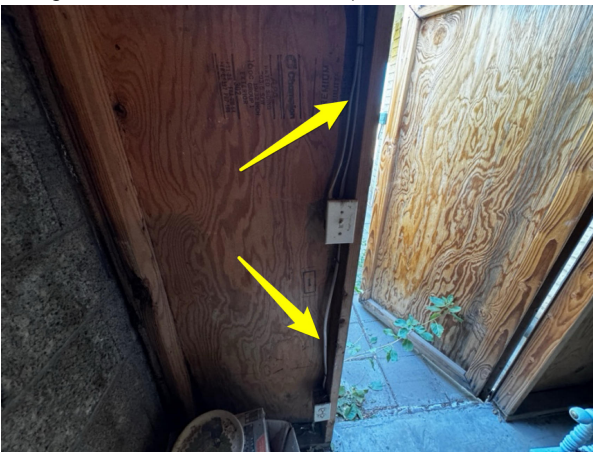
NOTE s-153: Exposed electrical wiring should be placed inside a conduit or otherwise protected where subject to damage - Attention. (e.g. storage room, kitchen exhaust hood)

Example: exposed wiring

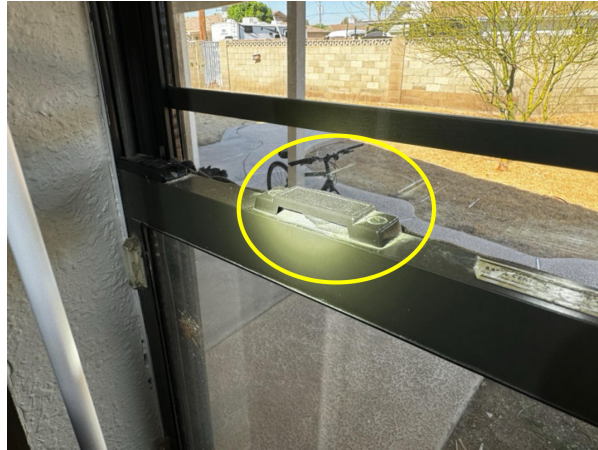
Example: damaged latch handle

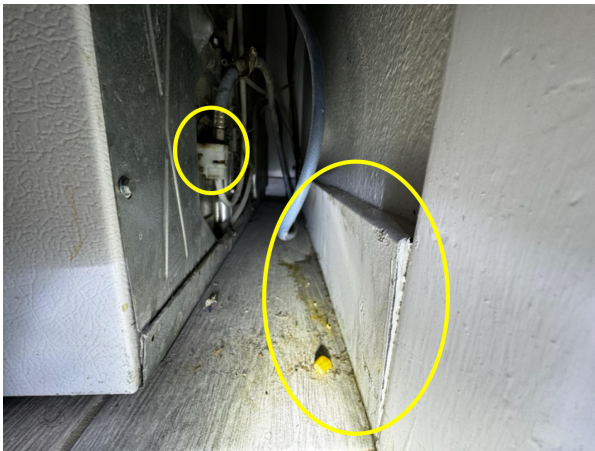
NOTE s-184: There is a leak at the refrigerator water supply line that needs repair. Damage was observed at the base of the adjacent wall - Attention.

Leak & water damage
