4604 Feagan Street Houston, Texas 77007

Client	Humberto Marquez
Type	Home Inspection Report - 4604 Feagan Street
Inspected by	Rio Bravo - Inspectify Pro - Houston
State license	TREC 22388
InterNACHI	17031522
Scheduled	January 24, 2025, 4:00 PM
Completed	January 24, 2025, 5:50 PM

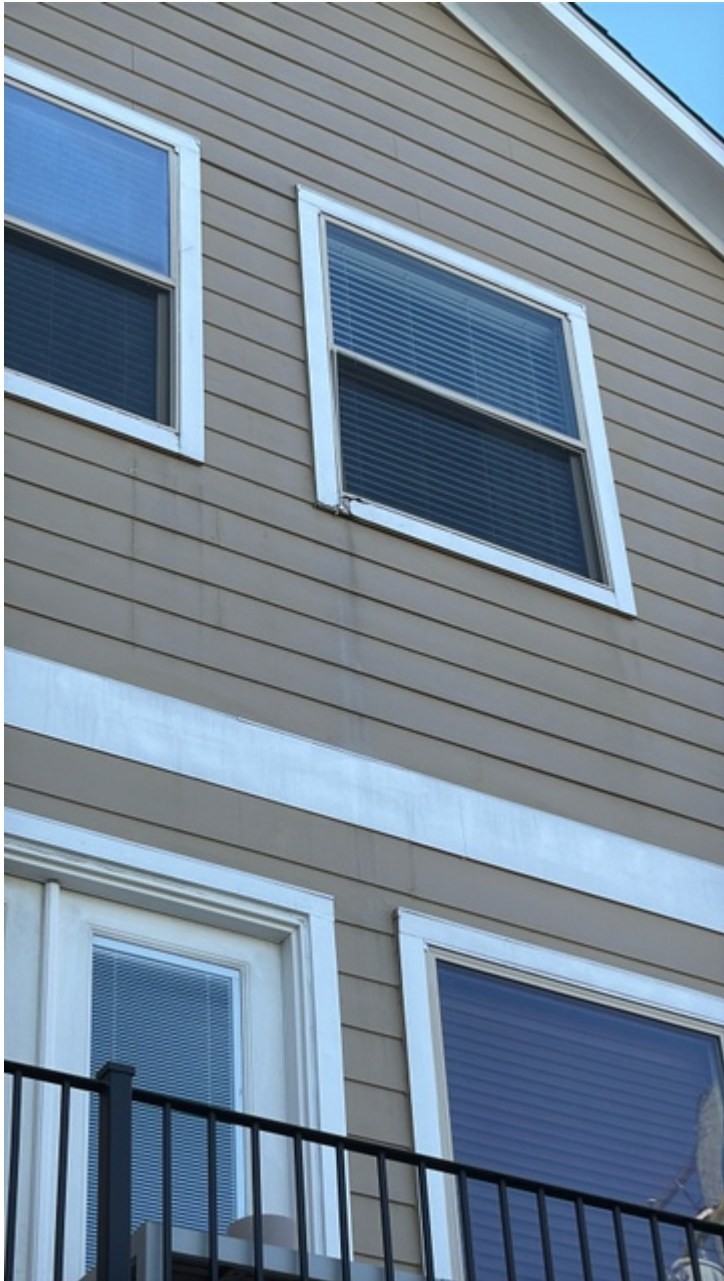
**Repair deficiency**

Damaged Trim

There are signs of damage to the trim.

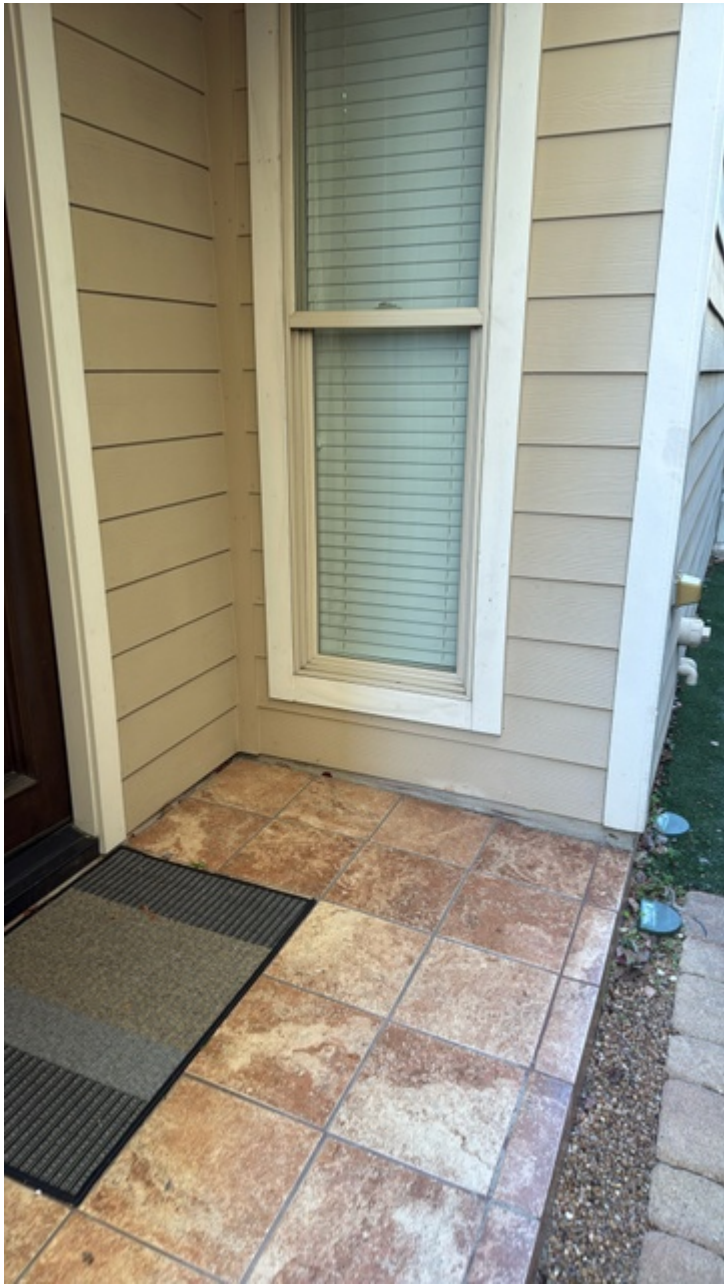
Monitor deficiency

Missing Window Screen

One or more windows are missing a screen.

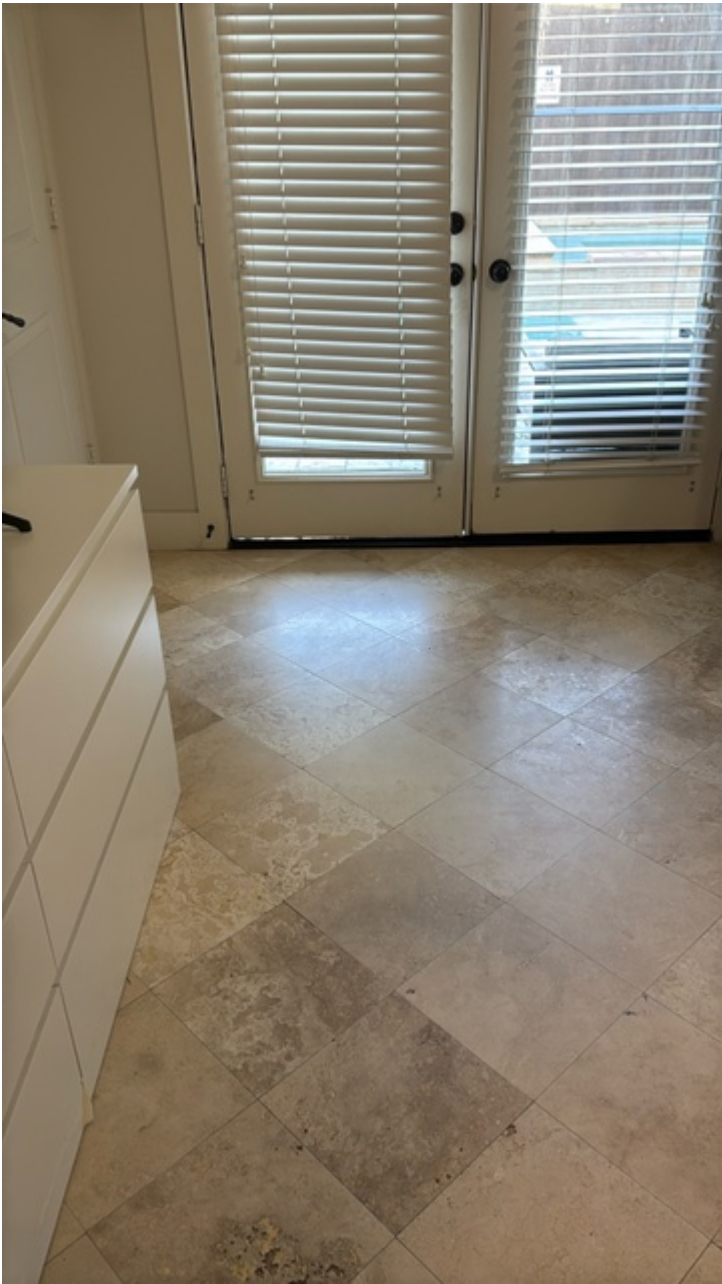
**Repair deficiency**

Damaged Weatherstripping on Exterior Door

The weatherstripping on an exterior door is damaged or deteriorated.

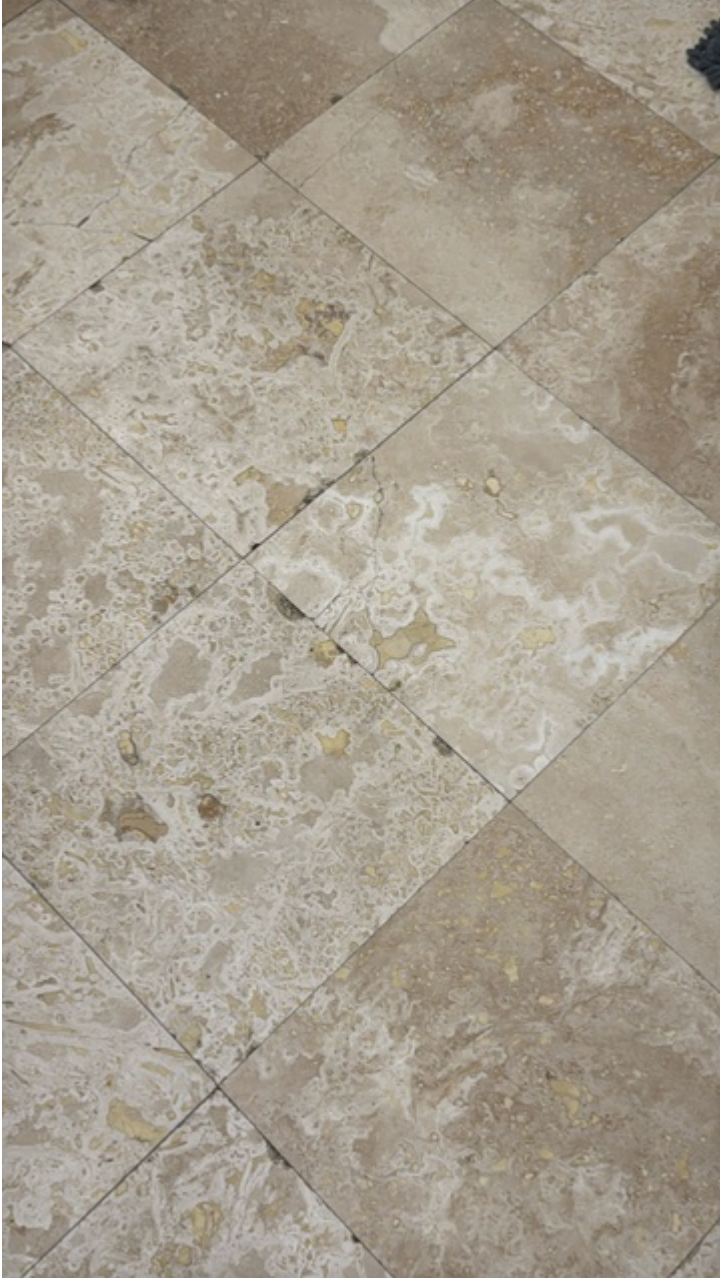
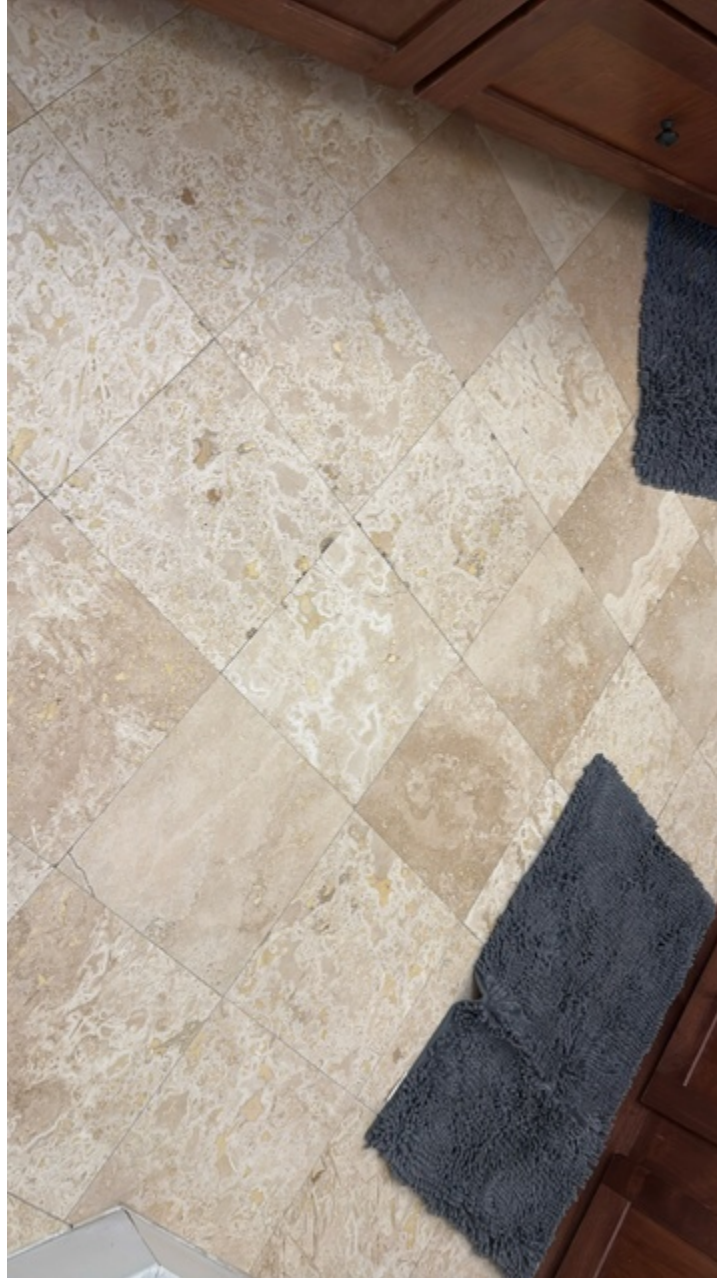
**Repair deficiency**

Damaged / Cracked Floor Tiles

The tile flooring is cracked and in poor condition.

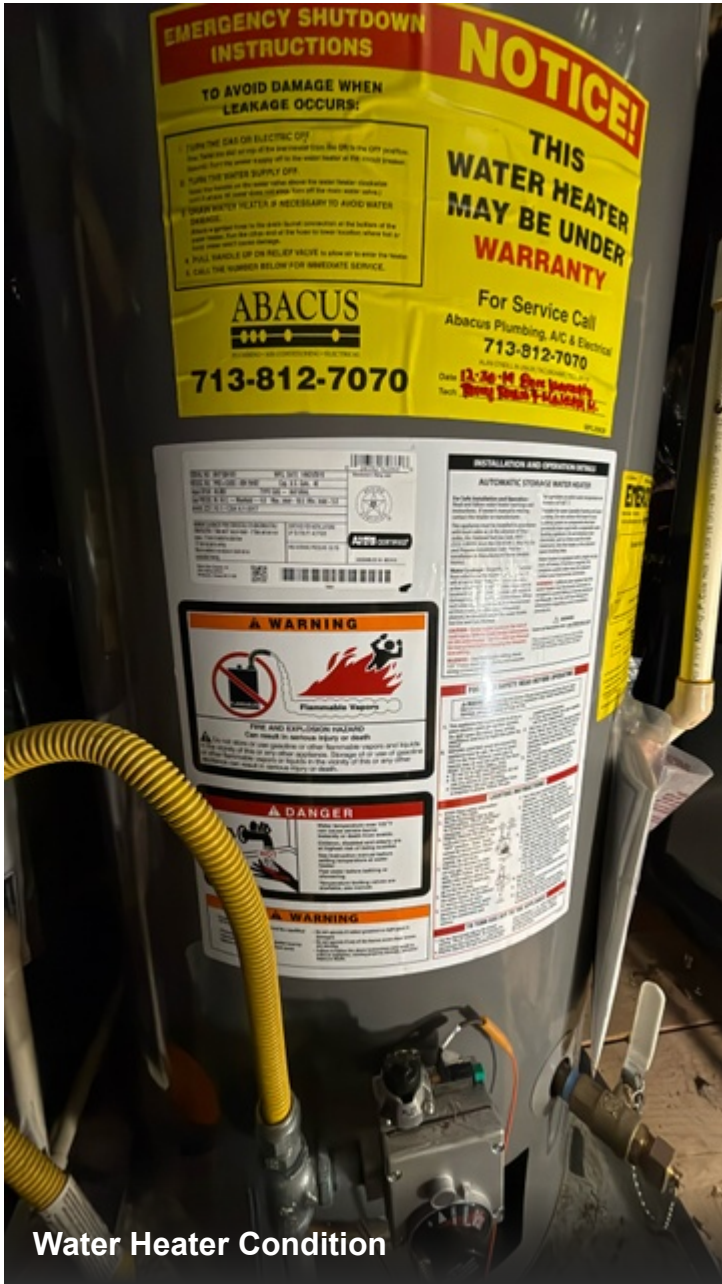
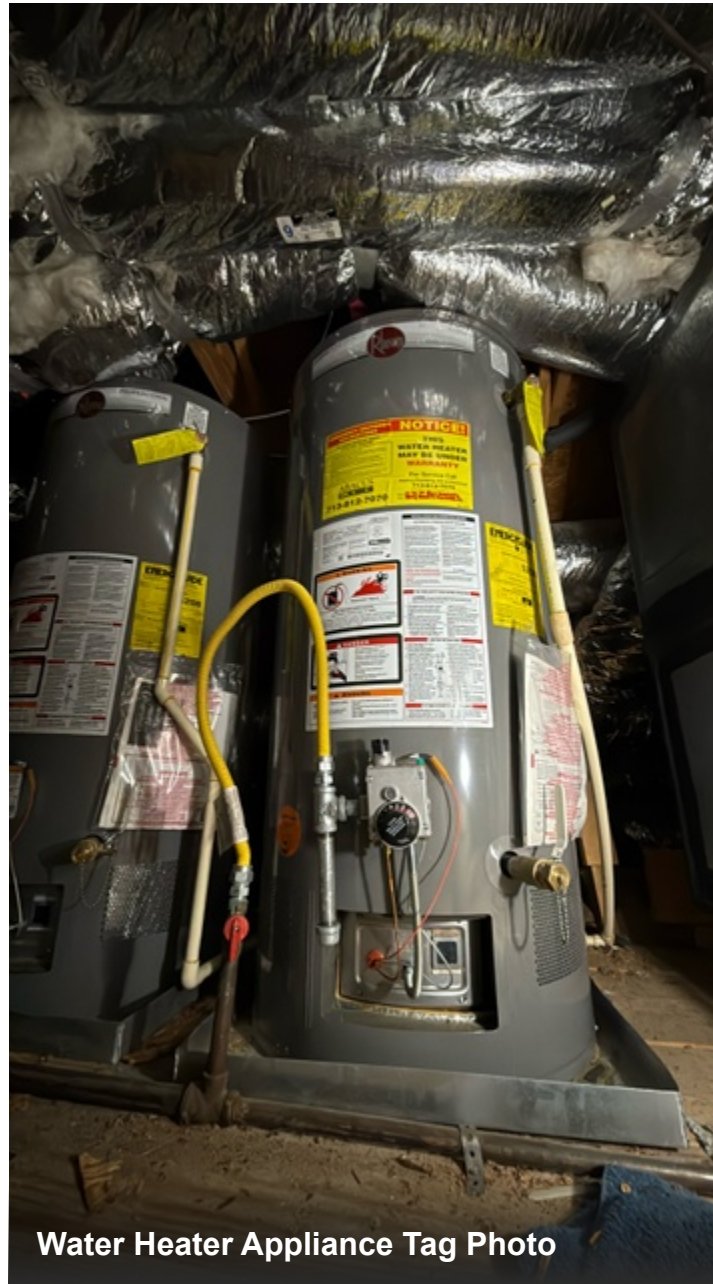
+ Safety deficiency

Vent not Attached to Water Heater

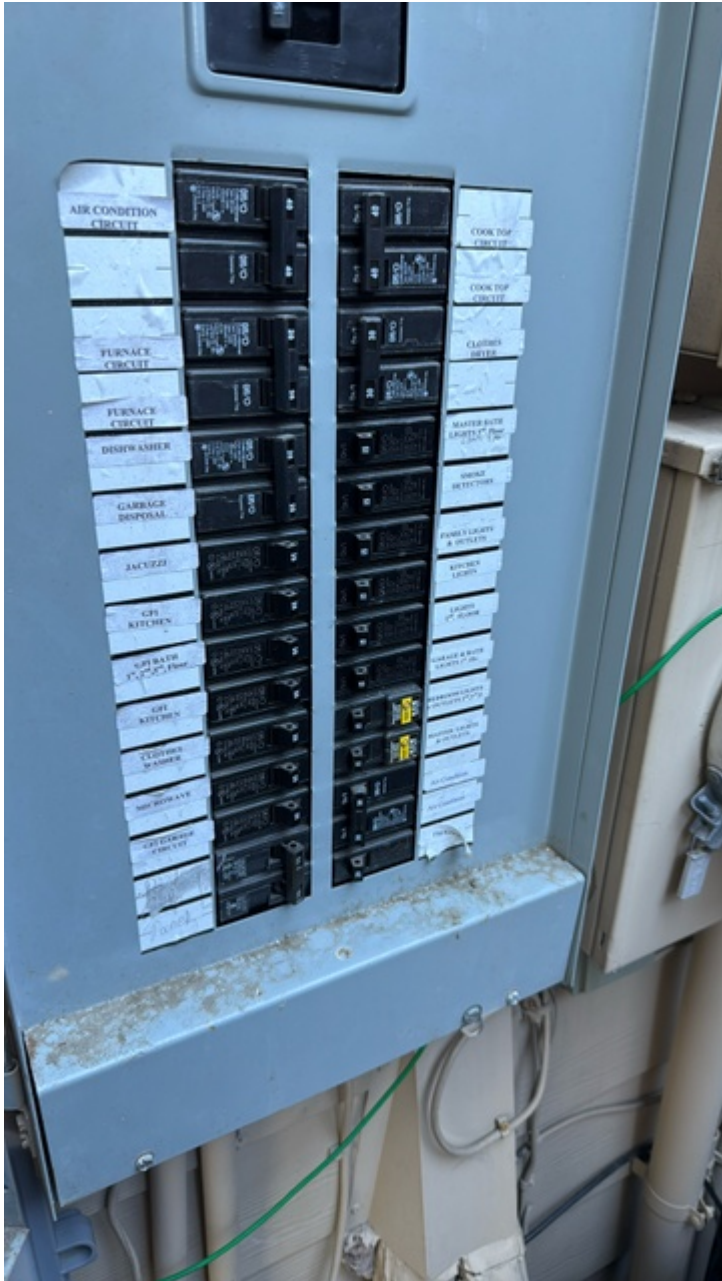
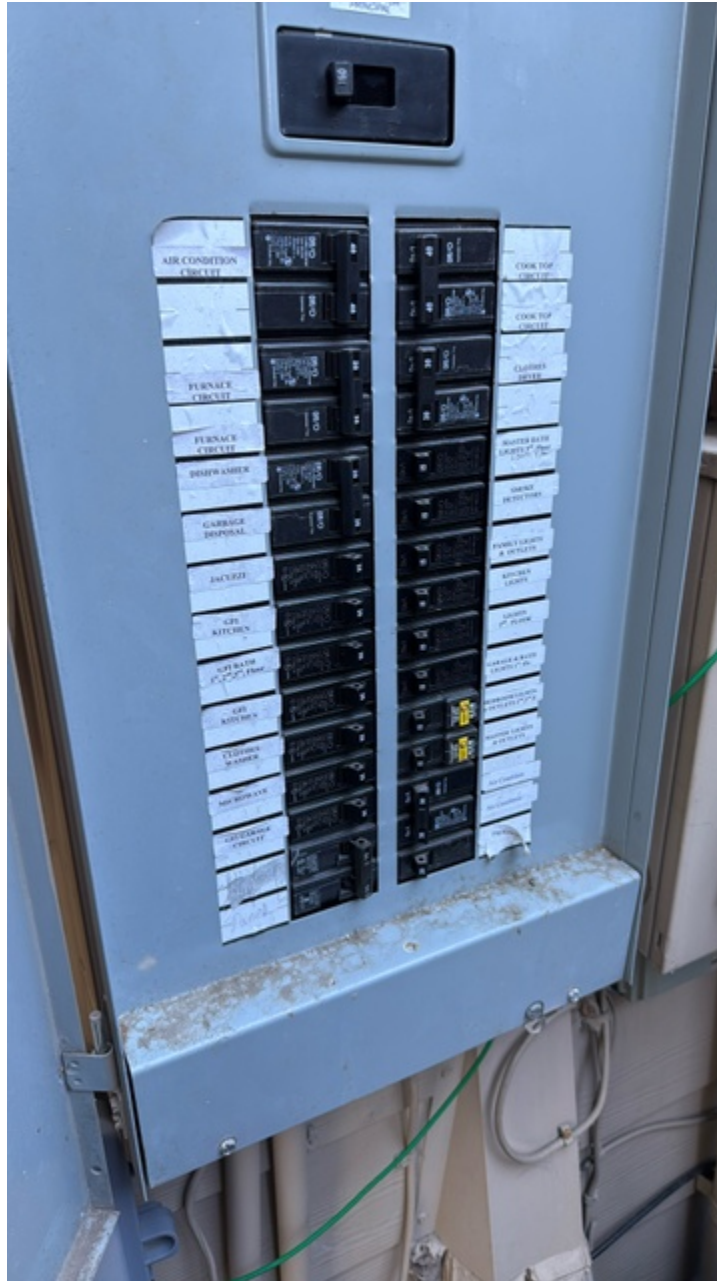
**Repair deficiency**

Missing AFCI Breaker

A required Arc-Fault Circuit Interrupter is missing.
