# Confidential Inspection Report

LOCATED AT:  
13906 TallHeath Court  
Houston, TX 77044

INSPECTED ON:  
Friday, June 16, 2023

Inspector, Said Rami 24193  
Nifty Home Inspections LLC

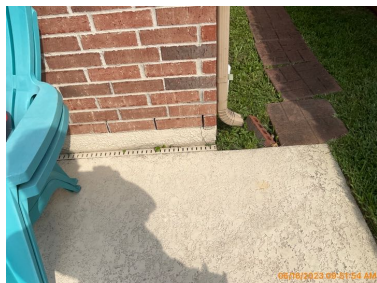
Corner cracks are common and cosmetic. Fill the voids and monitor.

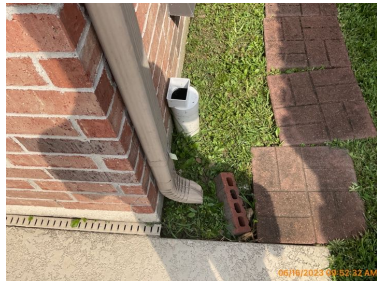
Splash blocks are missing from the base of the downspouts. We recommend they be added where missing to direct water away from the foundation.

**1:** Splash blocks are missing from the base of the downspouts. We recommend they be added where missing to direct water away from the foundation.

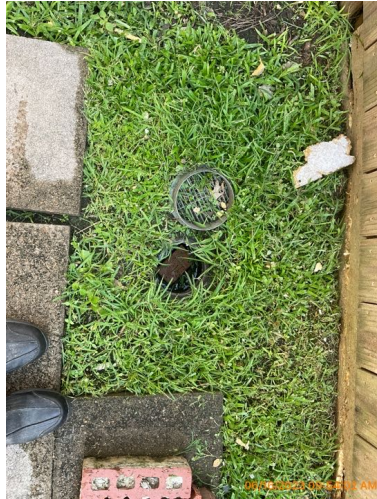
The drainage system appears to be in serviceable condition, but one or more of the grates is clogged and would be ineffective in a heavy rain. We recommend that debris be cleaned from the grates to ensure proper operation during heavy weather.

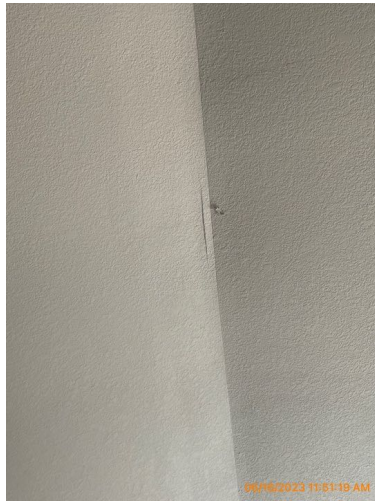
Living room

The tape on certain drywall joints has separated. We recommend resurfacing and refinishing to restore appearance.

**2:** The tape on certain drywall joints has separated. We recommend resurfacing and refinishing to restore appearance.

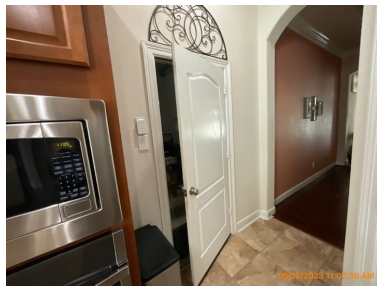
The door between the garage and the living space is of fire resistive construction. However, the door is not self-closing or self latching . We recommend the door be upgraded by installing a spring hinge or an automatic closer.

**4:** The door between the garage and the living space is of fire resistive construction. However, the door is not self-closing or self latching . We recommend the door be upgraded by installing a spring hinge or an automatic closer.

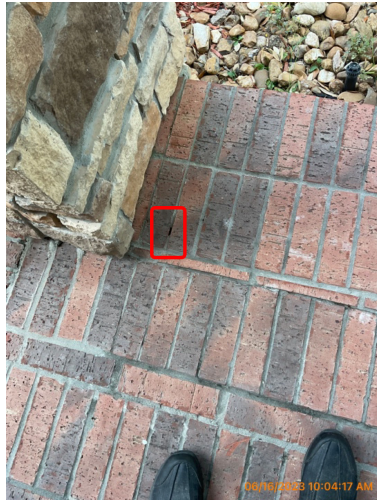
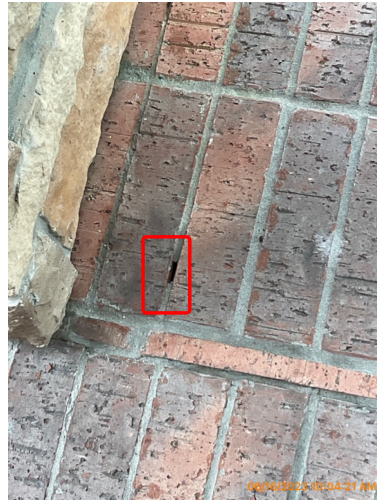
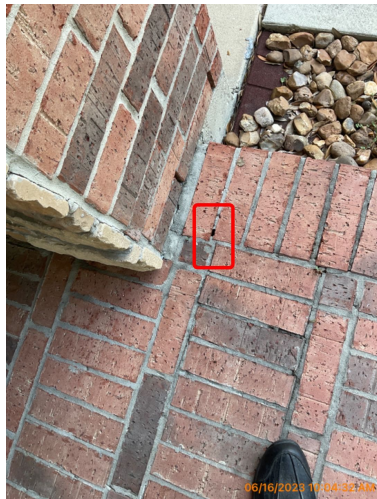
Front porch

Floor brick damaged. Recommend repair

**6:** Floor brick damaged. Recommend repair

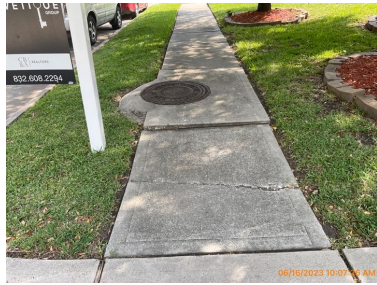
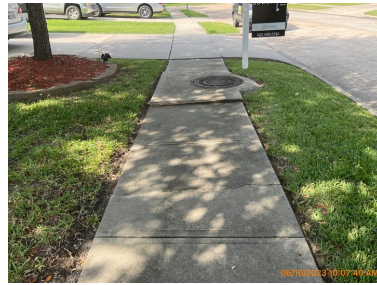
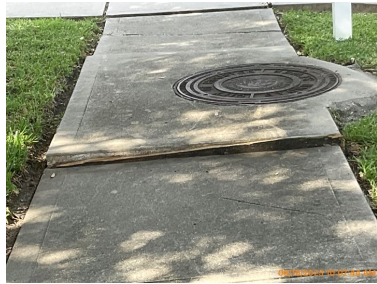
There is a trip hazard in the walkway or sidewalk. We recommend it be patched or repaired to prevent injury. If it's not part of the property, it is still recommended to report it to the proper authority to prevent injuries.

**7:** There is a trip hazard in the walkway or sidewalk. We recommend it be patched or repaired to prevent injury. If it's not part of the property, it is still recommended to report it to the proper authority to prevent injuries.

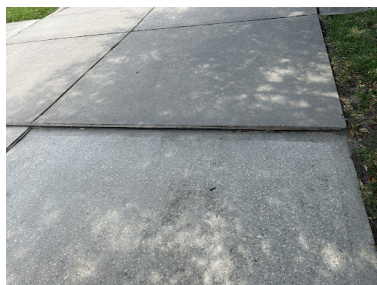
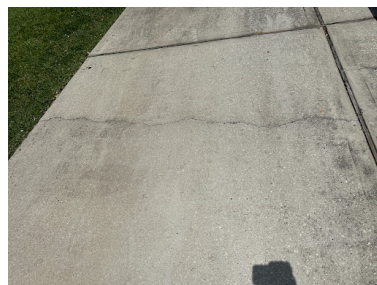
The driveway appears to be properly installed and is generally in good condition, with exceptions noted below. Visible cracks due to parts of the driveway uneven settlement.

**8:** The driveway appears to be properly installed and is generally in good condition, with exceptions noted below. Visible cracks due to parts of the driveway uneven settlement.

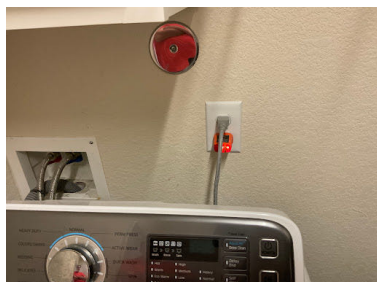
Laundry room

There is no GFCI protection for the wet areas. as required by present standards. Recommend installing GFCI outlets in wet areas of the house for safety of the occupants.

**10:** There is no GFCI protection for the wet areas. as required by present standards. Recommend installing GFCI outlets in wet areas of the house for safety of the occupants.

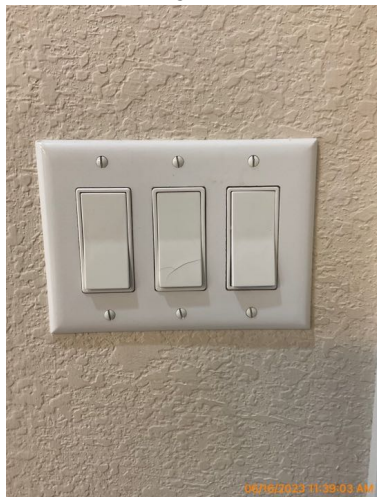
Master bathroom

The switch damaged . We recommend it be replaced.

**11:** The switch damaged . We recommend it be replaced.

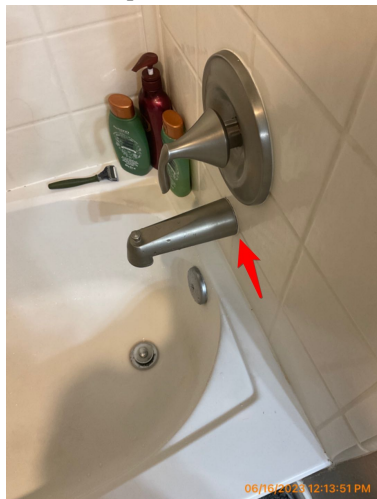
Bathroom 2

The faucet spout is loose. We recommend that it be repaired or replaced.

**14:** The faucet spout is loose. We recommend that it be repaired or replaced.

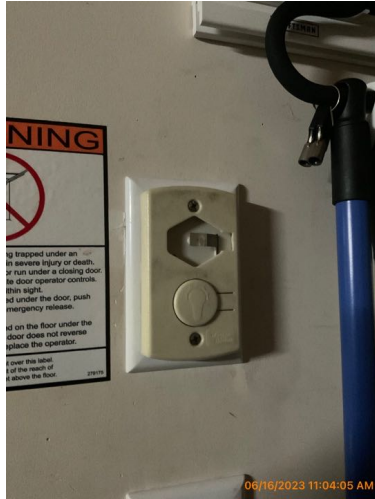
*Comments:*  
**GARAGE DOOR OPERATOR**  
 Wall control unit damaged

**16:** Wall control unit damaged

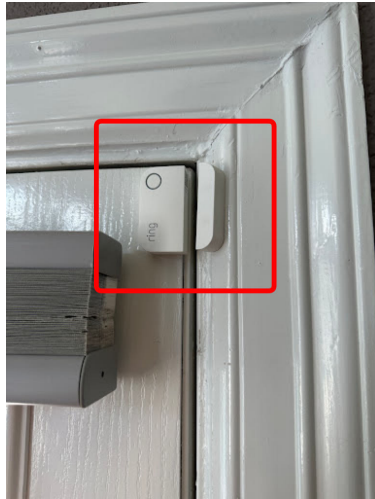
Door opening towards the pool from the house should be equipped with an audible alarm which sounds when the door and/or screen are opened.

The door from the house is equipped with a electronic monitoring device connected to the owners cellphone. Recommend installing a conventional stationary audible alarm system as required by present standards. The electronic version could supplement the conventional one. Also ask owners about transferability of the present system.

The door from the house is equipped with a electronic monitoring device connected to the owners cellphone. Recommend installing a conventional stationary audible alarm system as required by present standards. The electronic version could supplement the conventional one. Also ask owners about transferability of the present system.

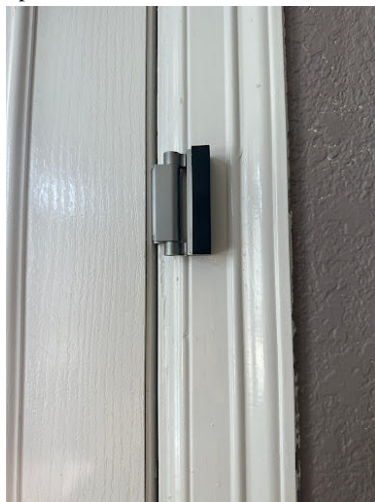
Access door to the pool from the house was equipped with a child proof lock that needs to be manually operated.
