## Property Inspection Report

3614 Cleburne St Houston, TX 77004

Inspection Date: 12-05-2024

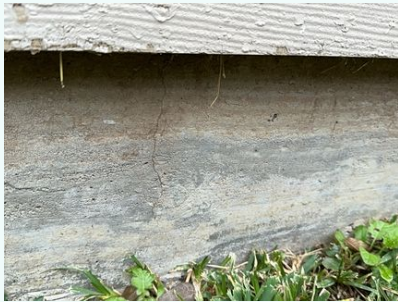
*Right*

**🕒 (SS-4) Monitor:** Expansion cracks were noted in the slab. Expansion cracks are often cosmetic but can be an indication of past foundation movement. These cracks may cause cracks in hard surface flooring materials if glued or secured to concrete slab. Mainly at -

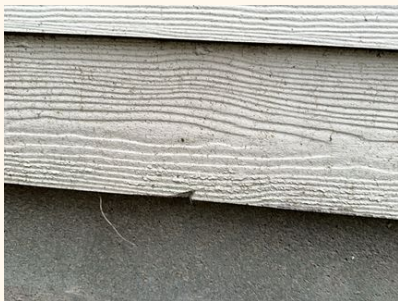
*Left*

**🔧 (SS-11) Recommended Repair:** There is some damage to the exterior siding, recommend repair or replacement to help prevent water penetration. Unable to determine the condition of the underlying materials. Mainly at -

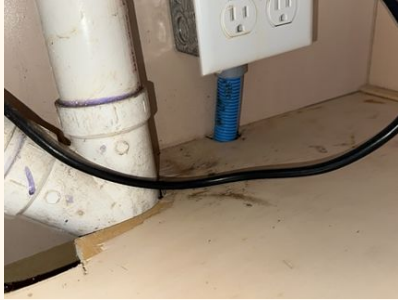
*Kitchen*

**🔧 (SS-37) Recommended Repair:** There are signs of water damage in the cabinet under sink. Mainly at -

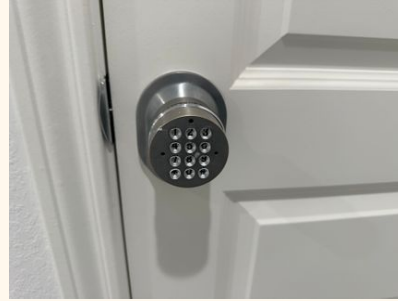
*Second floor hallway*

**🔧 (SS-40) Recommended Repair:** Some areas have limited access due to a locked door. Mainly at -

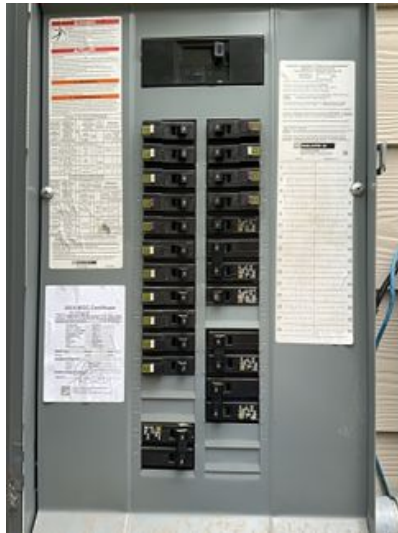
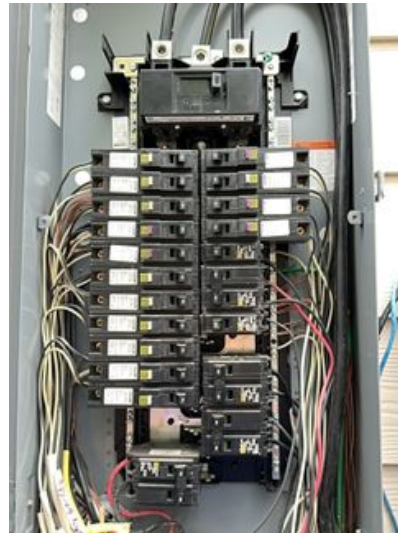
**(ES-1) Recommended Repair:** The electrical system only has one ground rod installed, it is now recommended that two ground rods be installed for your protection and the ground rods should be located at least 6' apart.

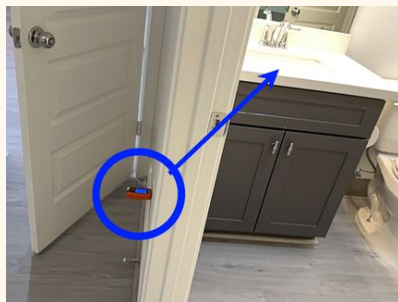
*Front right bedroom*

(ES-11) **Recommended Repair:** Not all the recommended electrical receptacles are GFCI (Ground Fault Circuit Interrupter) protected in one or more of the following areas: bathrooms, lavatory, garage and accessory building if accessible, outdoor receptacles, crawlspace, basement, receptacles that serve the kitchen counter, receptacles that are located within 6' of the outside edge of a sink, shower or bathtub, laundry room, indoor damp or wet location's, kitchen dishwasher receptacle, electric heated floors and electric water heaters. Mainly at -

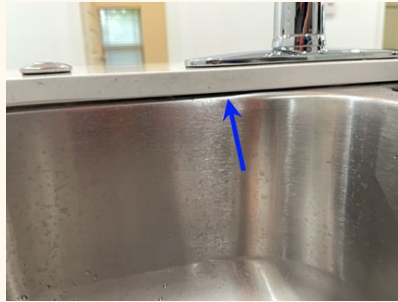
*Kitchen*

**🔧 (PS-1) Recommended Repair:** Undermounted sinks require sealant between the sink and counter top to help prevent water penetration to the surfaces below. Recommend sealing or repairing seal to help prevent water penetration and potential moisture damage to the underlying materials. Mainly at -

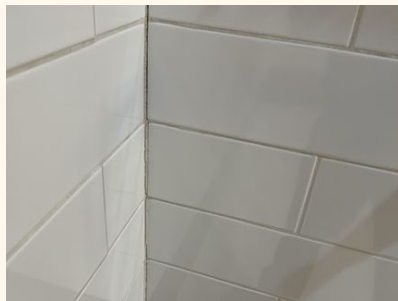
*Front right bedroom bath*

**🔧 (PS-3) Recommended Repair:** There were settlement cracks in the corners due to the use of grout in the corners. Recommend using a pliable sealant in corners to help prevent cracking and water penetration behind walls. Mainly at -

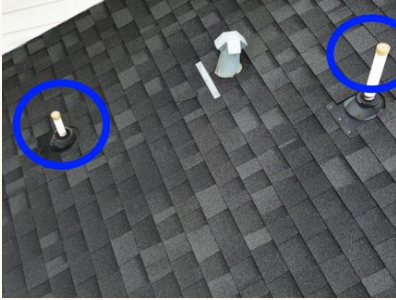
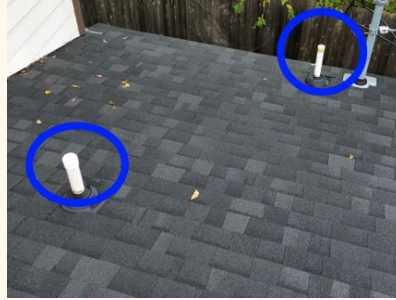
**🔧 (PS-6) Recommended Repair:** There is a capped plumbing vent noted, recommend contacting the seller or a licensed plumber to determine the reason for the vent being capped. A capped plumbing vent can create issues with drainage as the system needs air to properly drain. It can be dangerous to cap a plumbing vent as a sewage backup is almost imminent.

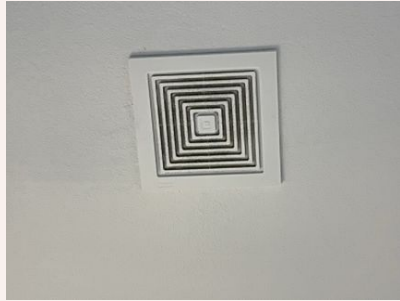
*The bath or laundry exhaust fan is dirty, recommend cleaning.*

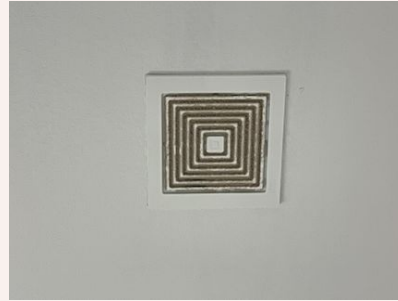
*The bath or laundry exhaust fan is dirty, recommend cleaning.*
