INSPECTION REPORT

**Property Address
4829 Golden Forest Dr
Houston, TX 77091
September 2, 2024**

PROPERTY INSPECTION REPORT FORM

Joey Gumataotao <i>Name of Client</i>	09/02/2024 <i>Date of Inspection</i>
4829 Golden Forest DrHouston, TX 77091 <i>Address of Inspected Property</i>	
Angel Medina <i>Name of Inspector</i>	24264 <i>TREC License #</i>

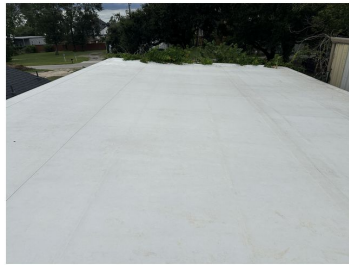
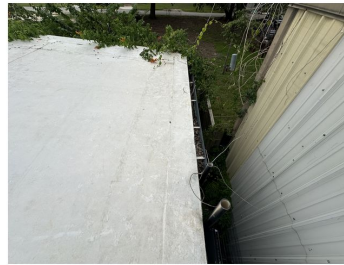
The roof covering and its components were found to be functioning adequately on the day of the inspection. The roof demonstrated the ability to effectively shed water, with no visible signs of leaks or pooling. Its operational features, configuration, and overall condition align with accepted industry standards, considering its age and the normal wear and tear associated with regular use. While the roof is currently performing well, it is important to note that, like any roofing system, it is subject to the effects of aging and environmental factors over time. Without proper maintenance, these factors could eventually lead to performance issues. To maintain the integrity and performance of the roof, it is recommended to schedule regular maintenance inspections and promptly address any minor wear and tear as it arises.

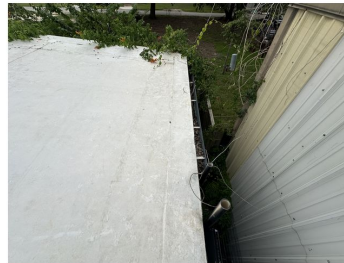
Location: Rear Side of Roof Structure

- **Tree Branches and Limbs - Extending over the roof covering**

Tree branches and limbs were observed extending over the roof. Overhanging branches and limbs can potentially cause damage to the roof covering, fascia, soffit, and eave materials. The weight and movement of these branches may lead to physical damage, such as scratches or punctures in the roofing material, and can also obstruct proper water drainage. Consult with a tree service company to trim the branches and limbs away from the roof. This will help prevent damage to the roofing materials and surrounding structures, ensuring the long-term integrity and performance of the roof. Regular tree maintenance is advised to avoid future issues and maintain a clear distance between trees and roofing.

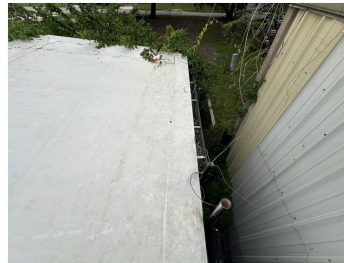
Locations: Left and Right Side of Roof Structure (Facing Rear of Home)

Observed that the guttering system had accumulated leaves and debris. This build-up of asphalt shingle granules can impede the flow of water and hinder the system's ability to provide proper drainage. Additionally this condition increases the vulnerability of the underlying layers of the roof covering to water intrusion. Recommend cleaning out the guttering system to remove the leaves and debris, ensuring unrestricted water flow and effective drainage.

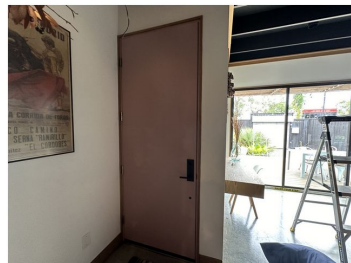
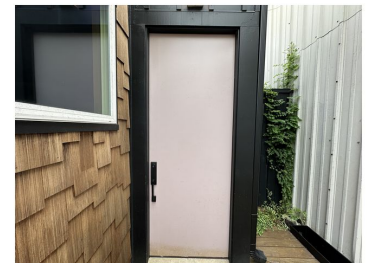
Front Entry Door Weather-Stripping at Door Frame - Missing at corner

The front entry door was inspected and found to be in satisfactory condition, with no visible signs of damage, warping, or misalignment. The door and its associated components, including locks and hinges, were functioning properly and contributing to overall performance. However, visible daylight was observed at the bottom corner of the door, indicating a gap where weather-stripping was missing. The gap at the bottom corner of the entry door suggests inadequate sealing between the door and its frame, which compromises the door's energy efficiency. This opening may allow drafts, moisture, and pests to enter, potentially leading to increased energy costs and discomfort inside the home due to fluctuating indoor temperatures. It is recommended to install or replace the missing weather-stripping at the bottom corner of the front entry door to ensure a proper seal. This will enhance the door's energy efficiency, prevent drafts, and contribute to maintaining a more consistent and comfortable indoor environment.

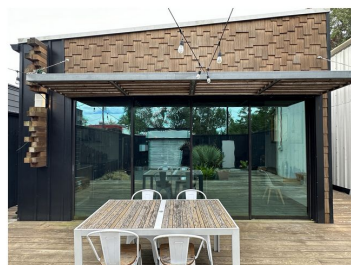
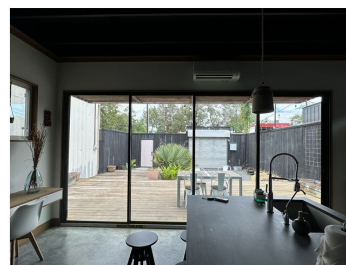
Exterior Door

The sliding entry door found to be in satisfactory condition, with no visible signs of damage, warping, or misalignment. They were functioning properly, providing adequate safety and energy efficiency. All associated components, including locks, hinges, and weatherstripping, were also functioning appropriately and contributing to the overall performance of the doors. It is recommended to continue regular maintenance, such as lubricating hinges and checking weatherstripping, to ensure they remain in good working order. Periodic inspections will help detect any potential wear or damage early, allowing for timely repairs to maintain the doors performance and efficiency.

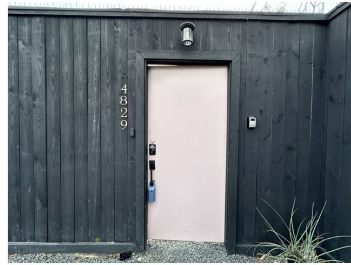
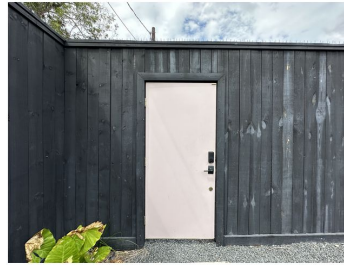
Exterior Door

The outside entry door found to be in satisfactory condition, with no visible signs of damage, warping, or misalignment. They were functioning properly, providing adequate safety and energy efficiency. All associated components, including locks, hinges were also functioning appropriately and contributing to the overall performance of the doors. It is recommended to continue regular maintenance, such as lubricating hinges to ensure they remain in good working order. Periodic inspections will help detect any potential wear or damage early, allowing for timely repairs to maintain the doors performance and efficiency.

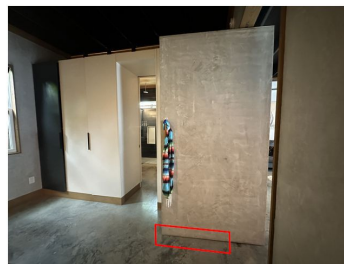
Location: Bedroom

Interior Double Doors - Misaligned

The interior door was found to be misaligned, causing rubbing at the floor. This misalignment can lead to issues with the door closing properly, potentially affecting their functionality and appearance. It is recommended to adjust the alignment of the door to ensure they close properly and align correctly. This adjustment will help prevent rubbing, reduce gaps, and improve both the operation and aesthetic of the door.

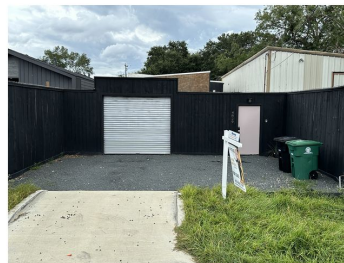
Overhead Door

The overhead door could not be opened because the remote control was not functioning. This prevents access and use of the overhead door. It is recommended to replace or repair the remote control to restore its functionality. If the issue persists, consult with a professional garage door technician to diagnose and resolve any underlying problems with the door opener system.

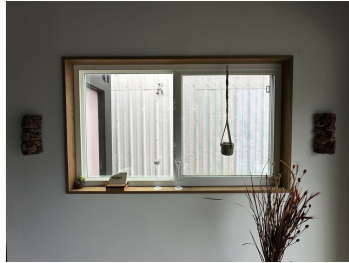
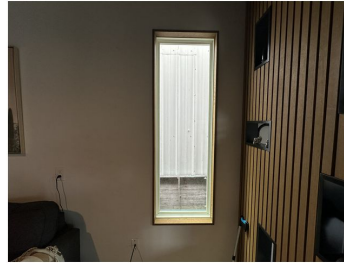
During the inspection, the windows and associated components were found to be performing adequately and in satisfactory condition. They exhibited an operation, function, and overall condition that aligns with accepted industry standards and practices. This assessment also takes into consideration factors such as age, normal wear and tear, and routine maintenance associated with regular use. Based on the findings, it appeared there are no immediate concerns or deficiencies regarding the windows and their components.

Note: The photos provided serve as a visual representation (examples) of all windows that were observed along the perimeter of the home.

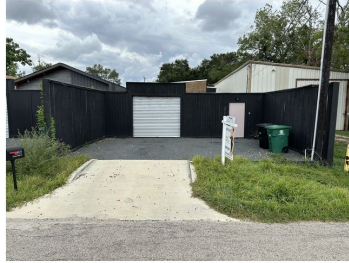
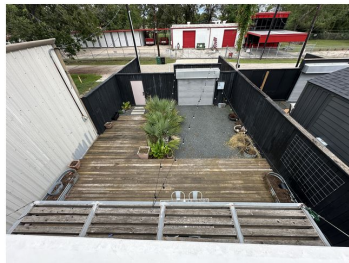
- **Walkway**

During the inspection, the walkway was found to be in a satisfactory condition with no significant issues or damage. The walkway and its associated components showed no signs of structural concerns or deterioration, aligning with acceptable standards. It was determined that the walkway was well-maintained, functional, and performing adequately.

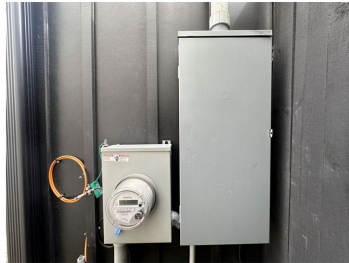
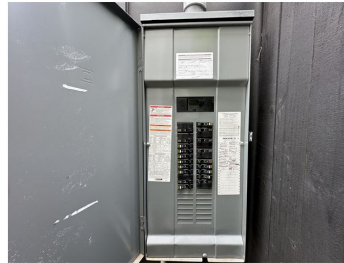
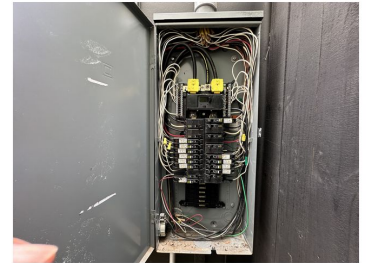
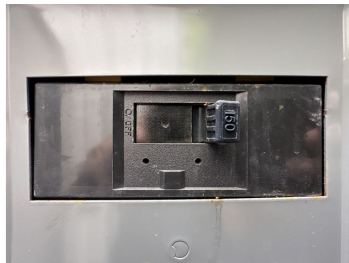
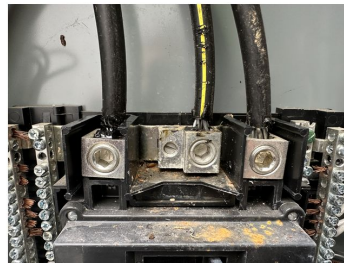
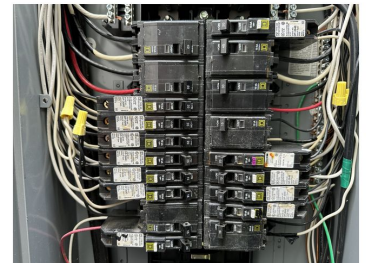
Location: Right Side (Facing Front of Home)

The main breaker box and its components were evaluated and found to be in satisfactory condition, with no visible signs of damage or wear. The assessment was conducted in accordance with standard industry practices, considering the age and usage of the equipment. Although the breaker box is currently performing well, ongoing maintenance is essential to ensure its continued optimal performance and safety. It is recommended to conduct routine inspections of the main breaker box to maintain its performance and safety. Regular maintenance will help prevent potential issues and ensure the equipment continues to function effectively. Should any concerns arise, consult a qualified, licensed electrical contractor for further evaluation and corrective actions.

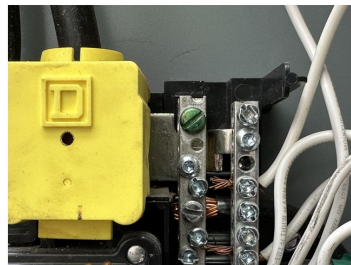
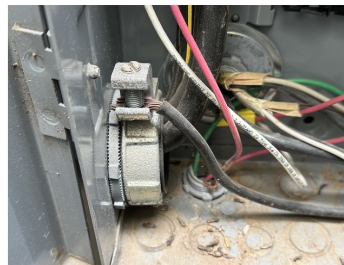
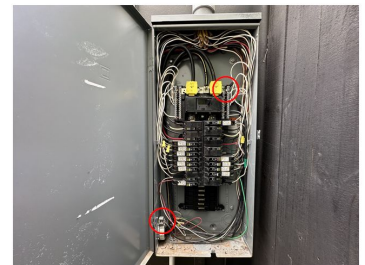
Location: Right Side (Facing Front of Home)

The bonding to the main breaker box was observed to be correctly installed and functioning properly, with secure connections and no visible signs of corrosion or damage. Despite its current satisfactory condition, the bonding system is subject to potential issues over time due to weather exposure, corrosion, and general wear and tear. Compromised bonding can affect electrical safety and operation. It is recommended to have a qualified, licensed electrical contractor perform regular inspections of the bonding connections, ideally once a year. This will help verify their condition, ensure they remain secure, and identify any signs of deterioration. If issues are found, prompt evaluation and repairs should be conducted.

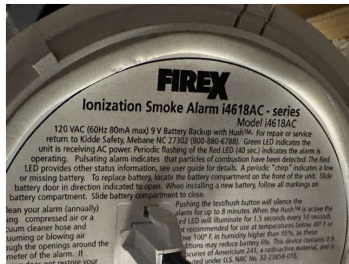
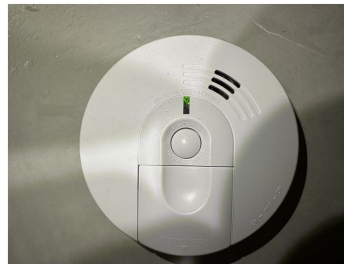
● **Smoke Alarms**

All the smoke alarms were tested to confirm their functionality, including checking the sensors, power source, and alarm sound. The alarms met operational safety standards and were found to be in working condition. To maintain optimal performance and safety, it is important to replace the batteries in all smoke alarms once a year. Regular testing and maintenance are also crucial to verify that the smoke alarms continue to function properly.

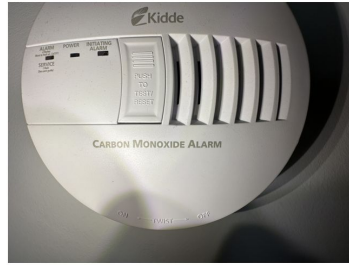
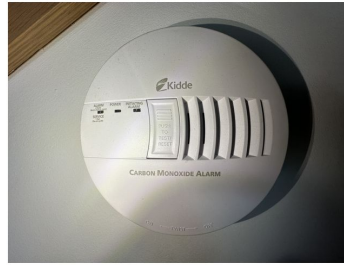
● **Carbon Monoxide Alarms**

All the carbon monoxide alarms were tested for functionality, including sensors, power source, and alarm sound. The alarms were found to be in proper working condition and met operational safety standards. It is advised to replace the batteries in all carbon monoxide alarms annually to ensure continued reliability and performance. Regular maintenance and periodic testing of these alarms are essential for protecting occupants from potential carbon monoxide hazards.

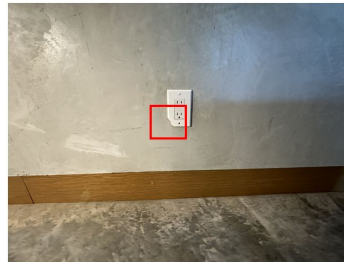
Location: Bedroom

● **Receptacle Cover - Damaged (Broken)**

The receptacle cover plate was damaged (broken) at the corner. For safety reasons, it is recommended to replace the cover plate.

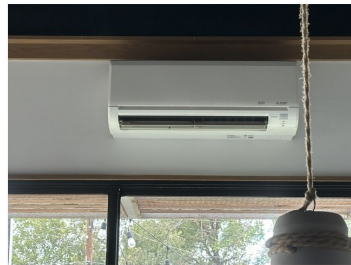
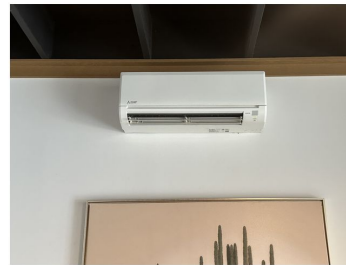
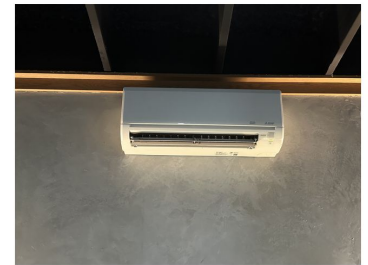
During the inspection, the inspector conducted an inspection of the heating system (mini-split units), to assess the heat outputs. Based on this observation, the heating system appeared to be operating, functioning, and configured in accordance with accepted industry standards, taking into account factors such as age and normal wear and tear resulting from ordinary use.

Note: Temperature readings were also taken from each vent to verify the flow of warm/hot air. Any notable discrepancies in air flow will be noted in the report.

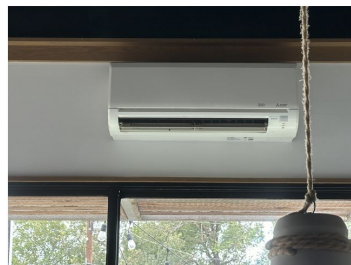
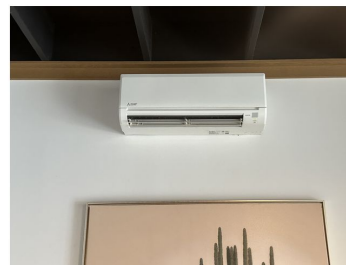
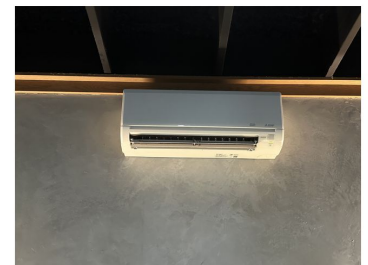
During the inspection, the inspector conducted an inspection of the cooling system (mini-split units), to assess the cold outputs. Based on this observation, the cooling system appeared to be operating, functioning, and configured in accordance with accepted industry standards, taking into account factors such as age and normal wear and tear resulting from ordinary use.

Note: Temperature readings were also taken from each unit to verify the flow of cold/cool air. Any notable discrepancies in air flow will be noted in the report.

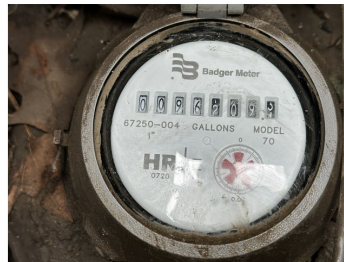
Location: Front Side of Home near Curb

The inspector observed mud inside the water meter box, obstructing the view of the water pipes. The presence of mud inside the water meter box prevented the inspection of the pipes and connections, making it impossible to assess for potential leaks or other issues. This obstruction can hide existing problems that may require attention, leading to undetected issues that could worsen over time. Consult with a landscape professional to perform a thorough cleaning of the inside of the water meter box. This will allow for a proper inspection of the pipes and connections to ensure there are no leaks or other issues. Regular maintenance of the water meter box is also advised to prevent future obstructions.

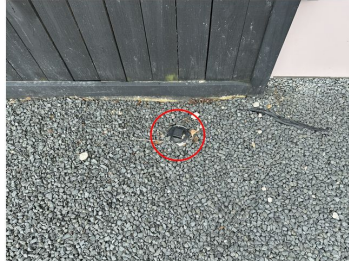
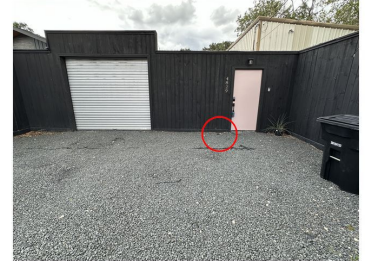
Location of Main Cleanout: Front Side of Home

- The drains, wastes, and vent pipes (DWV) components were observed to be functioning satisfactory during the inspection. After running water at accessible plumbing fixtures, no blockages or slow draining were detected. The DWV system is operating in compliance with accepted industry standards and is performing as expected, taking into account its age and the usual deterioration resulting from regular usage. No immediate concerns or problems were identified with the DWV system during the inspection.

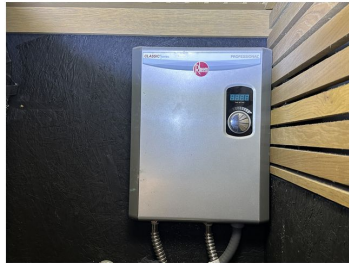
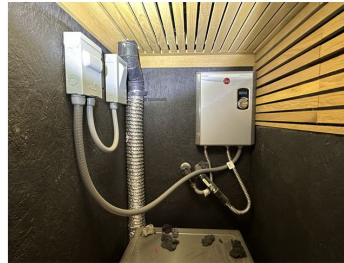
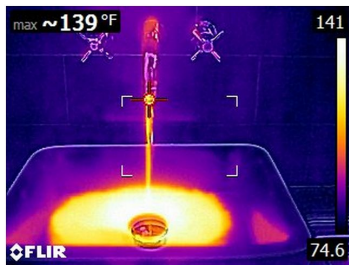
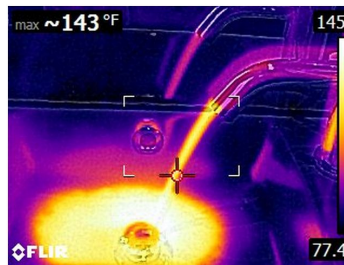
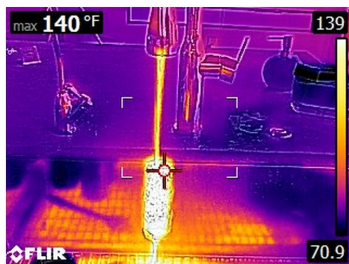
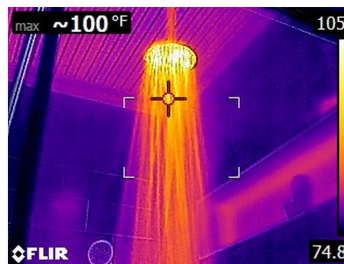
The tankless water heater and its components were found to be performing adequately during the inspection. The unit was in satisfactory condition, with no signs of notable malfunctions, significant defects, or safety hazards that would adversely affect the tankless water heater's performance or safety. Additionally, the hot water temperature was tested at the kitchen sink and was found to be functioning correctly. The assessment revealed no issues affecting the operational or functional performance of the tankless water heater, indicating that it is functioning as intended within expected

parameters for its age and usage. It is advisable to continue regular maintenance to ensure the tankless water heater's optimal performance.

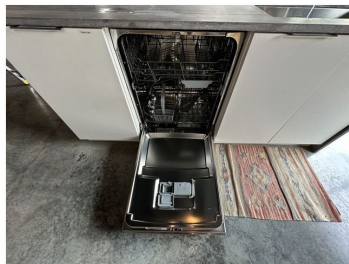
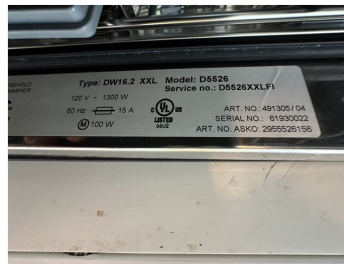
Location: Kitchen

- **Dishwasher - Not securely fasten (anchored)**

The dishwasher was not securely fastened (anchored) under the cabinet opening, as the appropriate hardware was missing or improperly installed. This lack of secure anchoring can lead to instability, causing the appliance to shift during operation. Such movement poses a safety hazard, as the dishwasher could potentially tip or become dislodged, which may also result in functionality issues, such as improper alignment with plumbing connections or difficulty in opening and closing the door. It is advised to properly secure the dishwasher using the recommended anchoring hardware. Ensuring that the dishwasher is firmly attached to the cabinet will enhance safety by preventing any unintended movement and will also ensure the appliance functions correctly within its intended installation.

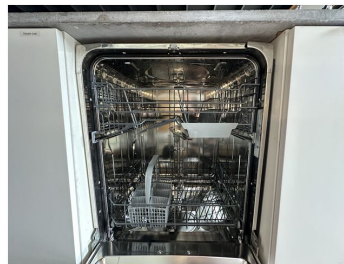
Location: Kitchen

- **Dishwasher Drain Hose - Improperly installed**

The dishwasher drain hose was improperly installed, lacking the necessary high loop that prevents backflow. The hose was not securely attached to the underside of the countertop, which is essential for ensuring proper drainage. The improper installation of the drain hose poses a risk of backflow or anti-siphoning, potentially allowing wastewater to flow back into the dishwasher. This situation can lead to contamination of clean dishes and create unsanitary conditions in the kitchen. Over time, such issues can also lead to damage to the dishwasher and plumbing system. It is recommended to consult with a qualified, licensed plumbing contractor to further evaluate the installation of the dishwasher drain hose and perform the necessary repairs or replacements.

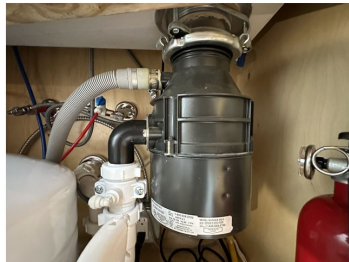
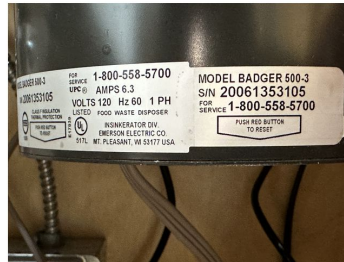
The food waste disposer and its components were found to be performing adequately. The unit was in satisfactory condition with no visible wear, leakage, or damage were present, and no malfunctions or safety hazards were identified. Given that the food waste disposer is in satisfactory condition and functioning properly, it is recommended to continue regular maintenance, such as periodic cleaning and inspection of the grinding components, to ensure continued performance and longevity.

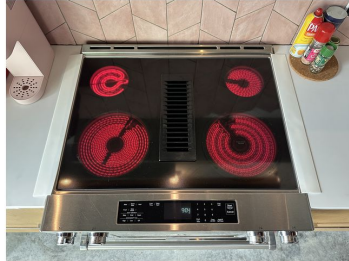
The exhaust system, integrated with the range, was found to be performing adequately and is deemed to be in satisfactory condition. During the inspection, no notable malfunctions, significant defects, or safety hazards were observed. The system appeared to be operating as intended, with no issues detected that would adversely affect its operational or functional performance.

account the expected condition of an exhaust system of similar age and usage over time. This assessment considered the system's operation, function, and configuration.

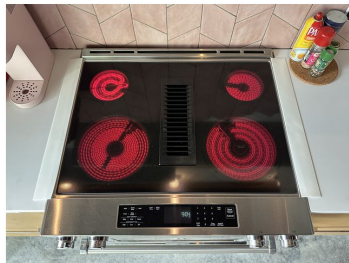
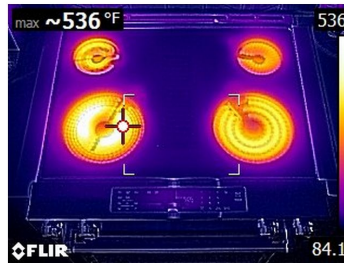
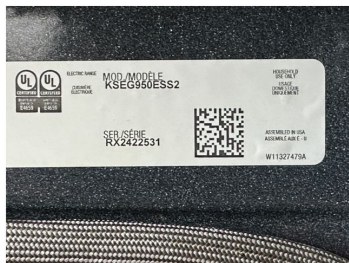
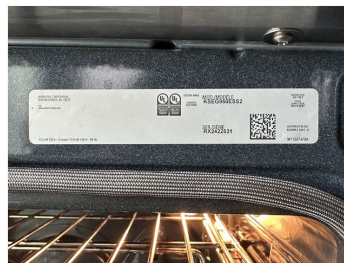
The range and its components were inspected and found to be performing adequately, with all aspects functioning as intended. The range was in satisfactory condition, with burners igniting properly and heating efficiently during the assessment. No notable malfunctions, significant defects, or safety hazards were observed, and the unit exhibited no issues that would adversely affect its operational or functional performance, indicating that it is currently safe and effective for use.

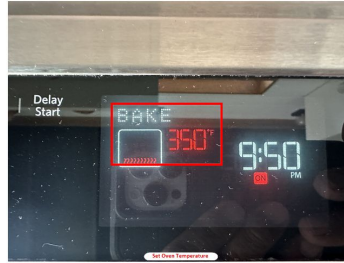
Location: Kitchen

- **Oven - Discrepancy in oven temperature**

The oven was set to a test temperature of 350 degrees Fahrenheit. However, the actual temperature of the oven was measured at 265 degrees Fahrenheit. According to general standards, ovens should maintain a temperature within a range of 25 degrees Fahrenheit of the set temperature. The observed discrepancy of 85 degrees suggests that the oven is not functioning correctly and may be incapable of reaching or maintaining the desired cooking temperature. It is recommended to consult with a qualified professional appliance company to assess the oven's performance and conduct any necessary repairs or replacement. Ensuring the oven operates within acceptable temperature parameters is important for safe and efficient cooking.

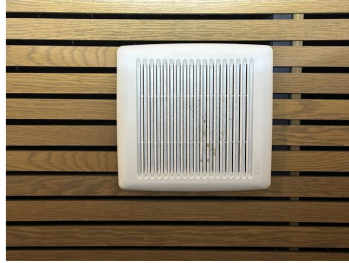
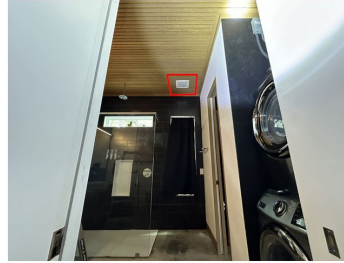
The exhaust vent cover fan grilles had accumulated a significant amount of dust and lint. The presence of dust and lint can impede the airflow through the grilles, which can lead to compromised ventilation. Additionally, the accumulation of dust and lint on the fan blades can result in reduced efficiency and pose a potential risk of overheating the fan motor. Recommend cleaning the exhaust vent cover and removal of any accumulated dust and lint from the fan blades.

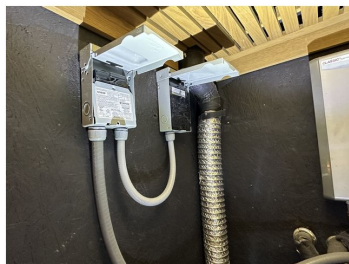
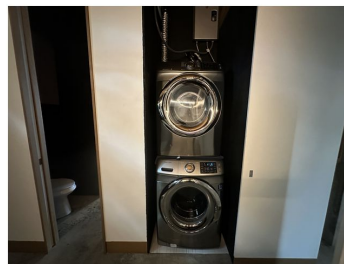
● **Dryer Exhaust System**

During the inspection, the dryer exhaust system and its components were observed to be functioning satisfactory. It demonstrated operational efficiency, functionality, and configuration that align with accepted industry standard practices, taking into account their age and the normal wear and tear expected from regular use. Based on the assessment conducted, it appeared there were no notable deficiencies or concerns identified with the dryer exhaust system and its components.

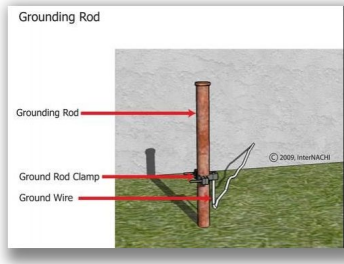
The inspector was unable to visually verify the installation of the ground electrode rod (grounding rod). It appeared that the ground rod and clamp were driven below the ground level. The ground electrode rod should be installed with the top at least 2 inches above ground level, and the ground rod clamp should be visible to ensure proper grounding and easy inspection. The current installation poses a safety hazard until corrected. Consult with a qualified, licensed electrician for a thorough evaluation

and necessary corrections. Ensuring the proper installation of the grounding rod is essential for electrical safety and compliance with standards.
