INSPECTION REPORT

**Property Address
2809 Rosedale St
Houston, TX 77004
September 5, 2024**

Angel Home Inspections

PROPERTY INSPECTION REPORT FORM

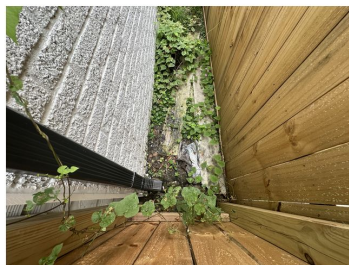
- **Splash Block - Missing**

The splash block was missing under the downspout. The absence of a splash block can lead to potential erosion or damage caused by the drainage from the downspout. Additionally, water may flow directly against the foundation, increasing the risk of soil erosion and water intrusion, which can compromise the integrity of the foundation over time. Recommend installing a splash block under the downspout to effectively redirect the water flow away from the foundation.

Additional Note: The accompanying photos illustrate the missing splash blocks observed along the perimeter of the home's foundation during the inspection.

Note: Downspouts should discharge water at a minimum distance of forty-eight inches (48") away from the foundation perimeter beam. This distance is necessary to effectively direct water away from the foundation of your home and prevent potential issues.

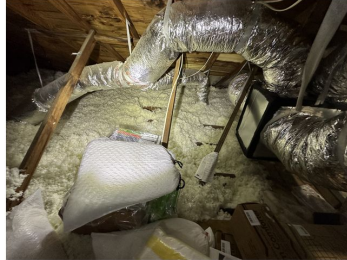
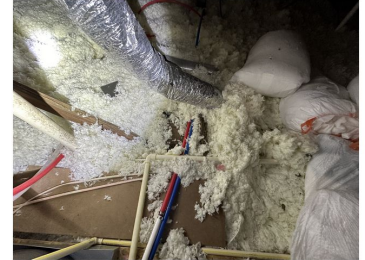
Various areas in the attic were found to meet the recommended R-30 rating for insulation. However, some areas were noted to have insulation levels below this standard, likely due to compression from items placed on top of the insulation, settlement over time, or an insufficient amount of insulation. Insufficient insulation in these areas can lead to significant temperature fluctuations within the home, resulting in increased heating costs and higher energy consumption. Additionally, compromised insulation can contribute to moisture buildup in the attic, which may create an environment conducive to mold and mildew growth. This situation not only reduces the home's energy efficiency but also poses potential health risks and structural concerns. It is advisable to consult with a professional insulation contractor to conduct a thorough evaluation of the attic's insulation. Enhancing the insulation to consistently meet the R-30 rating across the entire attic will help ensure optimal energy efficiency, thermal performance, and moisture control.

Important Note: The evaluation was conducted in accordance with standard industry practices, which recommend a depth of attic floor insulation at approximately 10+ inches to achieve an R-30 rating.

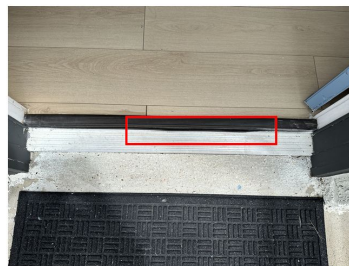
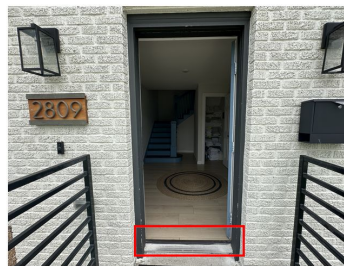
Location: Front Door Entry - Front Side of Home

• **Floor - Weather-Stripping at threshold - Loose**

The weather-stripping on the door threshold was observed to be loose. This can create gaps that allow drafts, moisture, and pests to enter, reducing the energy efficiency of the home and potentially causing damage over time. Proper weather-stripping ensures a tight seal, helping to maintain indoor temperatures and protect against external elements. It is recommended to repair or replace the loose weather-stripping to restore a secure seal and improve the overall efficiency of the door.

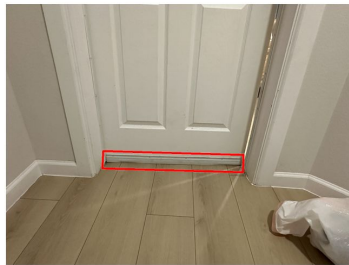
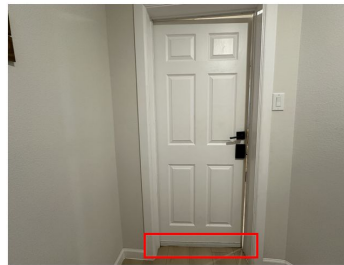
Location: Front Entry Door

- **Exterior Door Sweep - Scraping the floor**

The door sweep on the exterior door was observed scraping the floor, making it difficult to open or close. This condition can cause wear to both the door and the floor surface and may also compromise the door's ability to seal properly, potentially leading to energy loss. Recommend adjusting or replacing the door sweep to prevent further damage and ensure smooth operation of the door.

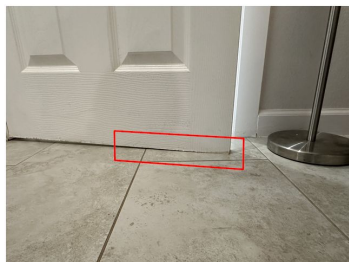
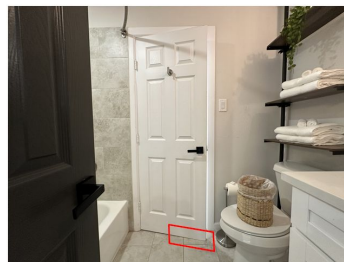
Location: Middle Bathroom, Closet Under Stairwell

The interior door was observed rubbing along the bottom rail on the floor, making it difficult to open or close and causing irregular operation. This issue suggests that the hinges may require readjustment or replacement. Recommend adjusting or replacing the hinges, to restore the door's smooth functionality and ensure proper operation.

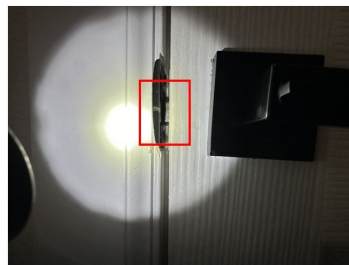
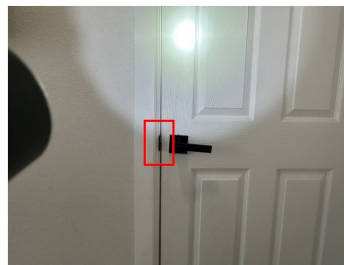
- Location: Rear Bedroom**

- **Door - Will not latch properly**

The door did not latch properly when closed. A noticeable misalignment was observed between the latch mechanism and the strike plate, preventing the door from securing effectively in its closed position. Recommend adjusting either the door latch or the strike plate to achieve proper alignment. This may involve repositioning the strike plate or making slight adjustments to the door hinges. If these adjustments do not resolve the issue, consult with a qualified carpenter or handyman for further evaluation and corrective measures to ensure the door latches securely and operates smoothly.

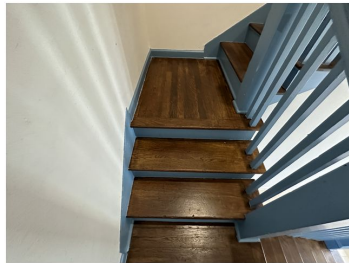
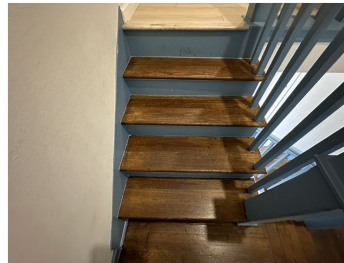
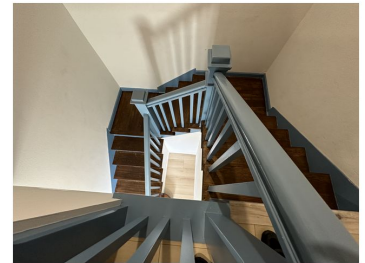
The interior stairway and its associated components were found to be performing adequately and in satisfactory condition. They exhibited an operation, function, and overall condition that align with accepted industry standards and practices. It appeared the interior stairway were structurally sound, stable, and free from significant defects or issues that could compromise its safety or functionality. This assessment also takes into consideration factors such as age, normal wear and tear, and routine maintenance associated with regular use. Based on the findings, it appeared there are no immediate concerns or deficiencies regarding the interior stairway and their components.

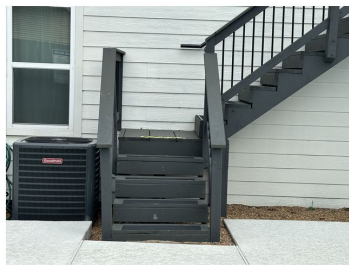
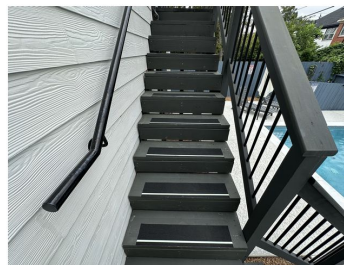
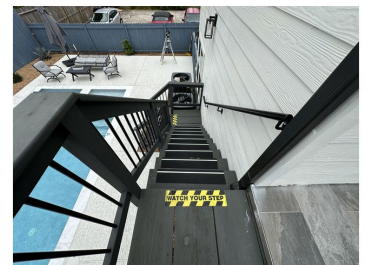
● **Exterior Stairways**

The exterior stairway and its associated components were found to be performing adequately and in satisfactory condition. They exhibited an operation, function, and overall condition that align with accepted industry standards and practices. It appeared the interior stairway were structurally sound, stable, and free from significant defects or issues that could compromise its safety or functionality. This assessment also takes into consideration factors such as age, normal wear and tear, and routine maintenance associated with regular use. Based on the findings, it appeared there are no immediate concerns or deficiencies regarding the interior stairway and their components.

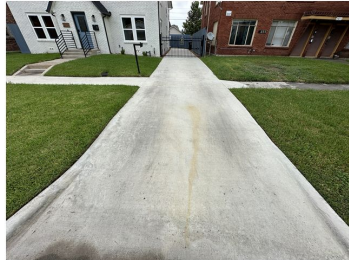
During the inspection, the driveway was found to be in a satisfactory condition with no significant issues or damage. The driveway and its associated components showed no signs of structural concerns or deterioration, aligning with acceptable standards. It was determined that the driveway was well-maintained, functional, and performing adequately.

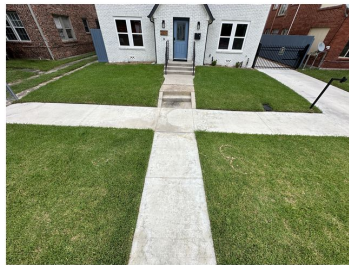
- **Walkway**

During the inspection, the walkway was found to be in a satisfactory condition with no significant issues or damage. The walkway and its associated components showed no signs of structural concerns or deterioration, aligning with acceptable standards. It was determined that the walkway was well-maintained, functional, and performing adequately.

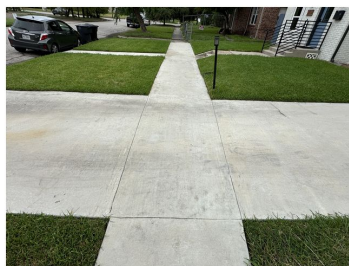
- **Sidewalk**

During the inspection, the sidewalk was found to be in a satisfactory condition with no significant issues or damage. The sidewalk and its associated components showed no signs of structural concerns or deterioration, aligning with acceptable standards. It was determined that the sidewalk was well-maintained, functional, and performing adequately.

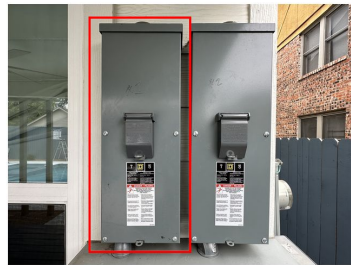
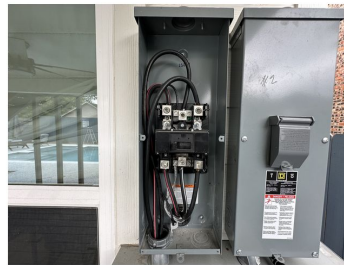
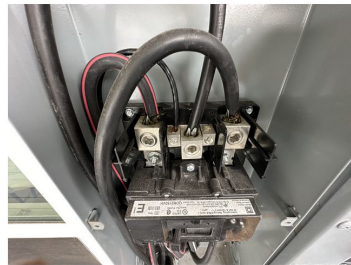
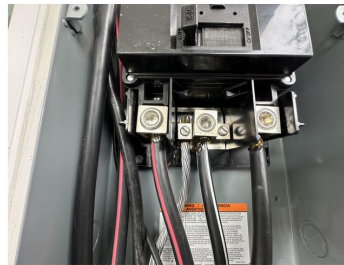
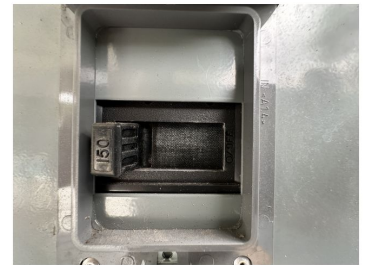
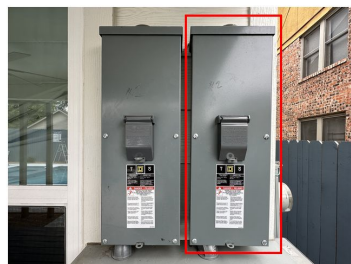
Location: Exterior Wall - Rear Side of Home

The main breaker boxes and its components were evaluated and found to be in satisfactory condition, with no visible signs of damage or wear. The assessment was conducted in accordance with standard industry practices, considering the age and usage of the equipment. Although the breaker boxes are currently performing well, ongoing maintenance is essential to ensure its continued optimal performance and safety. It is recommended to conduct routine inspections of the main breaker boxes to maintain its performance and safety. Regular maintenance will help prevent potential issues and ensure the equipment continues to function effectively. Should any concerns arise, consult a qualified, licensed electrical contractor for further evaluation and corrective actions.

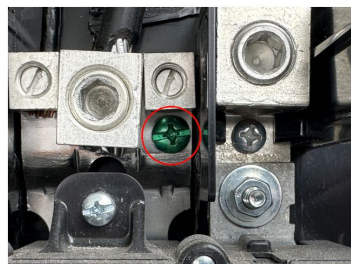
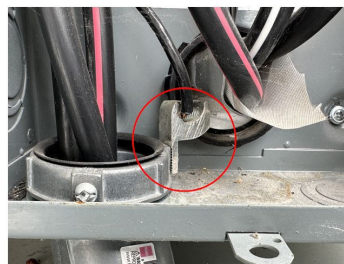
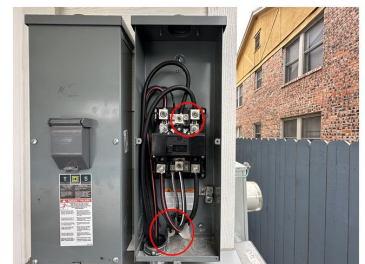
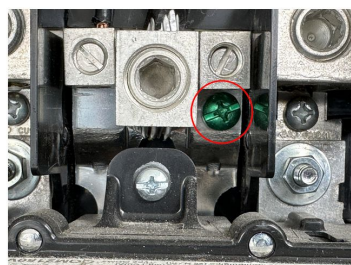
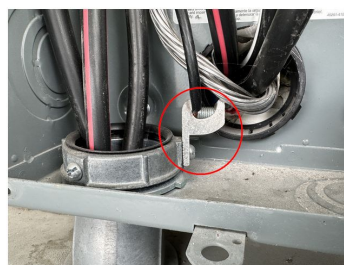
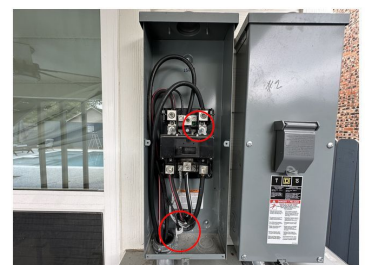
- **Main Breaker Boxes - Bonding**
Location: Rear Side of Home

The bonding to the main breaker boxes were observed to be correctly installed and functioning properly, with secure connections and no visible signs of corrosion or damage. Despite its current satisfactory condition, the bonding system is subject to potential issues over time due to weather exposure, corrosion, and general wear and tear. Compromised bonding can affect electrical safety and operation. It is recommended to have a qualified, licensed electrical contractor perform regular inspections of the bonding connections, ideally once a year. This will help verify their condition, ensure they remain secure, and identify any signs of deterioration. If issues are found, prompt evaluation and repairs should be conducted.

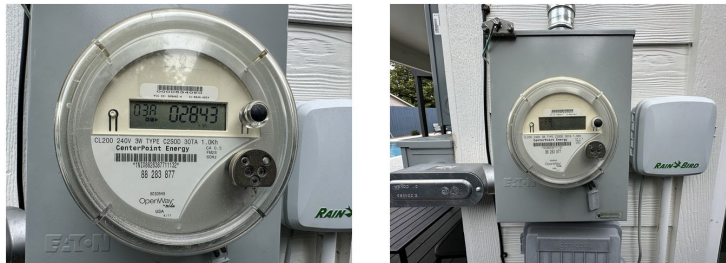
- **Location: Exterior Wall - Right Side (Facing Rear of Home)**

The electrical meter box was observed to be properly installed and functioning as intended. The setup appears to be in good working order, with no visible issues noted during the inspection. Despite its current functionality, the electrical meter box may be impacted by age, usage, and weather exposure over time. These elements could potentially impact its performance and reliability. It is advisable to periodically monitor the electrical meter and its components to ensure continued performance and safety. If any concerns or performance issues arise, consult with the electric utility company for further evaluation and prompt corrective action.

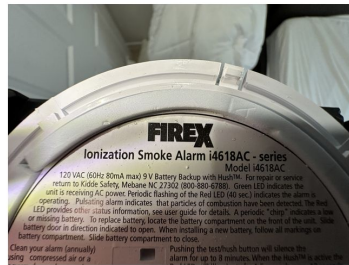
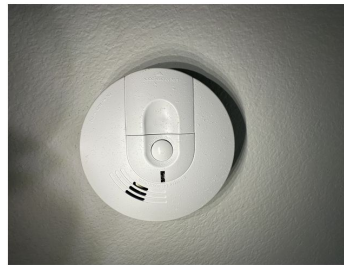
Location: Downstairs Front Bedroom

- **Smoke Alarm - Batteries Removed**

The smoke alarm batteries were observed to be removed. It is strongly recommended to reinstall batteries in compliance with fire and safety regulations. Properly functioning smoke alarms are essential for early detection of smoke and ensuring the safety of occupants. Reinstalling the batteries will help ensure the smoke alarms operate effectively and provide timely alerts in the event of a fire.

Additional Note: In accordance with fire alarm code requirements, it is mandatory to have smoke alarms installed inside every sleep room, even for existing homes. Furthermore, smoke alarms should be placed outside each sleeping area and on every level of the home as a minimum standard. Therefore, it is strongly recommended to reinstall the smoke alarms to comply with fire alarm code and maintain a safe living environment.

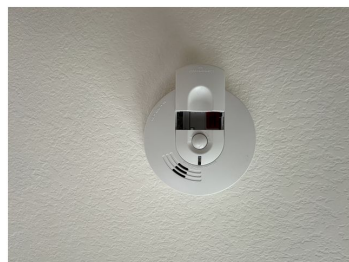
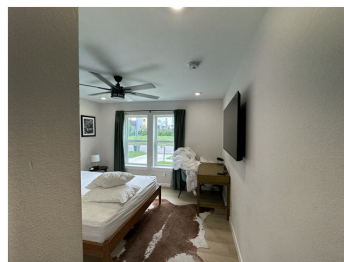
Locations: Upstairs and Downstairs Units

- **Carbon Monoxide Alarms - Not interlinked**

All the carbon monoxide alarms were tested to confirm their functionality, including checking the sensors, power source, and alarm sound. They met operational safety standards and were found to be in working condition. However, the alarms were not interlinked. Without interlinking, if one carbon monoxide alarm detects carbon monoxide, the other alarms will not be triggered. This delay can compromise the overall effectiveness of the carbon monoxide alarm system. It is recommended to consult with a qualified electrical contractor to interlink the carbon monoxide alarms. Interlinking ensures that all alarms activate simultaneously in the event of carbon monoxide detection, thereby enhancing safety and providing a more effective alert system throughout the home.

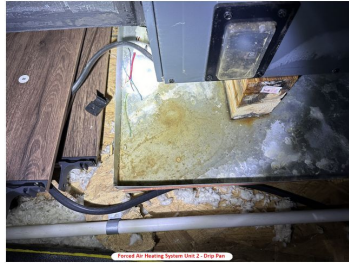
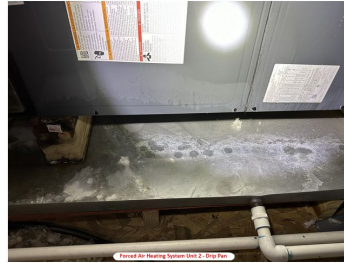
The drain pan located directly underneath the evaporator coils of the heating system unit was observed to have water accumulation. This standing water indicates a potential drainage issue, often caused by a blockage in the drain pipe that prevents proper condensation drainage. If not addressed, this can lead to water damage to surrounding components, mold growth, decreased system efficiency, and potential corrosion of the heating system. Recommend consulting with a professional HVAC contractor to evaluate the heating system unit. The contractor should identify and resolve the cause of the blockage and perform necessary maintenance to ensure proper drainage of condensation. Prompt action will help prevent water damage and maintain the system's efficiency and functionality.

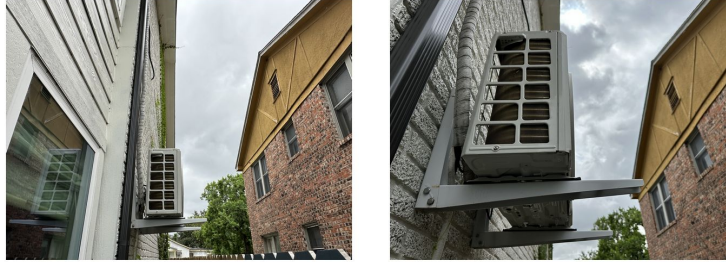
The mini-split unit was functioning as intended. Temperature readings were taken using an imaging infrared laser thermometer to verify the flow of cool or cold air. Any notable discrepancies in airflow will be documented in the report.

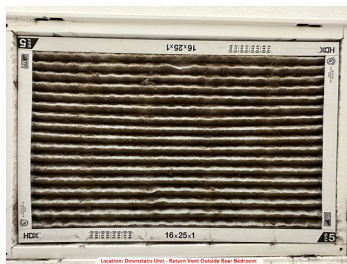
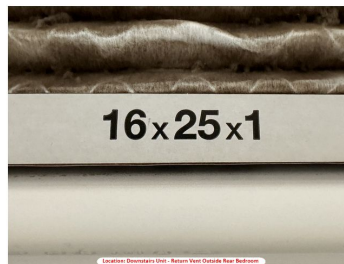
Locations: Downstairs Unit - Return Vent Outside Rear Bedroom, Upstairs Unit - Family Room Area

The filters at the return vents of the HVAC system were dirty filled with dust. This accumulation of contaminants restricts airflow, forcing the HVAC system to work harder to maintain desired temperatures. The reduced airflow can negatively impact the system's performance and efficiency, leading to compromised indoor air quality, increased energy consumption, and higher utility bills. Additionally, prolonged use of dirty filters can shorten the operational life of the HVAC system and lead to costly maintenance issues. It is recommended to replace the air filters to ensure optimal airflow, energy efficiency, and indoor air quality. It is advisable to replace the filters every 1-3 months, depending on usage and environmental factors.

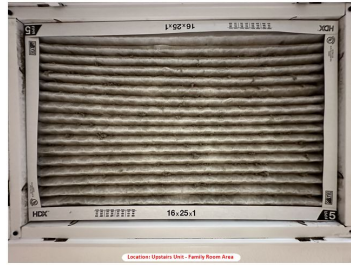
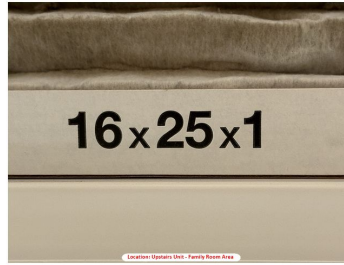
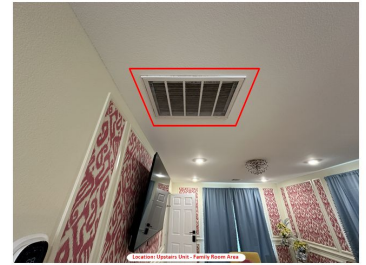
Locations: Downstairs Unit - Return Vent Outside Rear Bedroom, Upstairs Unit - Family Room Area

● **Return Vent Grilles - Dirty**

The grilles on the return vents for the HVAC system were found to be dirty, containing dust and lint particles that are pulled into the system. These contaminants are drawn into the HVAC system which can adversely affect performance by straining the air handler fan motor, potentially leading to motor burnout, overheating, and system failure. It is recommended to clean the return vents to improve the HVAC system's efficiency, prolong its operating life, contribute to energy savings, and reduce maintenance costs. **Note:** The photos provided serve as a visual representation (examples) of all return vent covers that require cleaning.

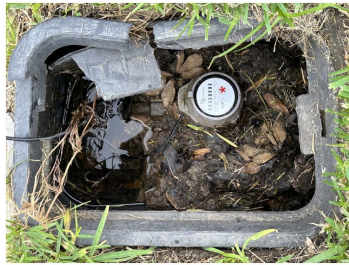
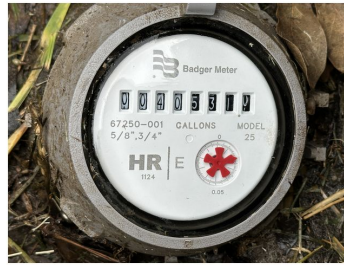
Location: Front Side of Home near Curb

The inspector observed mud inside the water meter box, obstructing the view of the water pipes. The presence of mud inside the water meter box prevented the inspection of the pipes and connections, making it impossible to assess for potential leaks or other issues. This obstruction can hide existing problems that may require attention, leading to undetected issues that could worsen over time. Recommend removing the mud from the meter box, ensuring that the pipes and connections are visible and accessible. This will allow for a proper inspection of the pipes and connections to ensure there are no leaks or other issues. Regular maintenance of the water meter box is also advised to prevent future obstructions.

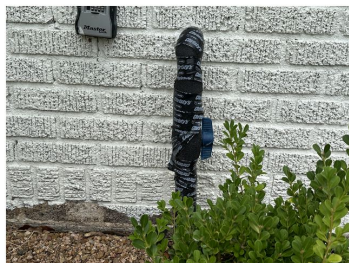
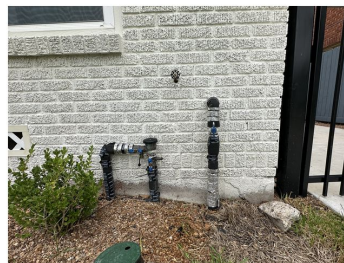
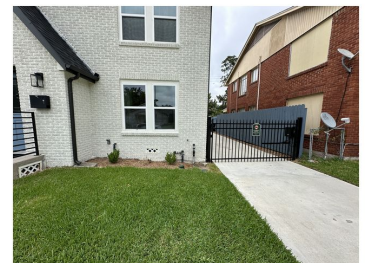
Location: Front Side of House within 3-feet of the Exterior Wall

The main water supply valve was inspected and found to be performing adequately. It was deemed to be in satisfactory condition, with no notable malfunctions, significant defects, or safety hazards that would adversely affect its operational or functional performance. Although the main water supply valve is currently in good working condition, it is advisable to continue regular maintenance and periodic inspections to ensure its ongoing reliability and functionality.

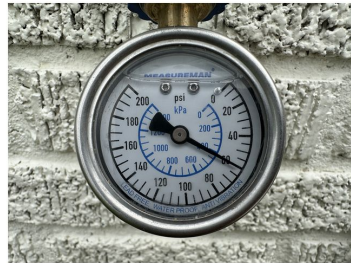
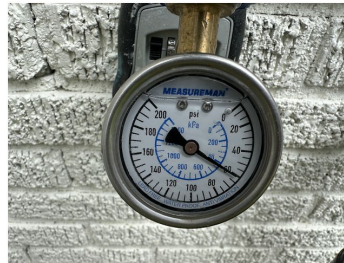
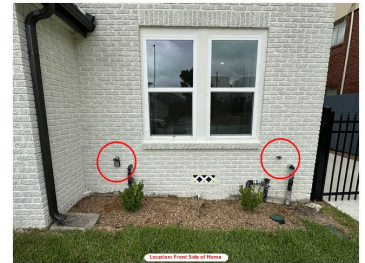
- **Static Water Pressure Reading**

During the inspection, the static water pressure was found to be within the acceptable water pressure range between 40 to 80 pounds per square inch (psi). The acceptable water pressure range of 40 to 80 psi is considered standard because it balances effective water flow with minimal stress on plumbing fixtures and pipes. Pressure below 40 psi may result in inadequate water flow, while pressures above 80 psi can strain plumbing systems and cause leaks or damage to fixtures.

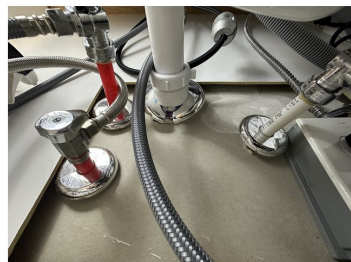
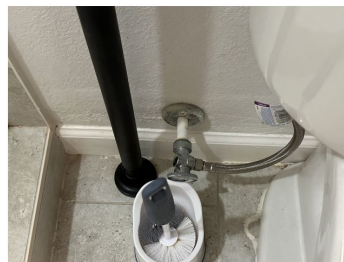
- **Type of Supply Piping Material PEX - Cross Linked Polyethylene Plastic Tubing**

The supply piping material was inspected and found to be performing adequately. It was deemed to be in satisfactory condition, with no notable malfunctions, significant defects, or safety hazards that would adversely affect its operational or functional performance. Although the supply piping material is currently in good working condition, it is advisable to continue regular maintenance and periodic inspections to ensure its ongoing reliability and functionality.

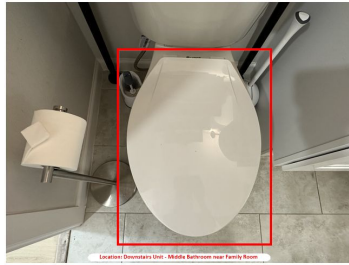
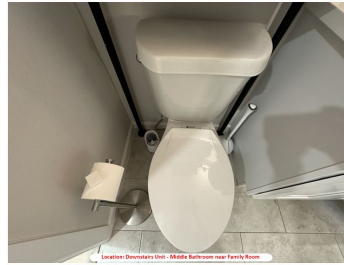
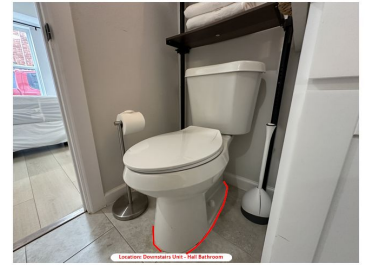
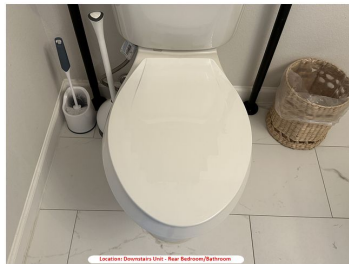
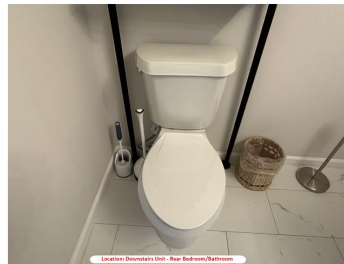
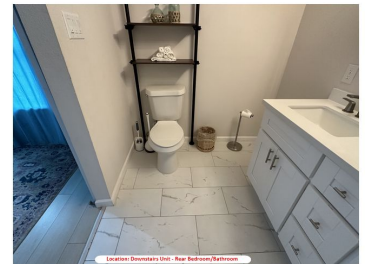
Location: Downstairs Unit - Middle Bathroom near Family Room, Downstairs Unit - Rear Bedroom/Bathroom Bathroom

- **Toilet Bowl - Loose at the floor mount**

The toilet bowl was found to be loose at the floor mount. A loose toilet can lead to several problems, including water leakage between the base of the toilet and the floor, which can cause water damage. Additionally, the instability may allow sewer gases to enter the home, posing potential health risks. Consult with a qualified, licensed plumber to perform a thorough assessment and make the necessary repairs or replacements. This will restore the toilet's stability and prevent potential water damage and health hazards associated with sewer gas.

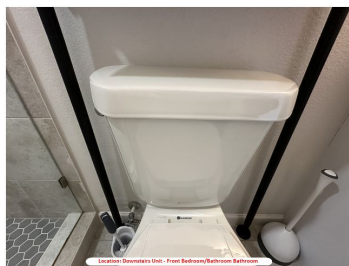
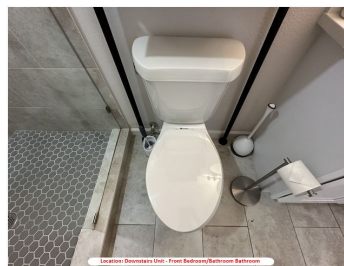
Location: Downstairs Unit - Front Bedroom/Bathroom Bathroom

● **Toilet Tank - Loose at the bowl connection**

The toilet tank was loose at the bowl connection. This instability was noticeable, indicating that the tank was not securely attached to the toilet bowl. The loose connection presents a potential risk of water seepage between the tank and the toilet, which can lead to leaks. If left unaddressed, this condition may result in water damage to the surrounding areas, including the floor and underlying structures, as well as increase the likelihood of mold growth. Consult with a qualified, licensed plumber for a thorough evaluation of the toilet tank connection. Necessary corrections should be made to secure the tank properly and prevent any potential leaks.

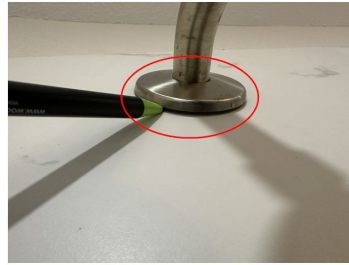
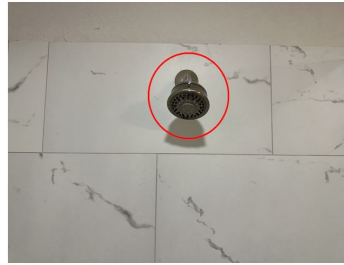
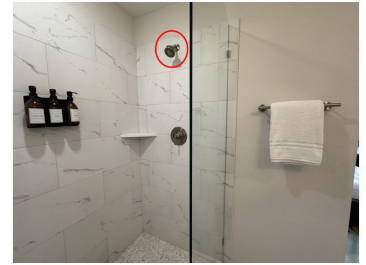
Location: Downstairs Unit - Middle Bathroom near Family Room

● **Shower Arm Flange (Cover) - Not sealed with caulking**

The shower arm flange (cover) that fits around the shower arm was not properly sealed with caulking. The absence of caulking around the flange increases the risk of water intrusion into the wall cavity, potentially leading to moisture accumulation, mold growth, and other moisture-related issues. It is recommended to seal the flange with caulking to prevent water intrusion and ensure the area remains protected.

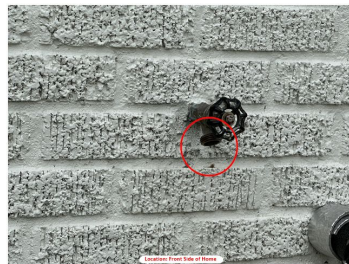
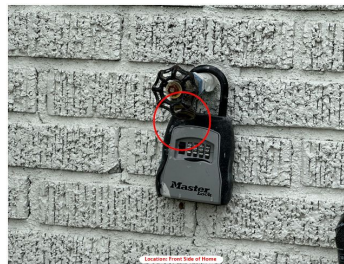
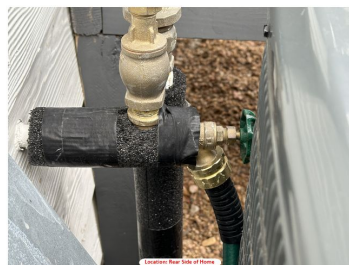
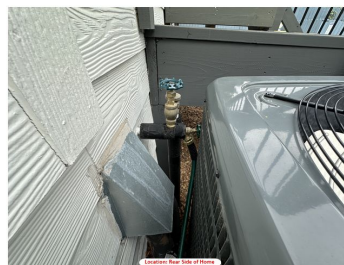
● **Hose Bibs/Spigot Vacuum Breakers (Backflow Preventers) - Missing**
Locations: Front and Rear Side of Home

The inspection revealed that the hose bibs/spigots were missing anti-siphon devices (vacuum breakers or backflow preventers). The absence of these devices poses a risk of water contamination by allowing backflow into the water supply, potentially compromising the system's integrity and leading to health hazards. Recommend installing the required anti-siphon devices to ensure the safety and integrity of the water supply.

Note: The anti-siphon devices were not required at the time the structure was built, it is important to report this as a deficiency in accordance with TREC (Texas Real Estate Commission) standards of practice.

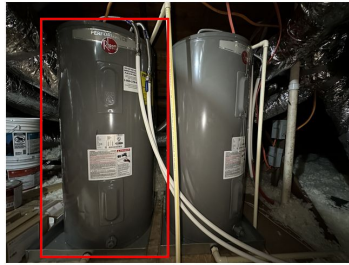
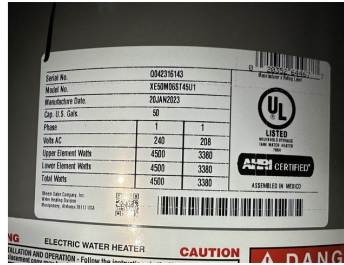
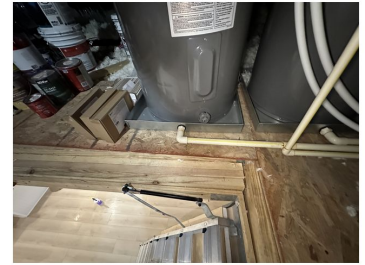
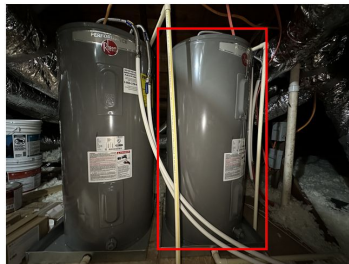
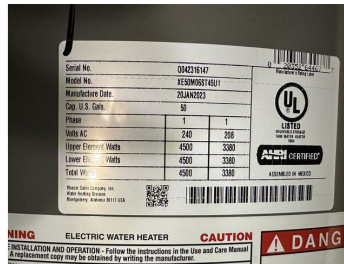
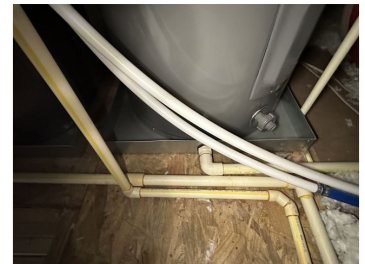
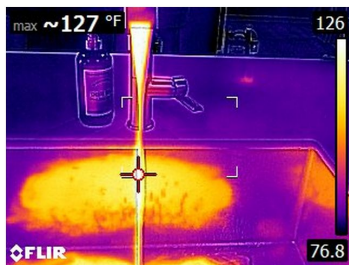
The electric water heaters and its components were found to be performing adequately during the inspection. The units was in satisfactory condition, with no signs of notable malfunctions, significant defects, or safety hazards that would adversely affect the electric water heater's performance or safety. Additionally, the hot water temperature was tested at the kitchen sinks and was found to be functioning correctly. The assessment revealed no issues affecting the operational or functional performance of the electric water heaters, indicating that it is functioning as intended within expected parameters for its age and usage. It is advisable to continue regular maintenance to ensure the electric water heater's optimal performance.

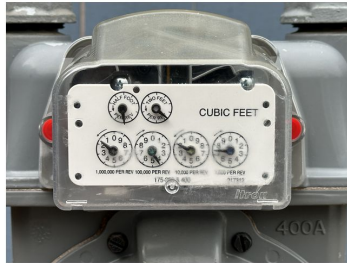
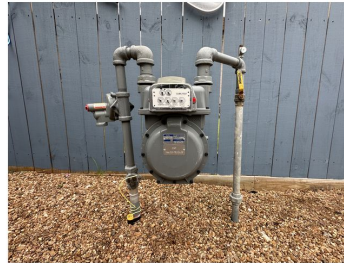
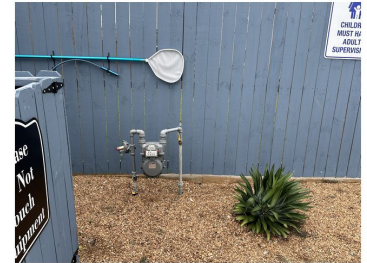
The gas distribution system, including the gas meter, was observed to be functioning adequately during the inspection. No apparent issues were noted with the system's operation. The presence of the bonding wire was confirmed, indicating proper grounding. Regularly check the gas meter and associated components for any signs of irregularities. If any concerns arise regarding the system's operation, promptly consult with a gas utility company for further evaluation and immediate correction.

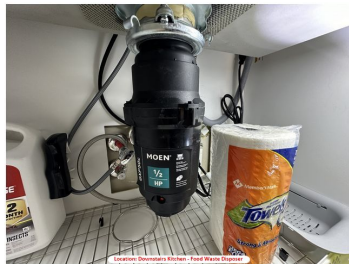
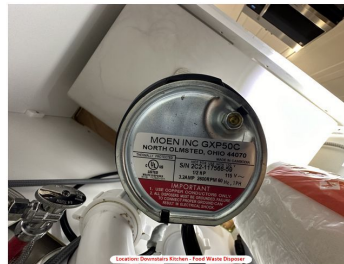
The food waste disposer and its components were found to be performing adequately. The unit was in satisfactory condition with no visible wear, leakage, or damage were present, and no malfunctions or safety hazards were identified. Given that the food waste disposer is in satisfactory condition and functioning properly, it is recommended to continue regular maintenance, such as periodic cleaning and inspection of the grinding components, to ensure continued performance and longevity.

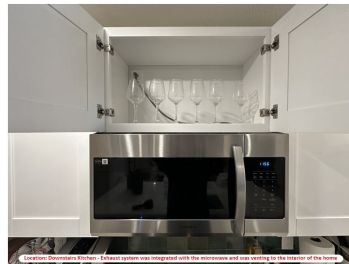
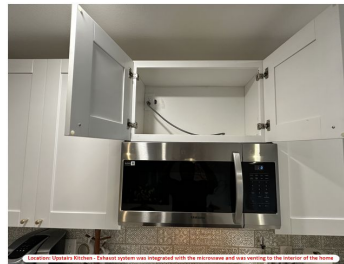
The exhaust system and its components were inspected and found to be performing adequately, with no notable malfunctions, significant defects, or safety hazards observed. The systems were deemed to be in satisfactory condition, with no issues that would adversely affect its operational or functional performance. While the exhaust systems are currently in good working order, it is advisable to continue regular maintenance and periodic inspections. This will help ensure ongoing reliability and functionality, preventing potential issues from arising in the future.

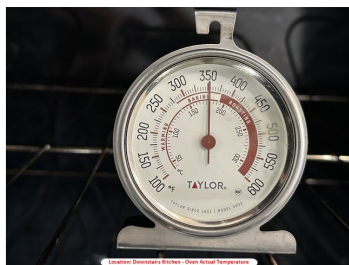
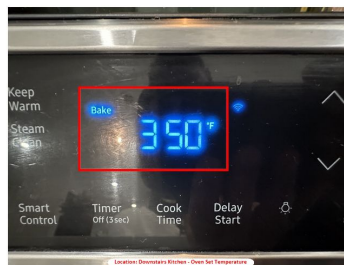
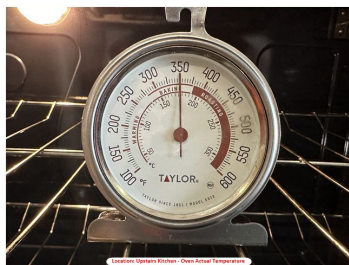
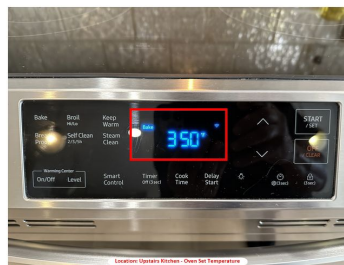
● **Oven**

Manufacturer: Samsung (Downstairs and Upstairs Kitchen)

The ovens were set to 350 degrees Fahrenheit, and the actual temperatures were accurately measured at 350 degrees Fahrenheit. The ovens operated within the accepted range, with all controls functioning correctly and no unusual noises detected. The performance meets the general standard of being within 25 degrees Fahrenheit of the set temperature, indicating proper functionality. No immediate action is necessary as the oven is functioning as intended. However, regular maintenance, including periodic calibration checks and cleaning, is recommended to ensure continued performance and extend the appliance's lifespan.

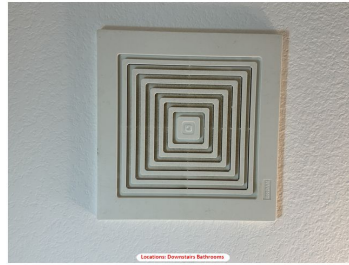
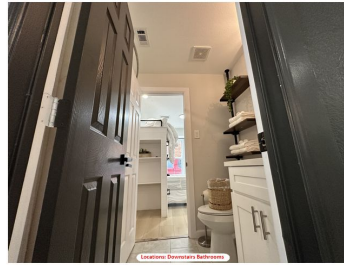
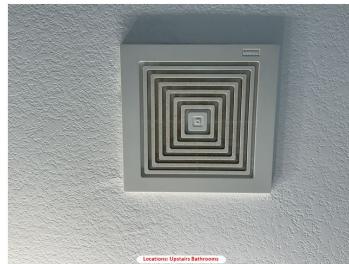
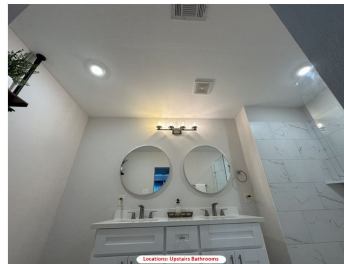
The exhaust vent cover fan grilles had accumulated a significant amount of dust and lint. The presence of dust and lint can impede the airflow through the grilles, which can lead to compromised ventilation. Additionally, the accumulation of dust and lint on the fan blades can result in reduced efficiency and pose a potential risk of overheating the fan motor. Recommend cleaning the exhaust vent cover and removal of any accumulated dust and lint from the fan blades.

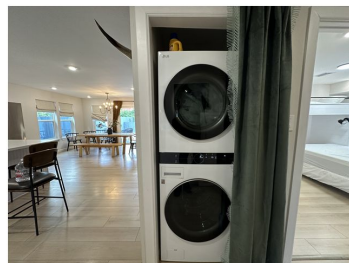
- **Dryer Exhaust System - Downstairs and Upstairs**

During the inspection, the dryer exhaust system and its components were observed to be functioning satisfactory. It demonstrated operational efficiency, functionality, and configuration that align with accepted industry standard practices, taking into account their age and the normal wear and tear expected from regular use. Based on the assessment conducted, it appeared there were no notable deficiencies or concerns identified with the dryer exhaust system and its components.

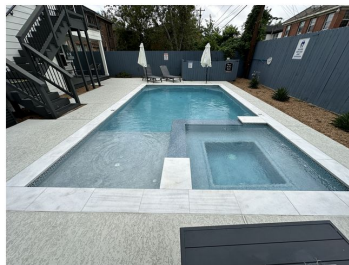
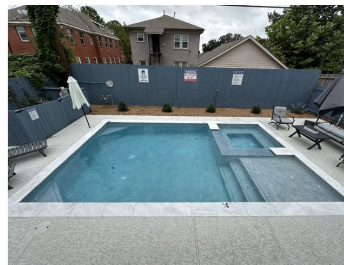
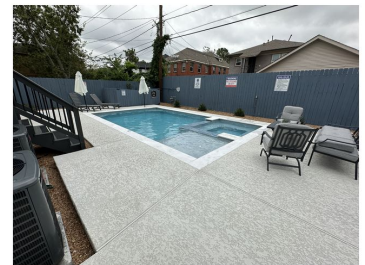
- It was noted that the pool system equipment located behind a gated area was not accessible and could not be fully inspected. The gate did not open sufficiently to allow entry into the area. Although the pool system equipment, including the pump, filter, pipes, and valves, was inspected from a distance and appeared to be operating effectively with proper water circulation, the restricted access prevented a comprehensive examination. Recommend addressing the issue with the gate to ensure proper access for future inspections. It is highly recommended to consult with a professional swimming company for further and correction.

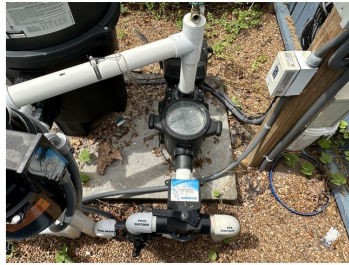
- **Type of Filter: Cartridge / Filter Gauge Pressure Reading: 10 to 15 psi**

A visual inspection from a distance of the cartridge pool filter was performed to confirm the secure placement of the enclosure and to identify any cracks or damages. The cartridge pool filter was found to be operating adequately, with no visible cracks or damages in the enclosure.

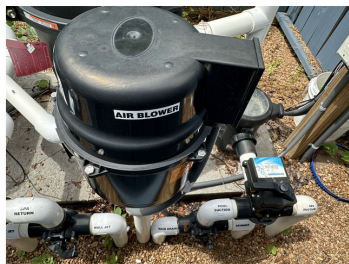
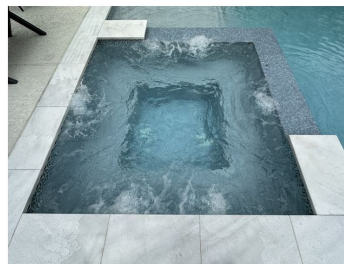
- **Air Blower**

The swimming blower were observed to be functioning as intended. They were operating correctly, providing the expected water effects and contributing to the overall aesthetic and functionality of the pool area. No issues were noted with their performance during the inspection.

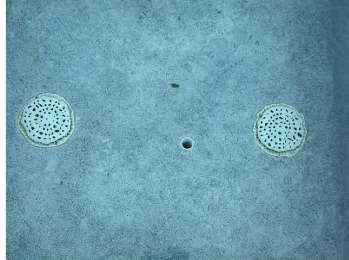
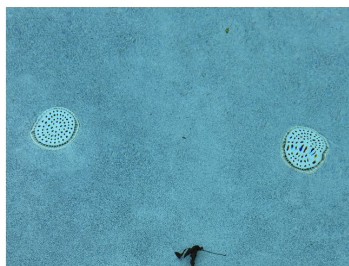
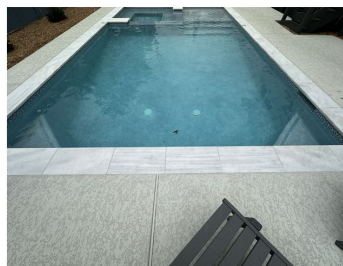
- **Drain Covers**

The drain coves were found to be in satisfactory condition and performing adequately. It demonstrated an operation, function, and overall condition that aligns with accepted industry standards and

practices. This assessment takes into account factors such as age, normal wear and tear, and routine maintenance associated with regular use. Based on the findings, it appears there are no immediate concerns or deficiencies regarding the drain covers.

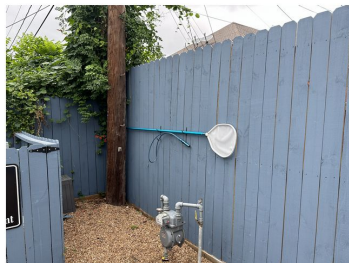
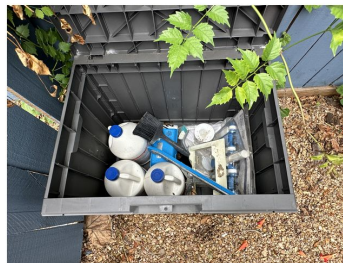
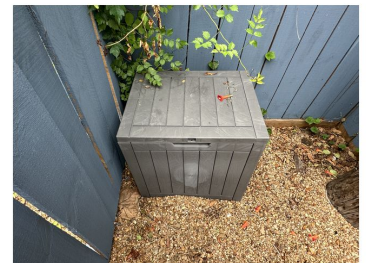
Pool Cleaning Equipment and Supplies

The pool cleaning pole was properly hung. The pool cleaning supplies were properly stored. Based on the findings, it appears there are no immediate concerns or deficiencies regarding the pool cleaning equipment and supplies.

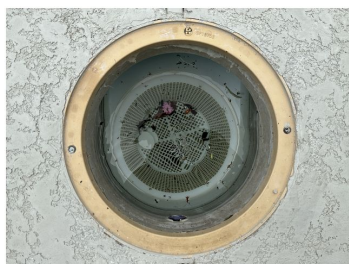
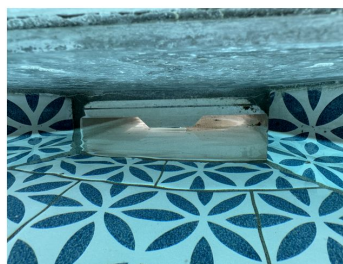
- **Pool Skimmers**

During the inspection, the pool skimmers were inspected and found to contain leaves and debris. It is recommended to clean the skimmers thoroughly to ensure the water remains clean and disinfected.

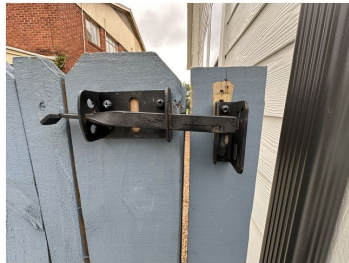
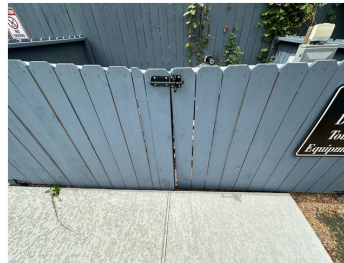
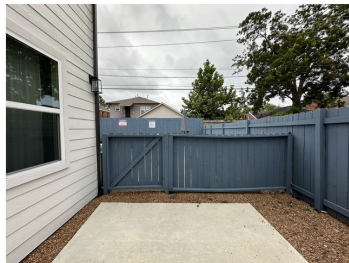
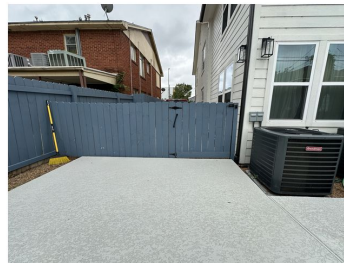
- **Access Gate: Opens outward and not self-closed**

According to safety guidelines, all pedestrian access gates for the pool area should open outward, away from the pool. Additionally, these gates should be self-closing and equipped with a self-latching device. It is important to ensure that the release mechanism is located no less than 54 inches from the bottom of the gate. Furthermore, a second release mechanism should be positioned on the pool side of the gate, at a minimum of 3 inches below the top of the gate.

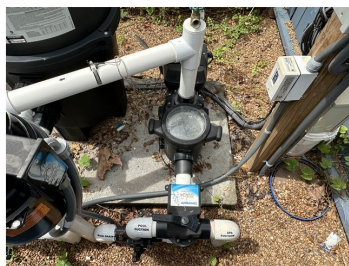
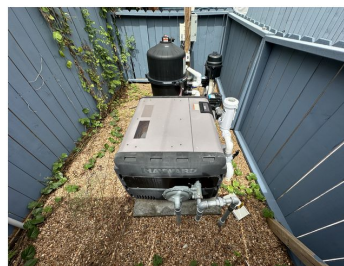
- **Swimming Pool PVC Piping - Not Completely Labeled**

Observed that the swimming pool PVC piping were not completely labeled. PVC piping for swimming pool equipment should be labeled to help keep the plumbing organized and safe, and to make it easier to understand and operate the pool. Labels can be printed on plastic or vinyl, and can indicate the type of water in each pipe, such as backwash or filtered water. Some labels also include directional arrows and wording such as "Intake" and "Return".

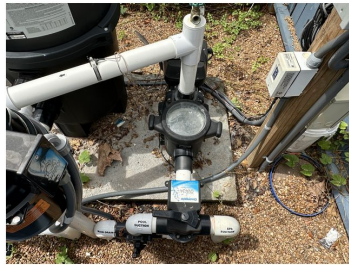
● **Pump - Bonding**

The bonding to the pool pump could not be confirmed during the inspection. Proper bonding is essential for ensuring electrical safety and preventing potential shock hazards. The bonding process helps to ground the electrical components and minimize the risk of electrical faults. Recommend consulting with a qualified, licensed electrician or pool professional to verify and ensure proper bonding of the pump. This will help to ensure the safety of the pool system and comply with electrical safety standards.

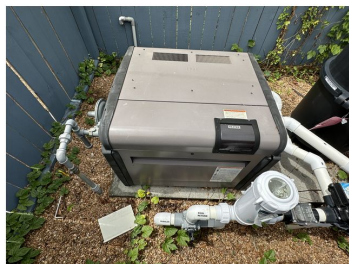
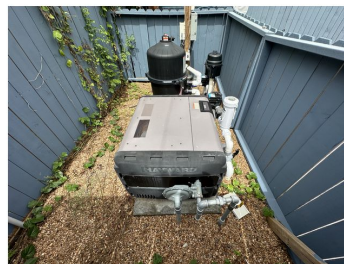
● **Pool Heater**

The pool heater could not be tested during the inspection. Without testing, it is not possible to confirm its operational status or efficiency. Recommend having a qualified pool technician evaluate and test the heater. They can verify its functionality, check for any issues, and ensure it operates efficiently and safely.

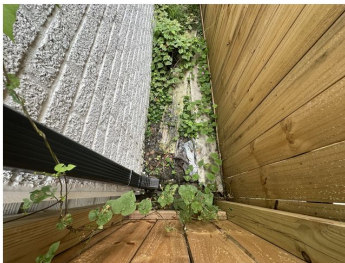
- **Splash Block - Missing**

- The splash block was missing under the downspout. The absence of a splash block can lead to potential erosion or damage caused by the drainage from the downspout. Additionally, water may flow directly against the foundation, increasing the risk of soil erosion and water intrusion, which can compromise the integrity of the foundation over time. Recommend installing a splash block under the downspout to effectively redirect the water flow away from the foundation.

- Additional Note:** The accompanying photos illustrate the missing splash blocks observed along the perimeter of the home's foundation during the inspection.

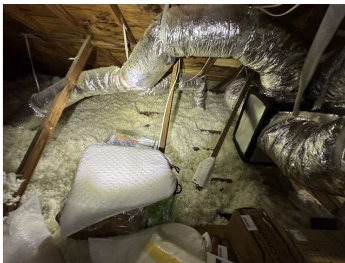
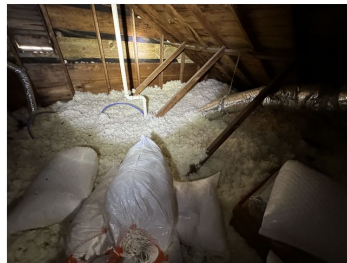
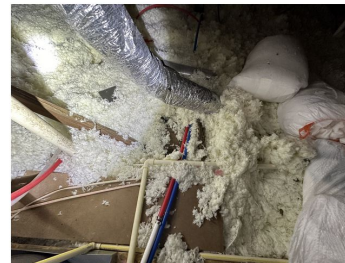
- Locations: Throughout the Attic**

- **Attic Insulation - Below the R-30 rating**

- Various areas in the attic were found to meet the recommended R-30 rating for insulation. However, some areas were noted to have insulation levels below this standard, likely due to compression from items placed on top of the insulation, settlement over time, or an insufficient amount of insulation. Insufficient insulation in these areas can lead to significant temperature fluctuations within the home, resulting in increased heating costs and higher energy consumption. Additionally, compromised insulation can contribute to moisture buildup in the attic, which may create an environment conducive to mold and mildew growth. This situation not only reduces the home's energy efficiency but also poses potential health risks and structural concerns. It is advisable to consult with a professional insulation contractor to conduct a thorough evaluation of the attic's insulation. Enhancing the insulation to consistently meet the R-30 rating across the entire attic will help ensure optimal energy efficiency, thermal performance, and moisture control.

- Important Note:** The evaluation was conducted in accordance with standard industry practices, which recommend a depth of attic floor insulation at approximately 10+ inches to achieve an R-30 rating.

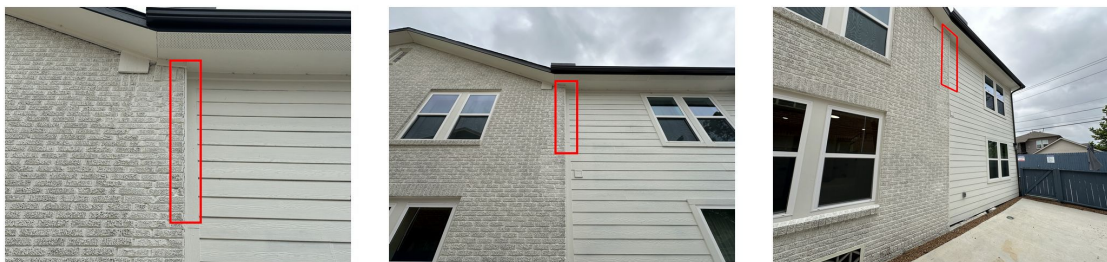
- Location: Exterior Wall - Right Side (Facing Front of Home)**

Sealant was observed to be missing between the trim board and the exterior wall. This gap can allow water intrusion, which may lead to moisture damage and wood rot over time. Proper sealing is essential to prevent water from penetrating the area and compromising the integrity of the trim and underlying wall structure. Recommend applying a high-quality exterior sealant to fill the gap and protect the structure from potential water damage.

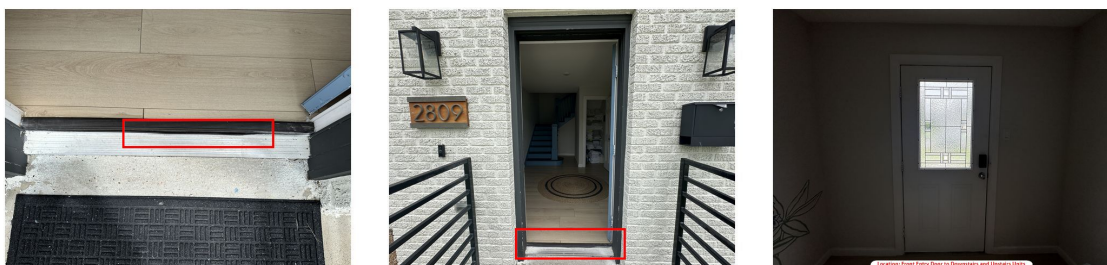
- Location: Front Door Entry - Front Side of Home**

- **Floor - Weather-Stripping at threshold - Loose**

The weather-stripping on the door threshold was observed to be loose. This can create gaps that allow drafts, moisture, and pests to enter, reducing the energy efficiency of the home and potentially causing damage over time. Proper weather-stripping ensures a tight seal, helping to maintain indoor temperatures and protect against external elements. It is recommended to repair or replace the loose weather-stripping to restore a secure seal and improve the overall efficiency of the door.

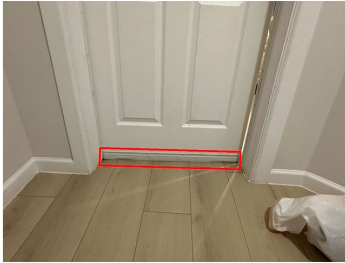
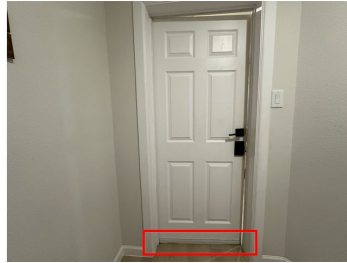
Location: Front Entry Door

- **Exterior Door Sweep - Scraping the floor**

The door sweep on the exterior door was observed scraping the floor, making it difficult to open or close. This condition can cause wear to both the door and the floor surface and may also compromise the door's ability to seal properly, potentially leading to energy loss. Recommend adjusting or replacing the door sweep to prevent further damage and ensure smooth operation of the door.

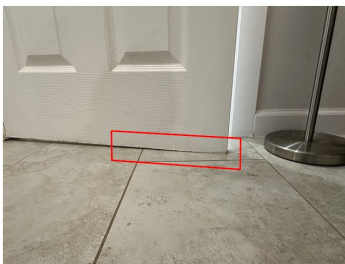
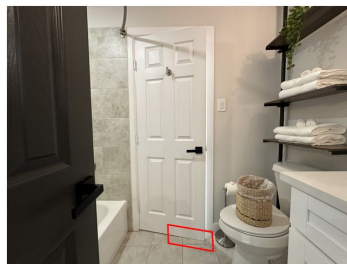
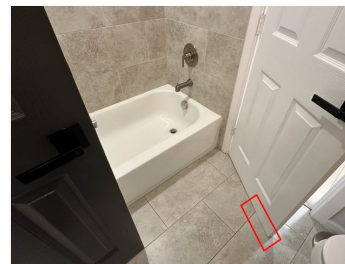
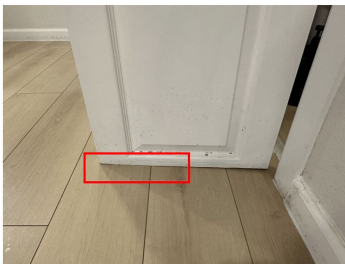
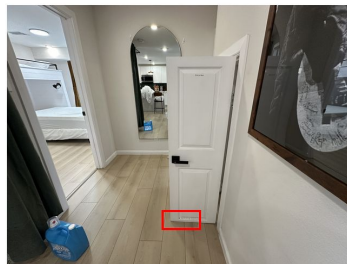
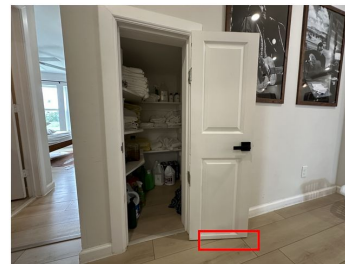
Location: Middle Bathroom, Closet Under Stairwell

● **Interior Door - Rubbing at bottom rail**

The interior door was observed rubbing along the bottom rail on the floor, making it difficult to open or close and causing irregular operation. This issue suggests that the hinges may require readjustment or replacement. Recommend adjusting or replacing the hinges, to restore the door's smooth functionality and ensure proper operation.

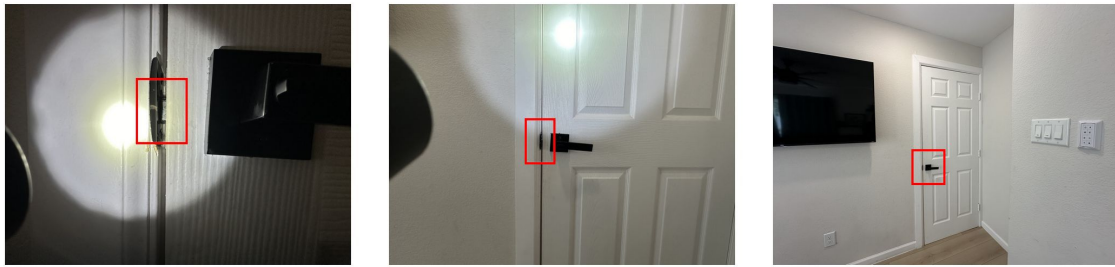
Location: Rear Bedroom

● **Door - Will not latch properly**

The door did not latch properly when closed. A noticeable misalignment was observed between the latch mechanism and the strike plate, preventing the door from securing effectively in its closed position. Recommend adjusting either the door latch or the strike plate to achieve proper alignment. This may involve repositioning the strike plate or making slight adjustments to the door hinges. If these adjustments do not resolve the issue, consult with a qualified carpenter or handyman for further evaluation and corrective measures to ensure the door latches securely and operates smoothly.
