INSPECTION REPORT

**Property Address
2809 Rosedale St
Houston, TX 77004
September 5, 2024**

Angel Home Inspections

PROPERTY INSPECTION REPORT FORM

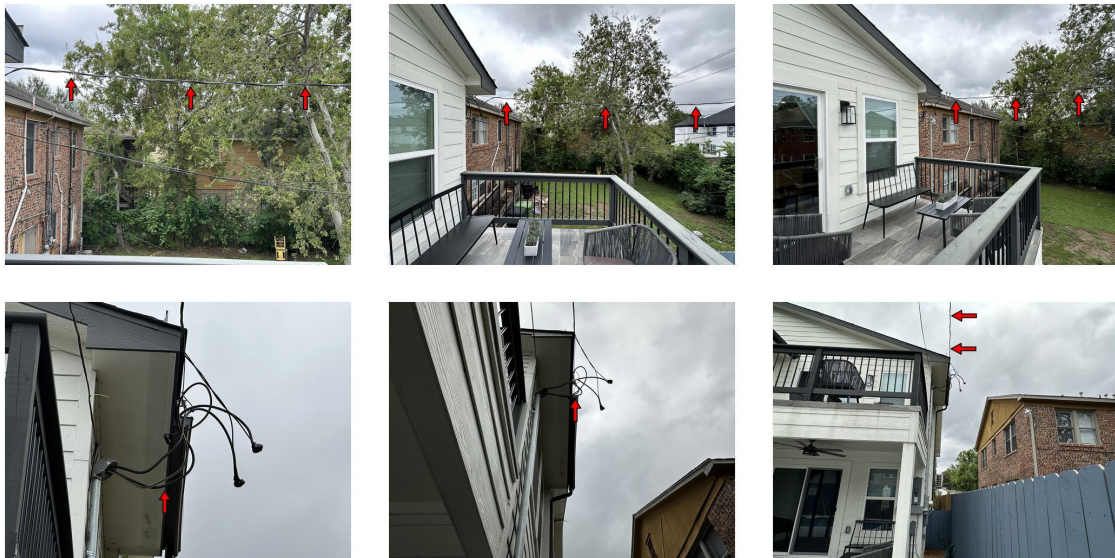
Location: Rear Side of Home

● **Service Entrance Conductors - Close proximity to deck**

The service entrance conductors were observed to be in close proximity to the 2nd floor deck. The horizontal distance of service conductors near decks or balconies is a significant safety concern. According to the National Electrical Code (NEC), service conductors must maintain a minimum horizontal clearance of 3 feet (0.9 meters) from any deck, balcony, window, or similar opening. This clearance is critical to ensure that people do not inadvertently or accidentally come into contact with the wires, which can lead to serious risks such as electrical shock, fire hazards, or other safety issues. It is recommended to consult with the electric service provider for further evaluation and necessary corrective measures to ensure compliance with safety standards and to mitigate the risk of electrical accidents.

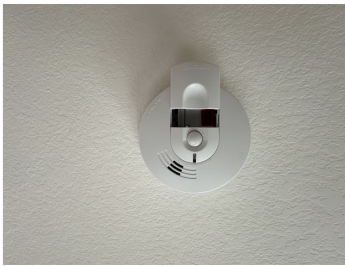
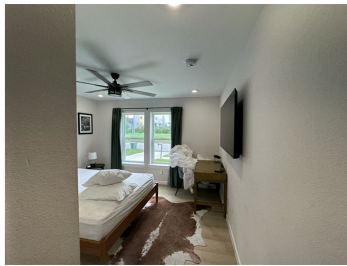
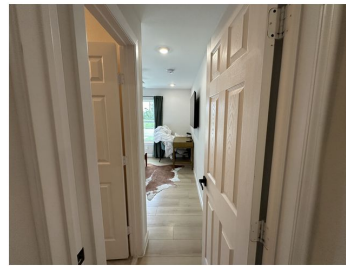
Location: Downstairs Front Bedroom

● **Smoke Alarm - Batteries Removed**

The smoke alarm batteries were observed to be removed. It is strongly recommended to reinstall batteries in compliance with fire and safety regulations. Properly functioning smoke alarms are essential for early detection of smoke and ensuring the safety of occupants. Reinstalling the batteries will help ensure the smoke alarms operate effectively and provide timely alerts in the event of a fire.

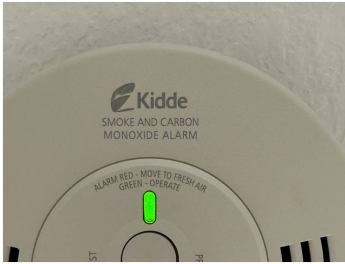
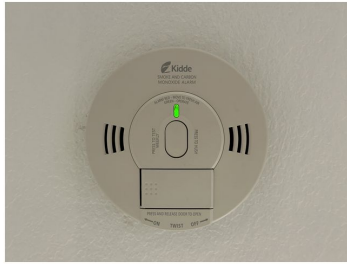
All the carbon monoxide alarms were tested to confirm their functionality, including checking the sensors, power source, and alarm sound. They met operational safety standards and were found to be in working condition. However, the alarms were not interlinked. Without interlinking, if one carbon monoxide alarm detects carbon monoxide, the other alarms will not be triggered. This delay can compromise the overall effectiveness of the carbon monoxide alarm system. It is recommended to consult with a qualified electrical contractor to interlink the carbon monoxide alarms. Interlinking ensures that all alarms activate simultaneously in the event of carbon monoxide detection, thereby enhancing safety and providing a more effective alert system throughout the home.

Additional Note: The accompanying photos represent the type of carbon monoxide alarms installed and tested in room(s) and hallway(s).

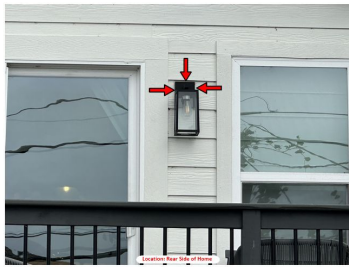
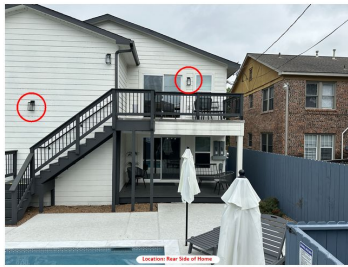
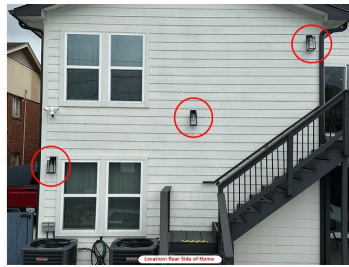
- **Locations: Rear Side of Home**

- **Light Fixtures - Lacked caulking**

Light fixtures were missing caulking, particularly at the top and sides. The absence of caulking creates and allow water to infiltrate, which poses a risk to the components and electrical wiring of the fixtures. Additionally, these gaps may allow dust and insects to enter, potentially compromising the performance and longevity of the light fixtures. Recommend applying caulking to the top and sides of the fixtures, leaving the bottom unsealed for ventilation. This will help prevent water damage and maintain the fixtures' integrity.

Note: The photos provided serve as a visual representation of the light fixtures requiring caulking to the top and sides, leaving the bottom unsealed for ventilation.

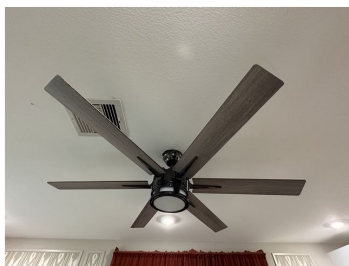
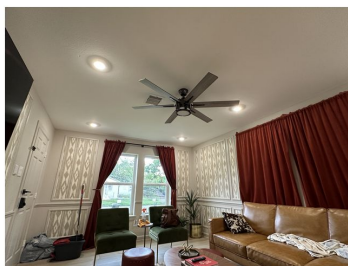
Location: Downstairs Unit - Family Room

● **Ceiling Fan and Light Fixture - Inoperative**

The ceiling fan and light fixture were inoperative during the functionally test. This issue could be related to an electrical problem, electrical connection problems, faulty wiring, malfunctioning component within the fixtures themselves, or a faulty switch. This inoperability can affect the effectiveness of air circulation and comfort within the space. Consult with a qualified, licensed electrician evaluate the cause of the inoperability and perform any necessary repairs or replacement to restore proper functionality and ensure the fan and light operate safety and effectively.

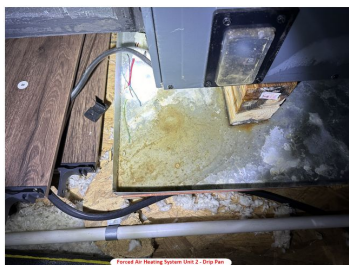
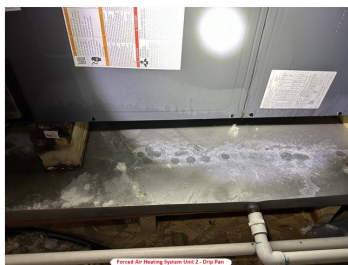
Location: Attic

● **Drain Pan under Evaporator Coils - Water accumulation**

The drain pan located directly underneath the evaporator coils of the heating system unit was observed to have water accumulation. This standing water indicates a potential drainage issue, often caused by a blockage in the drain pipe that prevents proper condensation drainage. If not addressed, this can lead to water damage to surrounding components, mold growth, decreased system efficiency, and potential corrosion of the heating system. Recommend consulting with a professional HVAC contractor to evaluate the heating system unit. The contractor should identify and resolve the cause of the blockage and perform necessary maintenance to ensure proper drainage of condensation. Prompt action will help prevent water damage and maintain the system's efficiency and functionality.

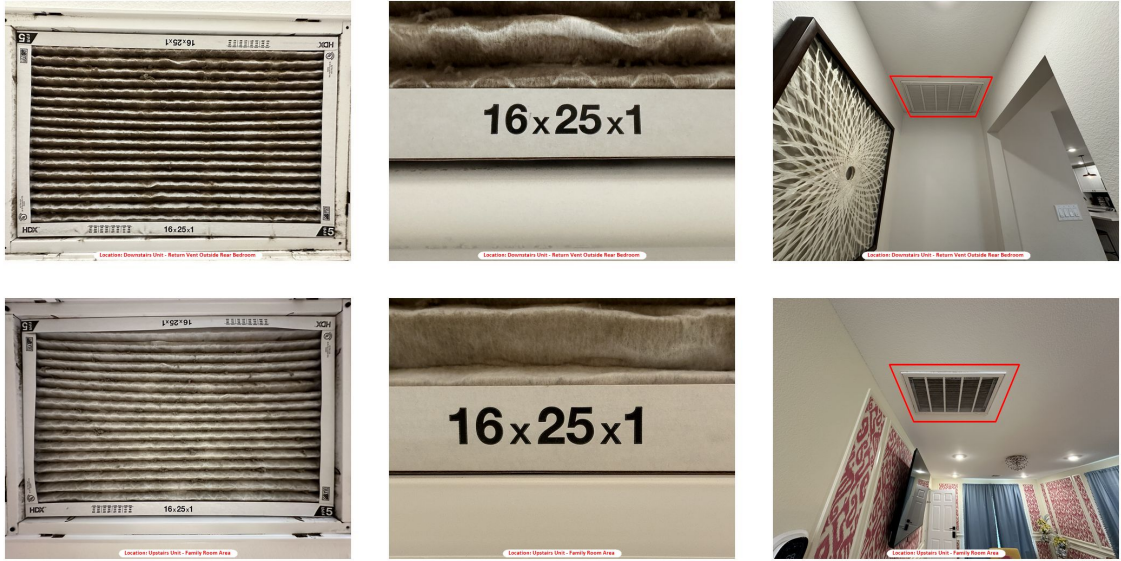
Locations: Downstairs Unit - Return Vent Outside Rear Bedroom, Upstairs Unit - Family Room Area

● **Air Filters - Dirty**

The filters at the return vents of the HVAC system were dirty filled with dust. This accumulation of contaminants restricts airflow, forcing the HVAC system to work harder to maintain desired temperatures. The reduced airflow can negatively impact the

system's performance and efficiency, leading to compromised indoor air quality, increased energy consumption, and higher utility bills. Additionally, prolonged use of dirty filters can shorten the operational life of the HVAC system and lead to costly maintenance issues. It is recommended to replace the air filters to ensure optimal airflow, energy efficiency, and indoor air quality. It is advisable to replace the filters every 1-3 months, depending on usage and environmental factors.

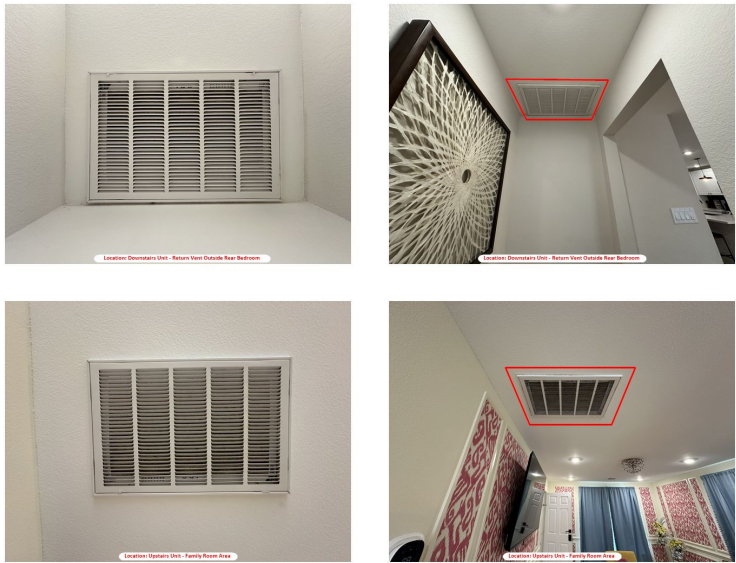
● **Return Vent Grilles - Dirty**
Locations: Downstairs Unit - Return Vent Outside Rear Bedroom, Upstairs Unit - Family Room Area

The grilles on the return vents for the HVAC system were found to be dirty, containing dust and lint particles that are pulled into the system. These contaminants are drawn into the HVAC system which can adversely affect performance by straining the air handler fan motor, potentially leading to motor burnout, overheating, and system failure. It is recommended to clean the return vents to improve the HVAC system's efficiency, prolong its operating life, contribute to energy savings, and reduce maintenance costs. **Note:** The photos provided serve as a visual representation (examples) of all return vent covers that require cleaning.

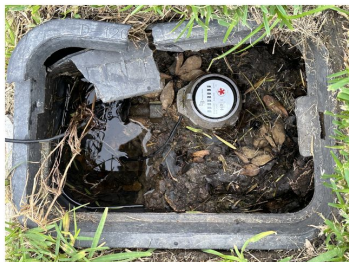
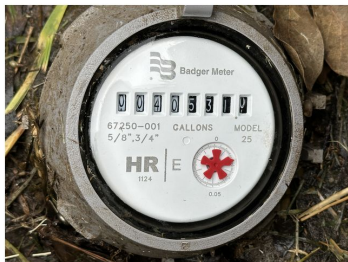
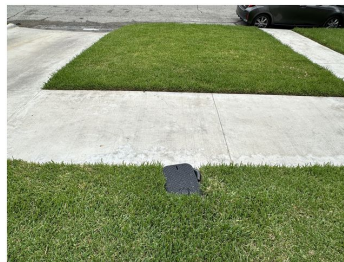
Location: Front Side of Home near Curb

● **Water Meter Box - Contained water**

The inspector observed mud inside the water meter box, obstructing the view of the water pipes. The presence of mud inside the water meter box prevented the inspection of the pipes and connections, making it impossible to assess for potential leaks or other issues. This obstruction can hide existing problems that may require attention, leading to undetected issues that could worsen over time. Recommend removing the mud from the meter box, ensuring that the pipes and connections are visible and accessible. This will allow for a proper inspection of the pipes and connections to ensure there are no leaks or other issues. Regular maintenance of the water meter box is also advised to prevent future obstructions.

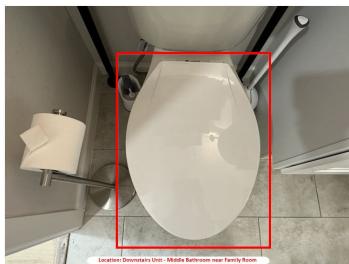
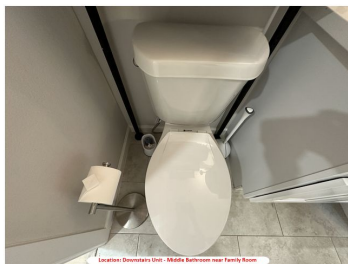
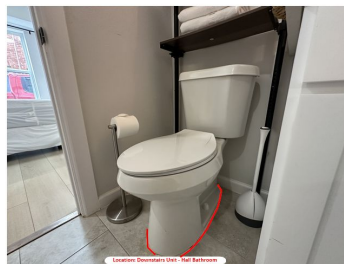
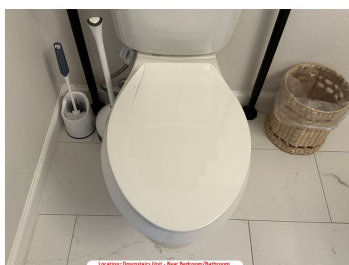
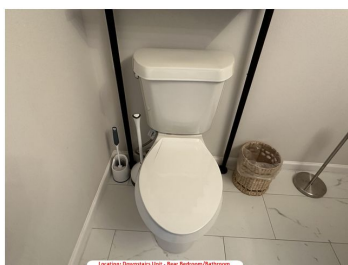
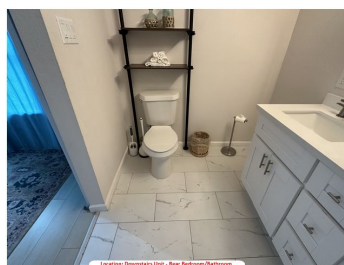
Location: Downstairs Unit - Middle Bathroom near Family Room, Downstairs Unit - Rear Bedroom/Bathroom Bathroom

● **Toilet Bowl - Loose at the floor mount**

The toilet bowl was found to be loose at the floor mount. A loose toilet can lead to several problems, including water leakage between the base of the toilet and the floor, which can cause water damage. Additionally, the instability may allow sewer gases to enter the home, posing potential health risks.

Consult with a qualified, licensed plumber to perform a thorough assessment and make the necessary repairs or replacements. This will restore the toilet's stability and prevent potential water damage and health hazards associated with sewer gas.

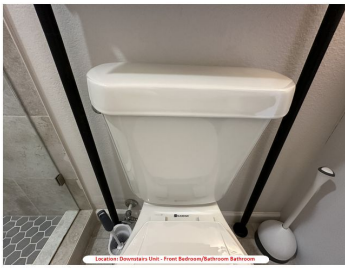
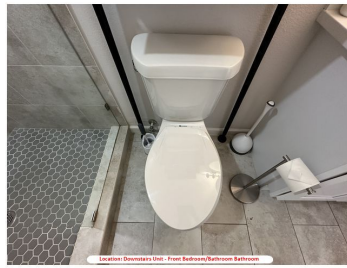
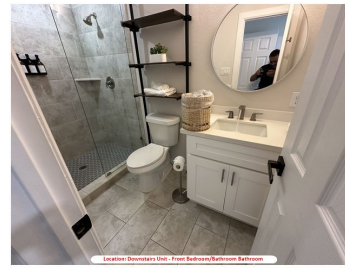
Location: Downstairs Unit - Front Bedroom/Bathroom Bathroom

● **Toilet Tank - Loose at the bowl connection**

The toilet tank was loose at the bowl connection. This instability was noticeable, indicating that the tank was not securely attached to the toilet bowl. The loose connection presents a potential risk of water seepage between the tank and the toilet, which can lead to leaks. If left unaddressed, this condition may result in water damage to the surrounding areas, including the floor and underlying structures, as well as increase the likelihood of mold growth. Consult with a qualified, licensed plumber for a

thorough evaluation of the toilet tank connection. Necessary corrections should be made to secure the tank properly and prevent any potential leaks.

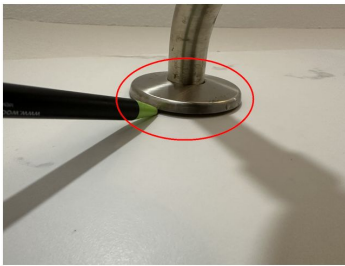
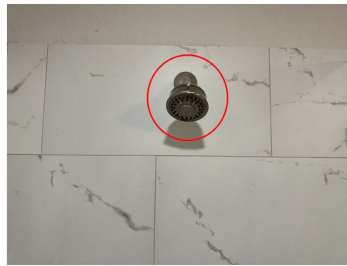
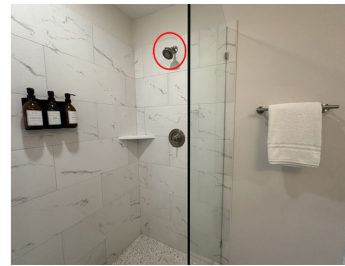
● **Shower Arm Flange (Cover) - Not sealed with caulking**
Location: Downstairs Unit - Middle Bathroom near Family Room

The shower arm flange (cover) that fits around the shower arm was not properly sealed with caulking. The absence of caulking around the flange increases the risk of water intrusion into the wall cavity, potentially leading to moisture accumulation, mold growth, and other moisture-related issues. It is recommended to seal the flange with caulking to prevent water intrusion and ensure the area remains protected.

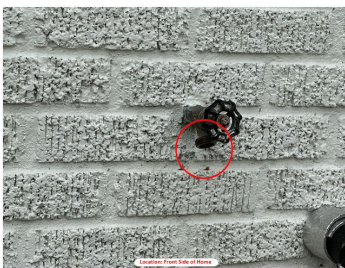
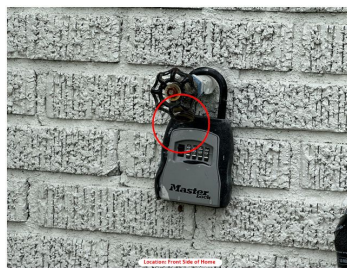
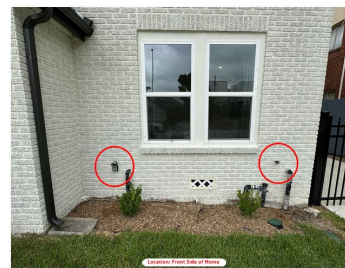
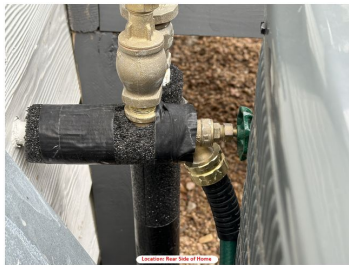
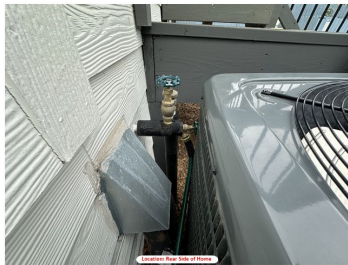
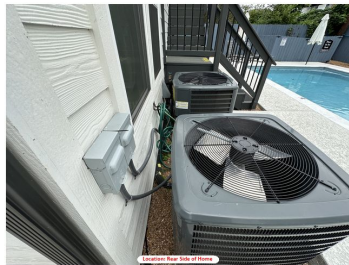
● **Hose Bibs/Spigot Vacuum Breakers (Backflow Preventers) - Missing**
Locations: Front and Rear Side of Home

The inspection revealed that the hose bibs/spigots were missing anti-siphon devices (vacuum breakers or backflow preventers). The absence of these devices poses a risk of water contamination by allowing backflow into the water supply, potentially compromising the system's integrity and leading to health hazards. Recommend installing the required anti-siphon devices to ensure the safety and integrity of the water supply.

Note: The anti-siphon devices were not required at the time the structure was built, it is important to report this as a deficiency in accordance with TREC (Texas Real Estate Commission) standards of practice.

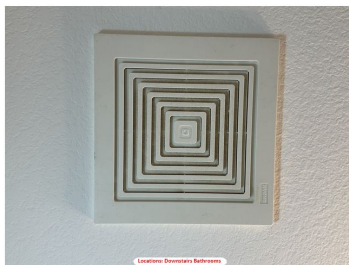
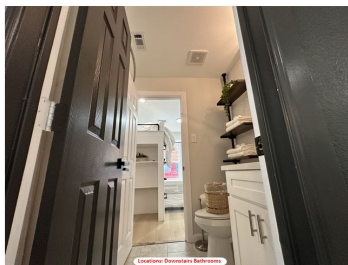
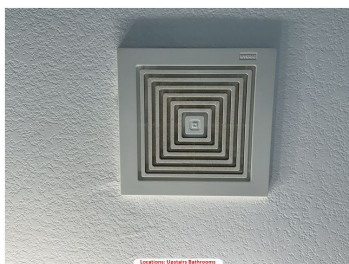
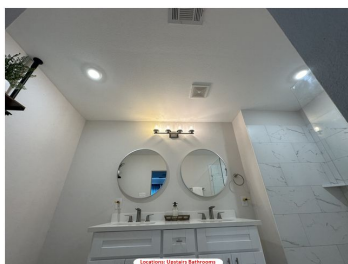
- **Locations: Downstairs and Upstairs Bathrooms**

- **Mechanical Exhaust Fan Vent Covers - Dirty fan grilles**

The exhaust vent cover fan grilles had accumulated a significant amount of dust and lint. The presence of dust and lint can impede the airflow through the grilles, which can lead to compromised ventilation. Additionally, the accumulation of dust and lint on the fan blades can result in reduced efficiency and pose a potential risk of overheating the fan motor. Recommend cleaning the exhaust vent cover and removal of any accumulated dust and lint from the fan blades.

Note: The photos provided serve as a visual representation (examples) of all exhaust fans installed in bathrooms and laundry room indicating that cleaning of the exhaust vent covers and removal of any accumulated dust and lint from the fan blades are necessary.

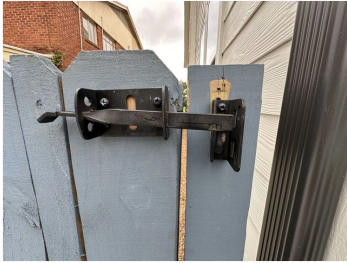
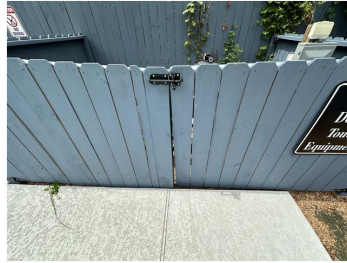
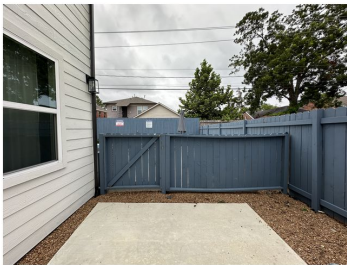
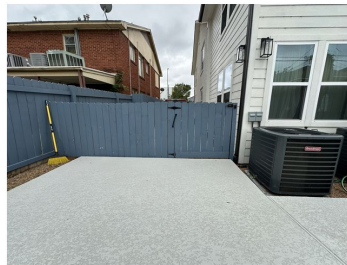
- **Access Gate: Opens outward and not self-closed**

According to safety guidelines, all pedestrian access gates for the pool area should open outward, away from the pool. Additionally, these gates should be self-closing and equipped with a self-latching device. It is important to ensure that the release mechanism is located no less than 54 inches from the bottom of the gate. Furthermore, a second release mechanism should be positioned on the pool side of the gate, at a minimum of 3 inches below the top of the gate.

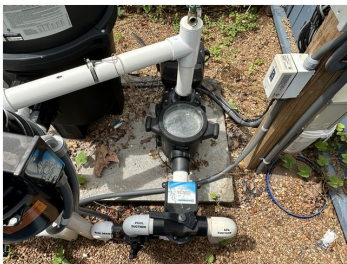
- **Pump - Bonding**

The bonding to the pool pump could not be confirmed during the inspection. Proper bonding is essential for ensuring electrical safety and preventing potential shock hazards. The bonding process helps to ground the electrical components and minimize the risk of electrical faults. Recommend consulting with a qualified, licensed electrician or pool professional to verify and ensure proper bonding of the pump. This will help to ensure the safety of the pool system and comply with electrical safety standards.

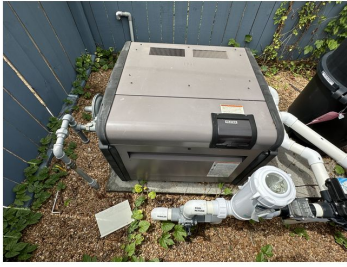
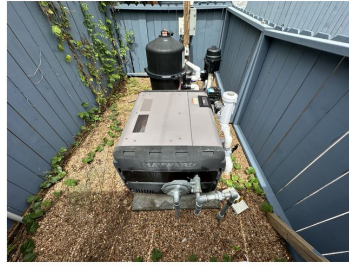
- **Pool Heater**

The pool heater could not be tested during the inspection. Without testing, it is not possible to confirm its operational status or

efficiency. Recommend having a qualified pool technician evaluate and test the heater. They can verify its functionality, check for any issues, and ensure it operates efficiently and safely.
