CONFIDENTIAL INSPECTION REPORT

Mogul 1046 Wedgewood LLC

*1046 N Wedgewood Dr
Mesa, AZ 85203*

Tuesday, October 1, 2024

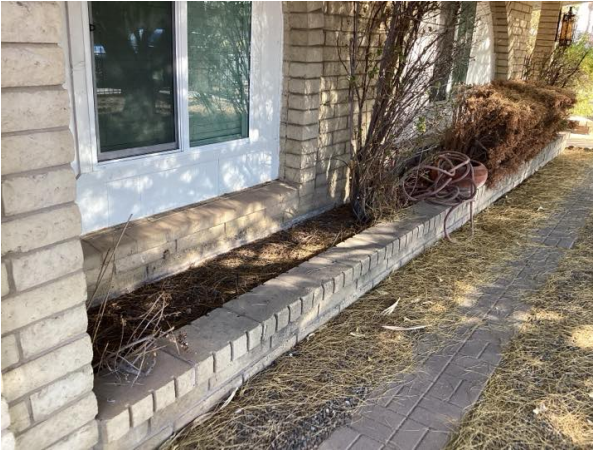
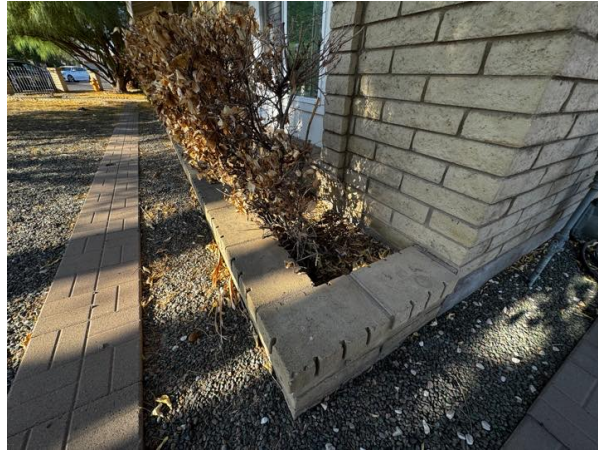
NOTE 7: Attached elevated planters exist at the property. This installation, although common, is not recommended due to the increased likelihood of moisture related issues. Consider removal or further evaluation of the waterproofing method used at the planter walls - Review. (e.g. front of structure)

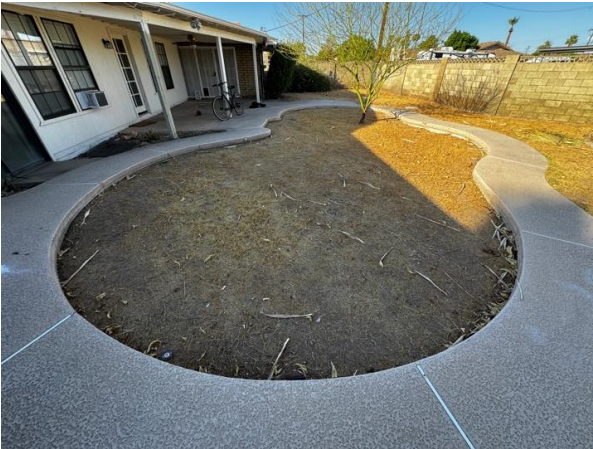
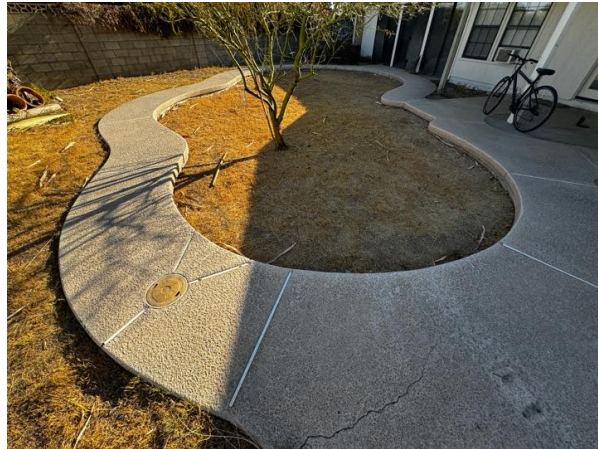
NOTE 8: A swimming pool was filled in at the property, which requires a specific process [CLICK HERE](#). We are unable to determine the methods used to abandon the swimming pool - Consult Records.

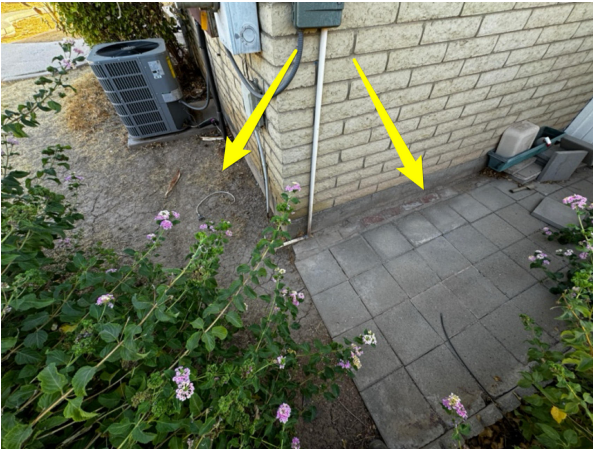
NOTE 10: Site drainage is poor at areas. Alterations are recommended to control water flow and keep it away from the structure - Attention. (e.g. rear of structure)

Example: evidence of water ponding

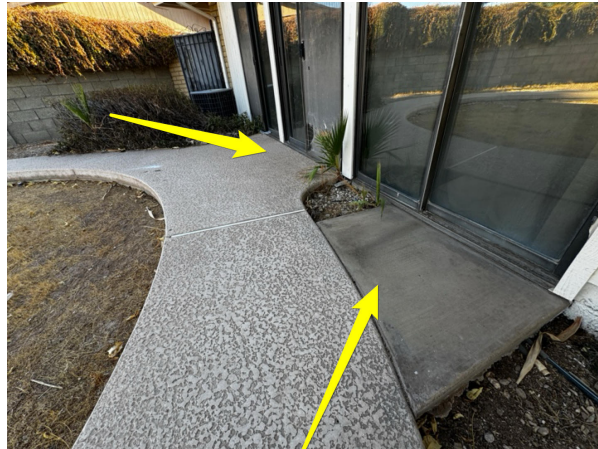
Example: surfaces slope toward structure

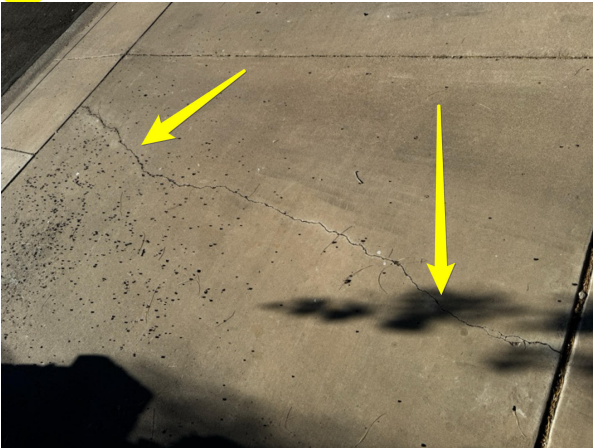
NOTE 11: Typical cracks were observed at the driveway, patio and walkway slabs - Review.

Example: crack

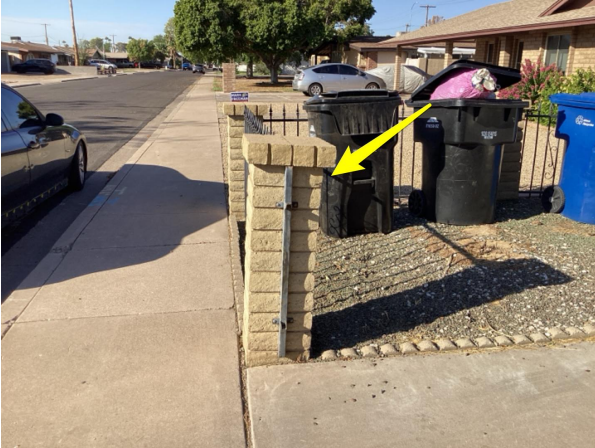
NOTE 13: Typical cracks/damage and evidence of displacement were observed at the block fence - Review.

Example: loose/leaning column

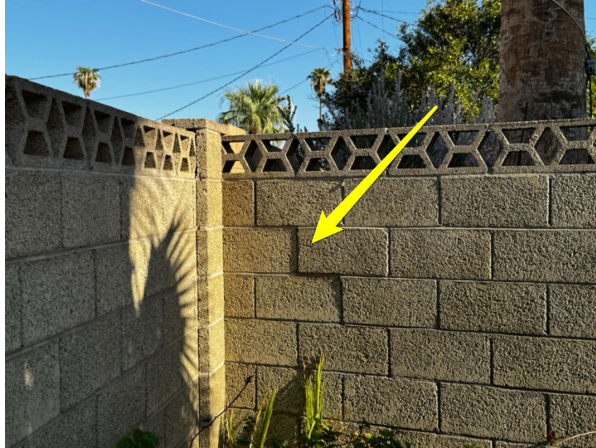
Example: crack/damage/displacement

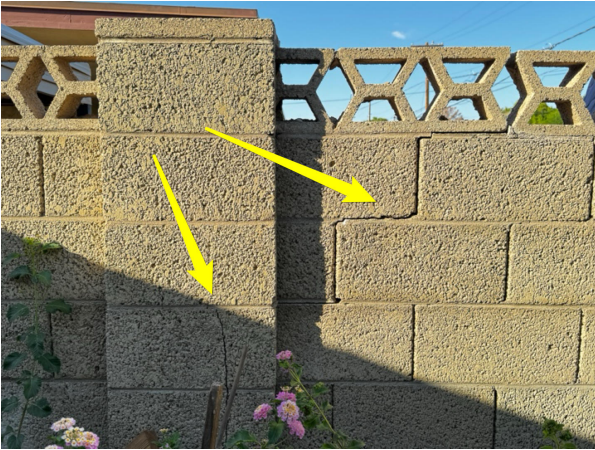
Example: crack/damage/displacement

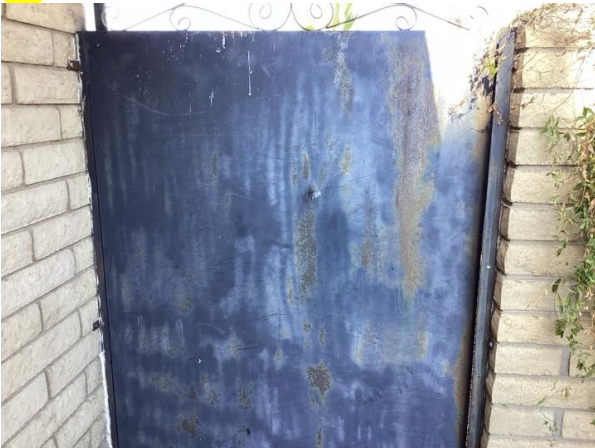
NOTE 14: Rust/deterioration was observed at the gates - Review.

Example: rust/deterioration

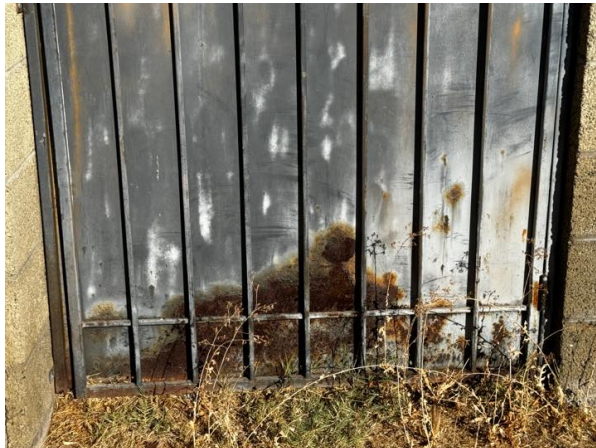
Example: rust/deterioration

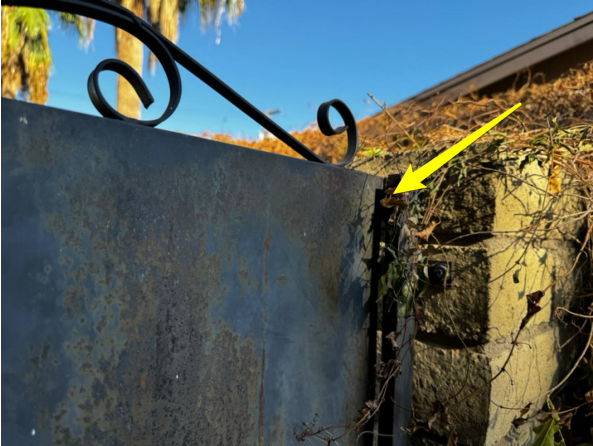
NOTE 15: The gate does not operate properly and needs repair - Attention. (e.g. north side)

Example: gate does not close

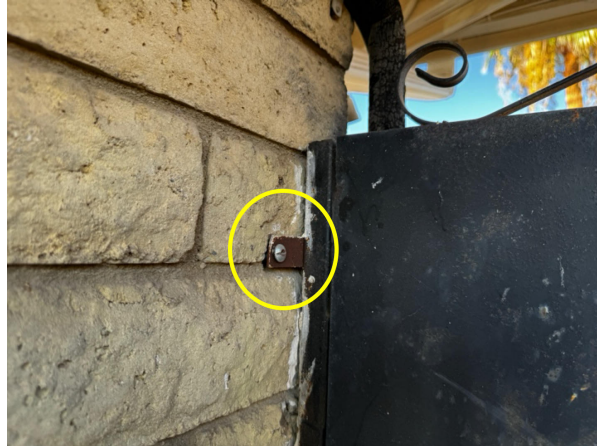
Example: loose anchor

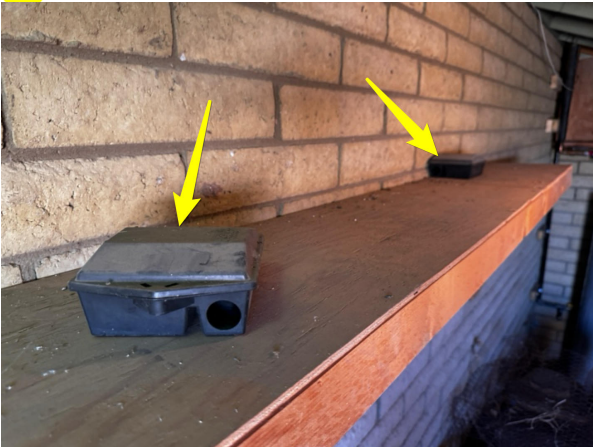
NOTE 16: Evidence of rodents activity was observed at the property - Review. (e.g. storage room)

Example: rodent traps

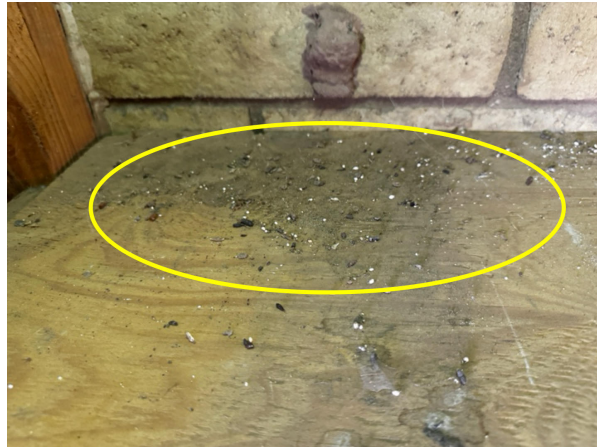
Example: rodent droppings

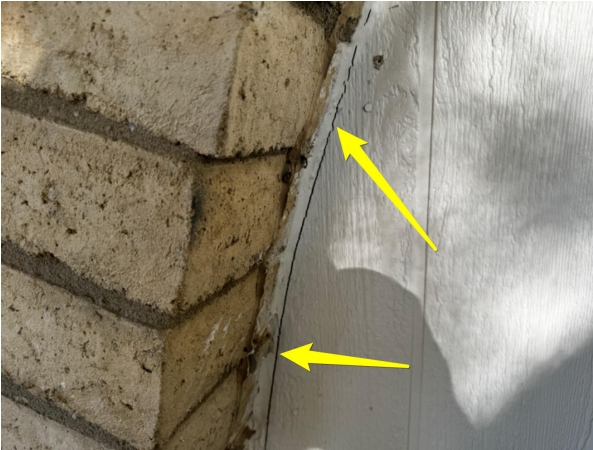
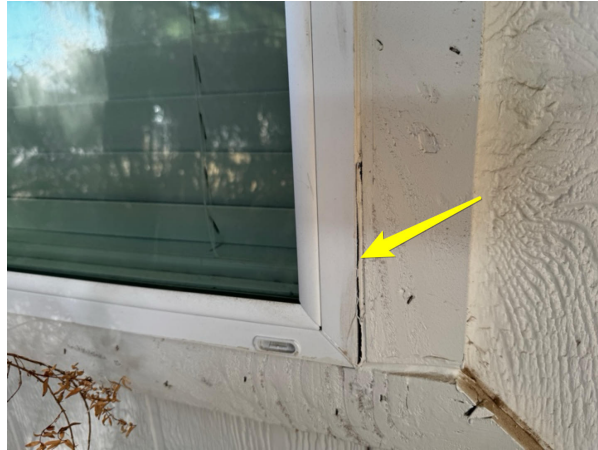
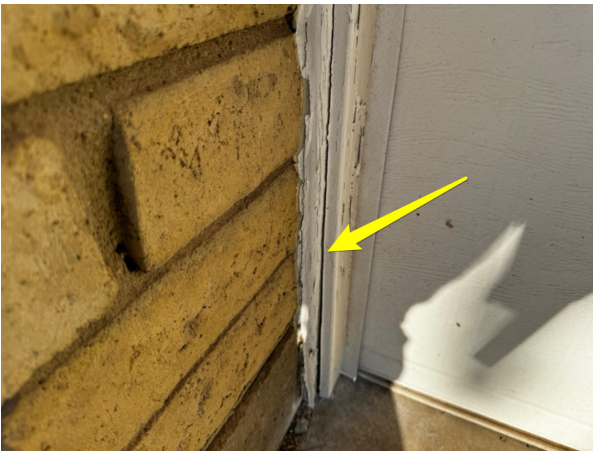
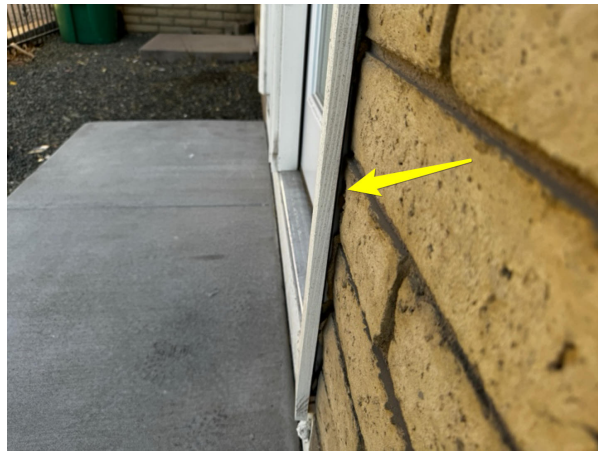
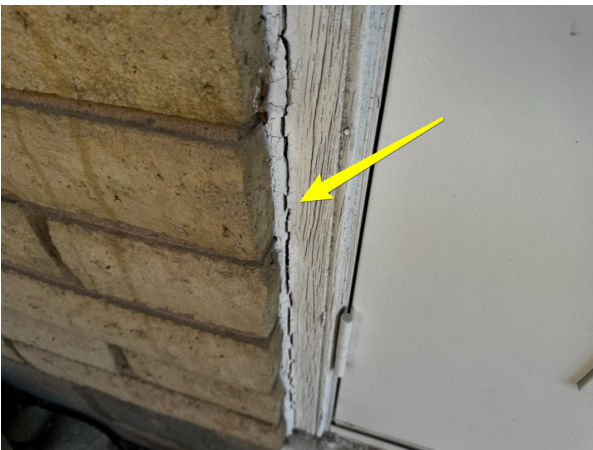
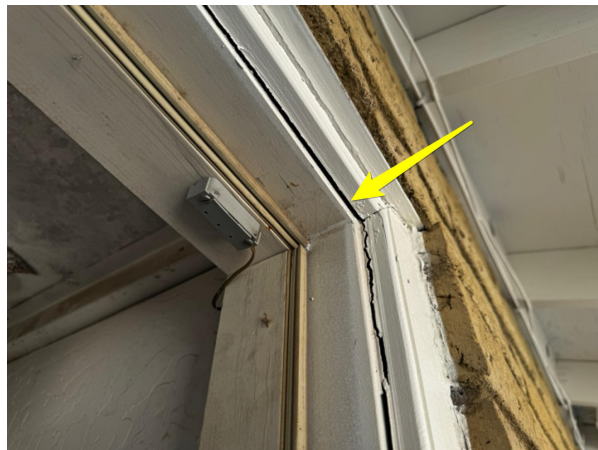
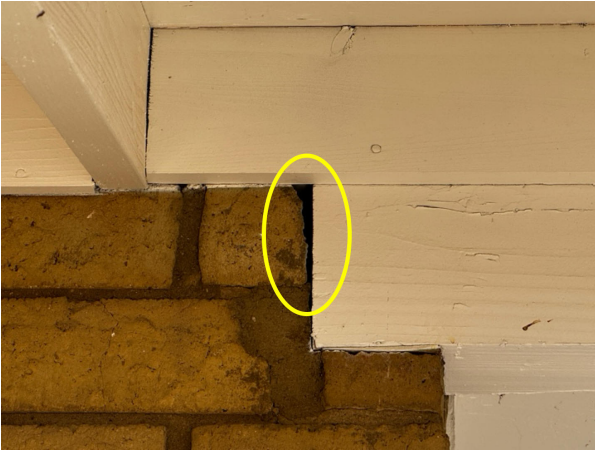
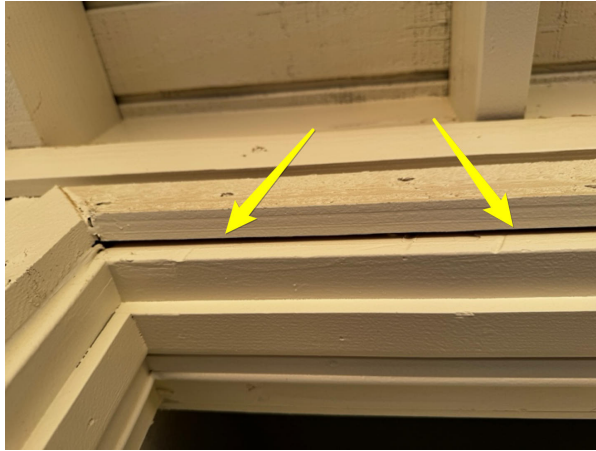
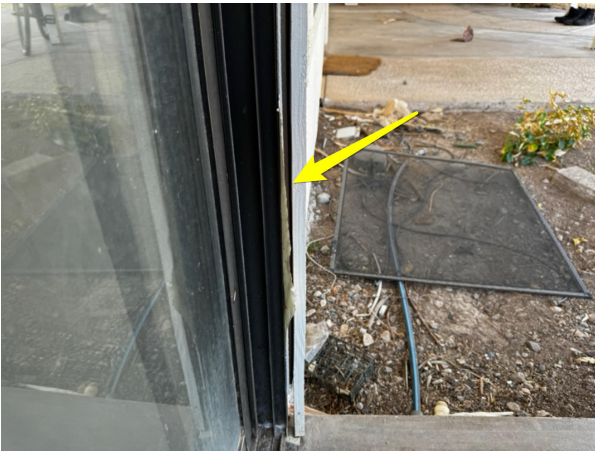
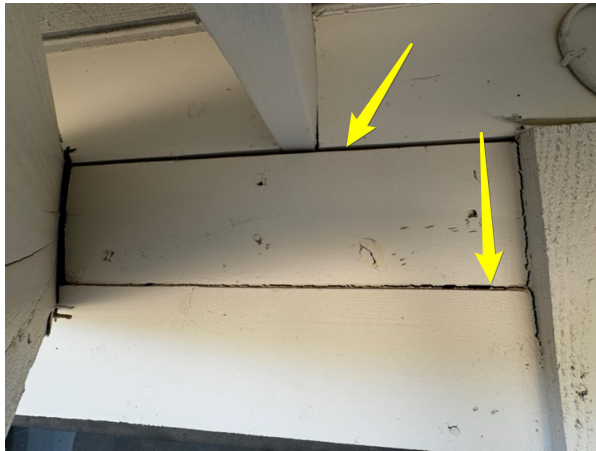
NOTE 21: There are various gaps/openings/separations at the exterior siding and trim that need to be sealed/repaired to prevent water entry (often found at perimeters of windows, doors, light fixtures, electrical outlets, various penetrations and transition areas) - Attention.

Example: various gaps/openings/separations

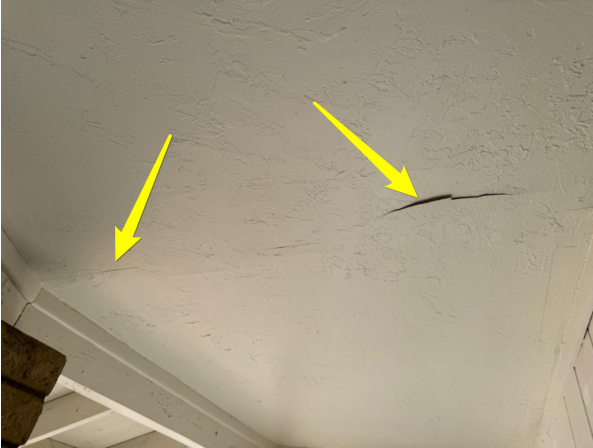
NOTE 23: Typical damage were observed at the patio cover ceiling surface - Review.

Example: crack/damage

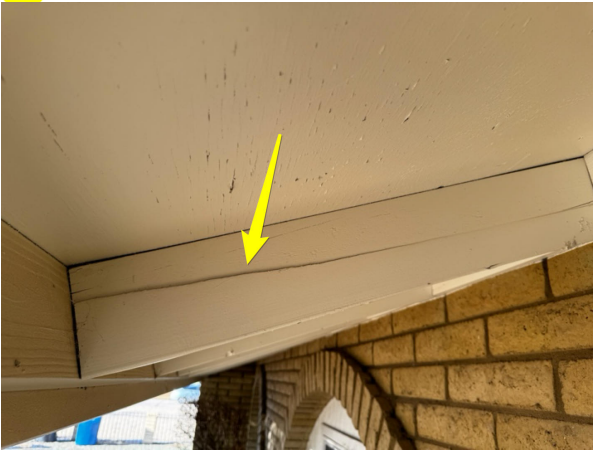
NOTE 24: Typical damage was observed at the eave areas - Review.

Example: cracked tail

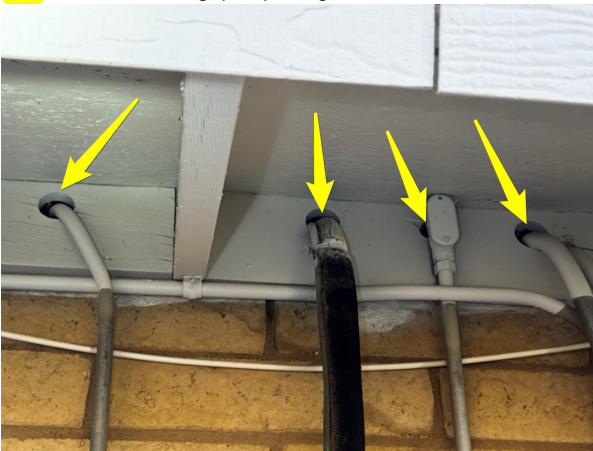
NOTE 25: There are gaps/openings at the eave areas that should be corrected to prevent pests from entering -Attention.

Example: gaps/openings

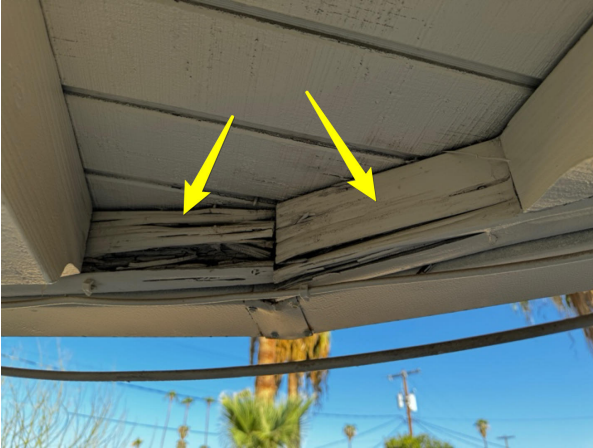
NOTE 26: There is moisture staining/damage at the eave areas that likely indicates past roof leaks - Review. (e.g. rear patio cover)

Example: rotted wood

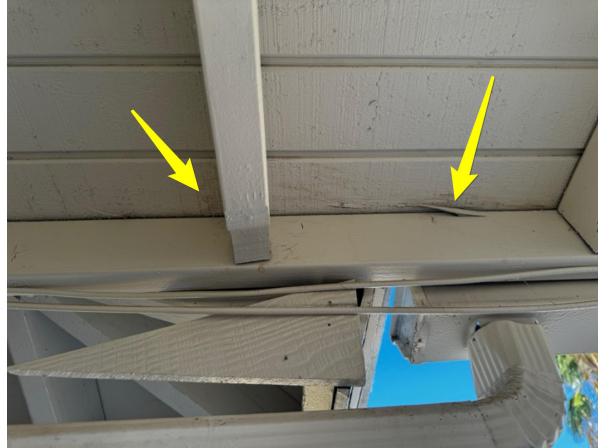
Example: moisture staining

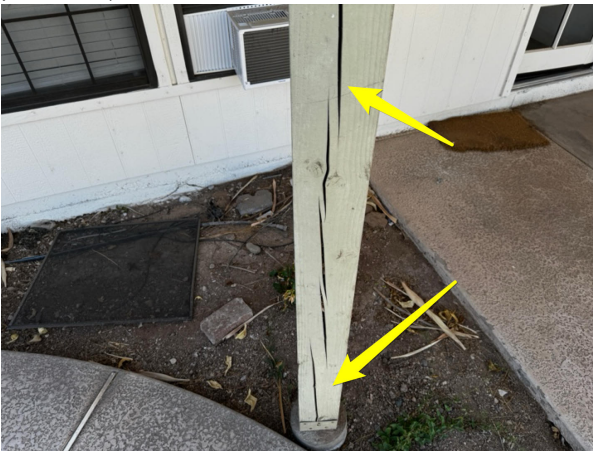
NOTE 27: Typical checking/splitting was observed at the wood columns. This is a natural occurrence with the wood that does not usually warrant any structural concern, however, sealing/filling the cracks can help prevent water entry and further deterioration - Review. (e.g. rear patio cover)

Example: splitting

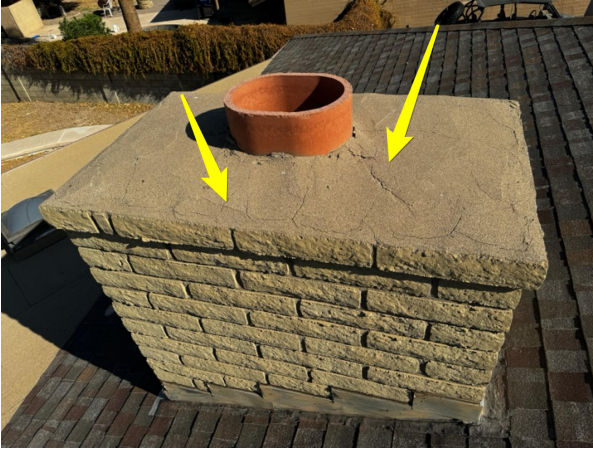
NOTE 28: The chimney crown (designed to seal the chimney top and shed rainwater) is cracked and should be sealed/repared -Attention.

Example: cracks at crown

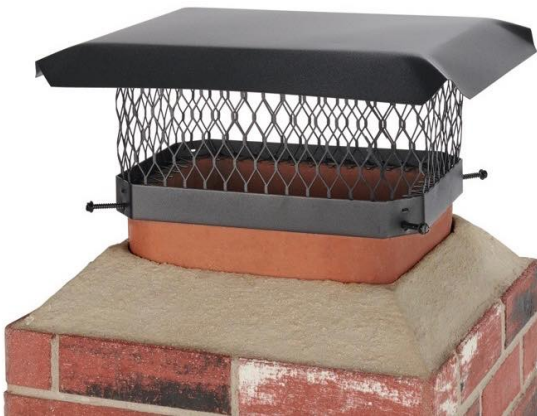
NOTE 29: The installation of a spark arrestor/rain cap is recommended at the chimney top -Attention.

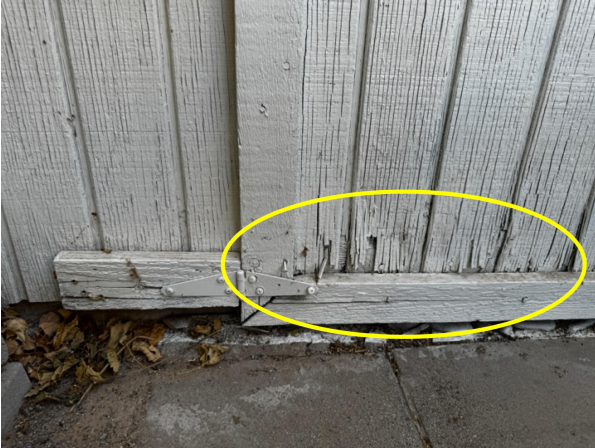
NOTE 31: Damage/deterioration and evidence of past roof leaks were observed at the storage room - Review.

Example: damage/deterioration

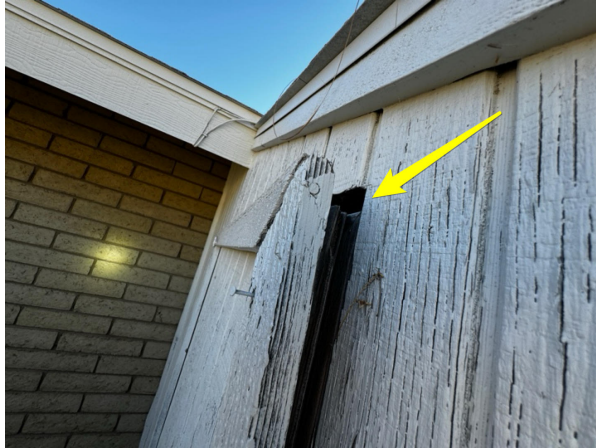
Example: door does not close/latch properly

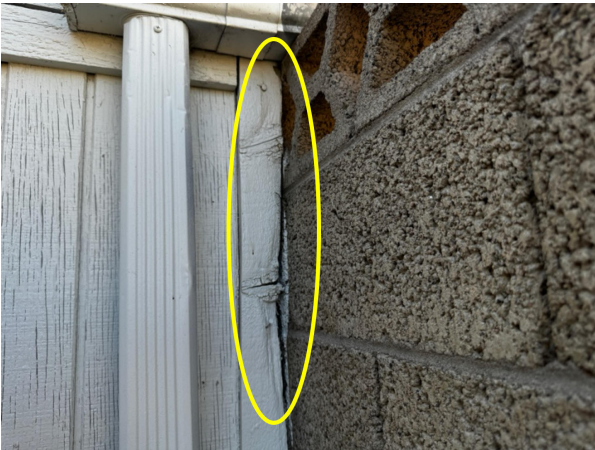
Example: rotted wood

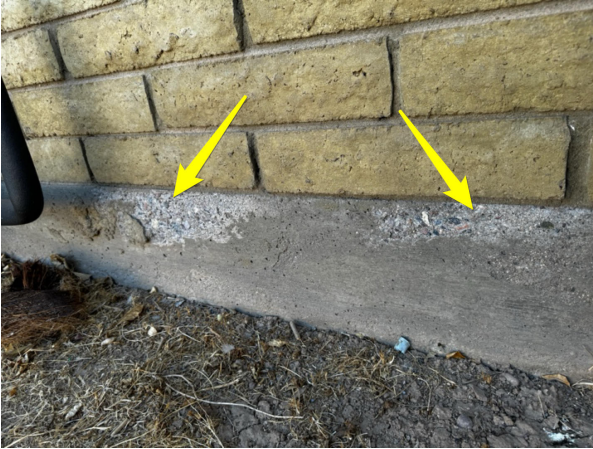
NOTE 32: Typical cracks and surface damage were observed at the foundation walls - Review.

Example: surface deterioration

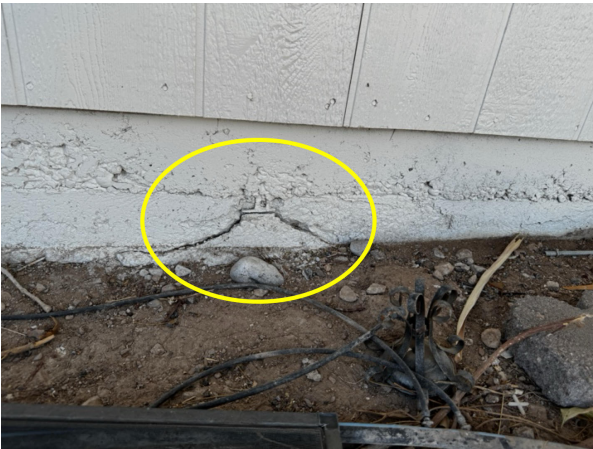
NOTE 33: Damage was observed at wall anchor areas of the foundation wall. Consult a specialist for further evaluation to determine the options for repair - Review. (e.g. rear addition)

Example: damage

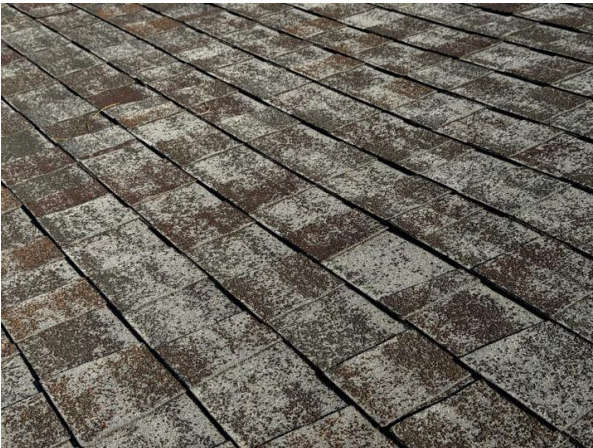
NOTE 37: The composition shingle roof appears to be at or near the end of its service life. Significant granule loss and material deterioration were observed. It should be further evaluated by a licensed roofer to determine options and cost of replacement - Review.

Example: significant granule loss

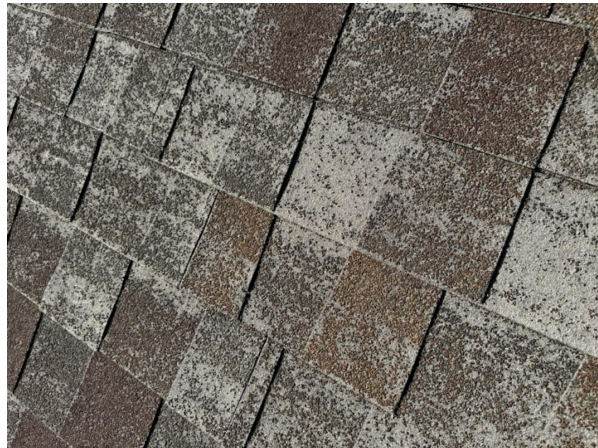
Example: significant granule loss

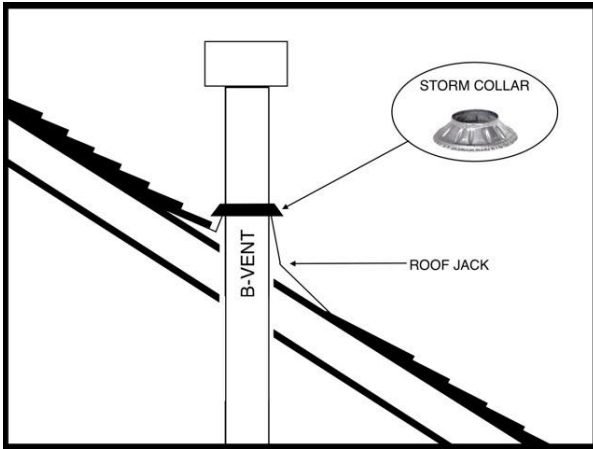
NOTE 38: Storm collars are not installed on the gas appliance vents at the roof level. These collars seal around the vent pipe at the top of the roof flashing and are required under current standards to prevent moisture infiltration; consider adding - Attention.

Example: storm collars not installed

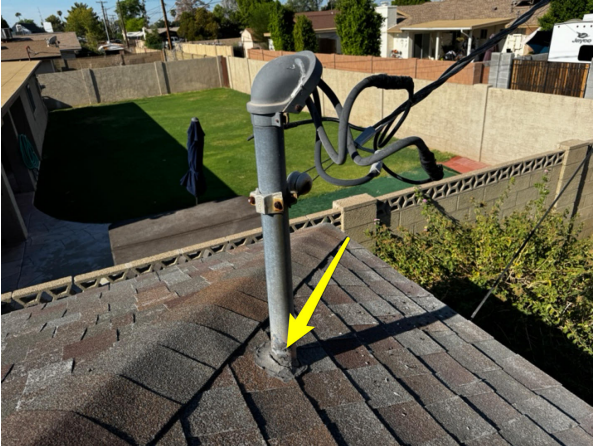
40: Roof flashing detail at penetrations is improper. Further evaluation by a licensed roofer is needed for repair - Attention.

Example: no roof jack installed at electrical mast penetration

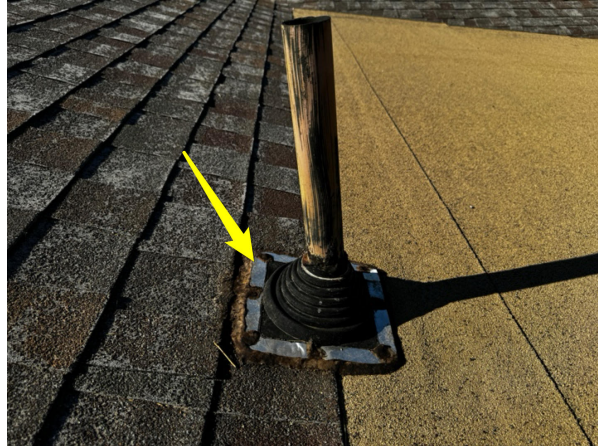
Example: plumbing vent roof jack improperly installed atop shingles

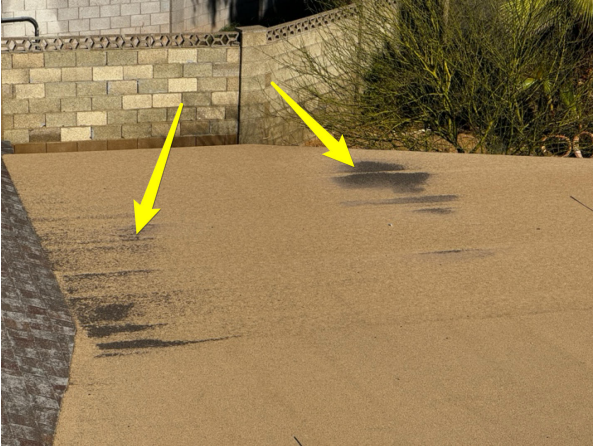
NOTE 44: Evidence of water ponding was observed at the roof - Review.

Example: granule accumulation

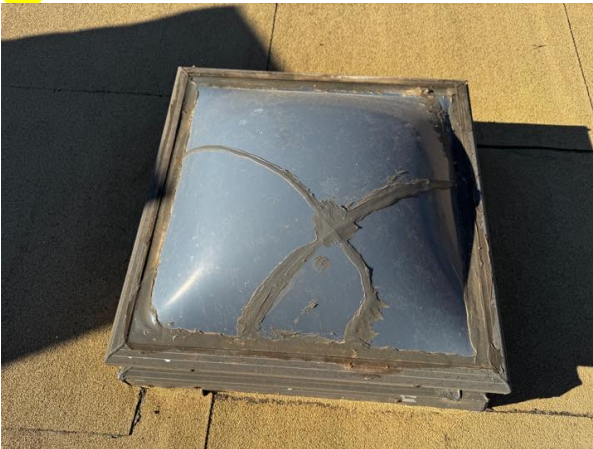
NOTE 45: The skylight lens is cracked/damaged and should be replaced - Attention.

Damaged lens

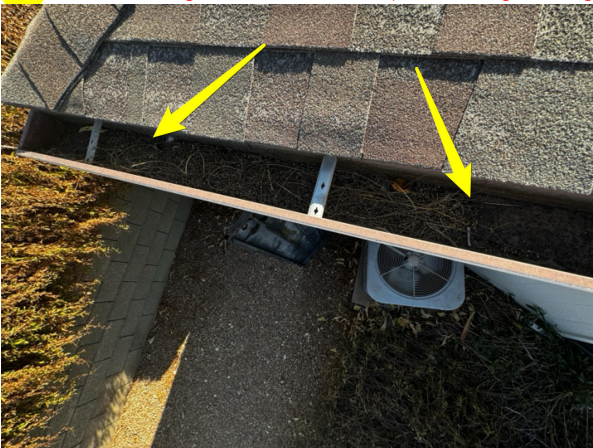
NOTE 46: The roof gutters need service (i.e. cleaning, sealing seams, securing as needed and aligning them to drain properly) - Attention.

Example: gutter full of debris

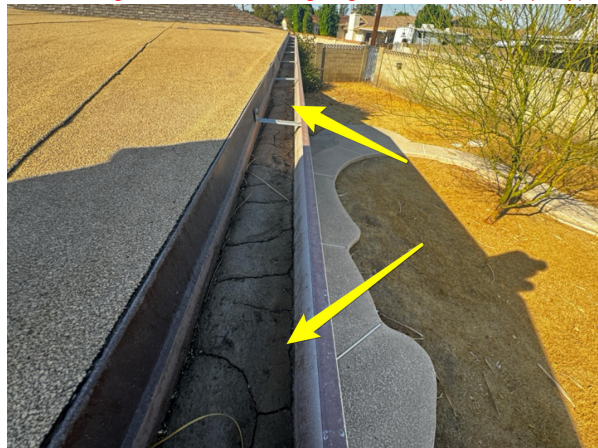
Example: gutter full of debris

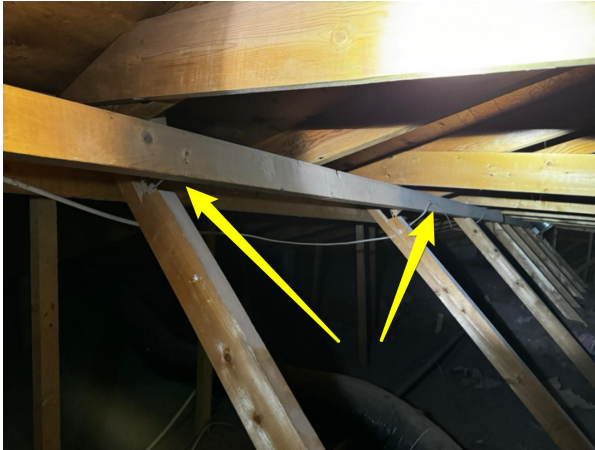
Location

NOTE 50: A purlin within the attic is damaged/loose. Consult a licensed contractor to repair/repair as required - Attention. (e.g. above living room)

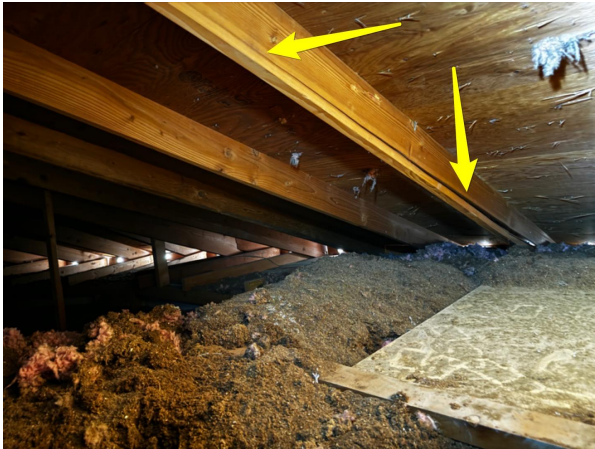
Location

NOTE 51: A rafter within the attic is cracked/damaged. Consult a licensed contractor to repair/repair as required - Attention. (e.g. near front entry)

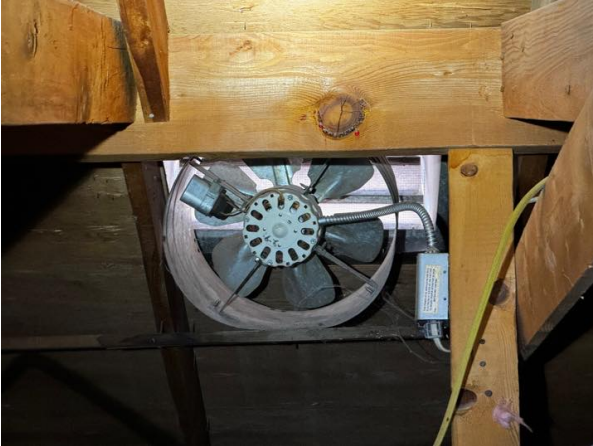
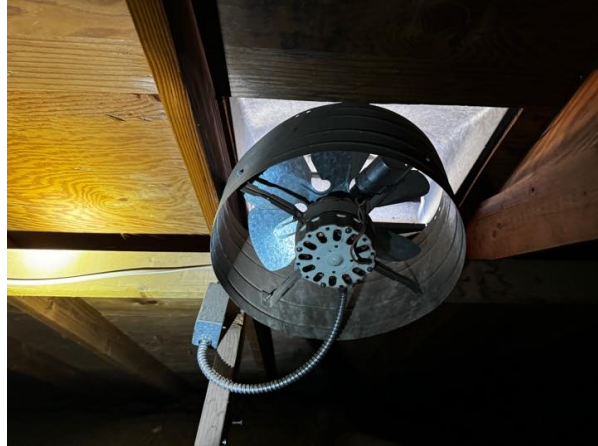
NOTE 54: The thermostatically controlled attic ventilation fans within the attic are outside the scope of this inspection and was not evaluated - Review.

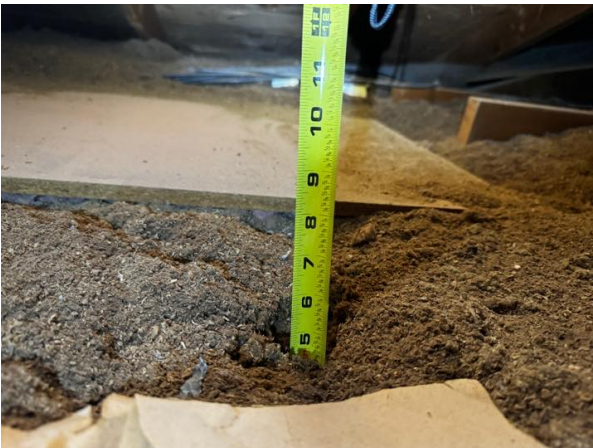
NOTE 56: Insulation within the attic is low and missing/displaced in areas. Additional material is needed for energy efficiency reasons and to comply with current building standards - Attention.

Example: low insulation

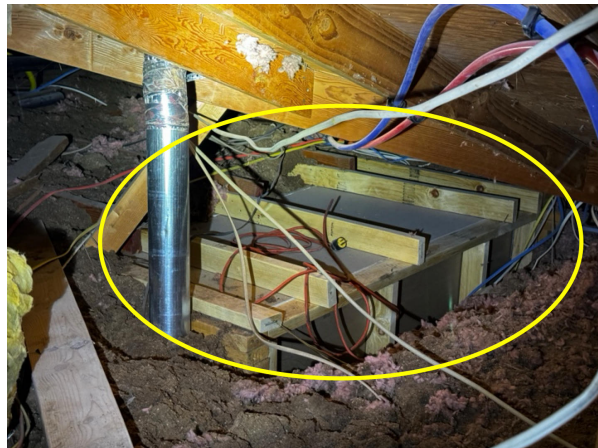
Example: missing insulation

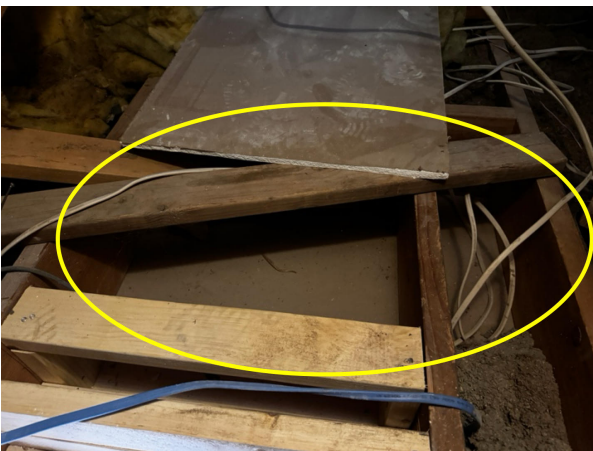
Example: missing insulation

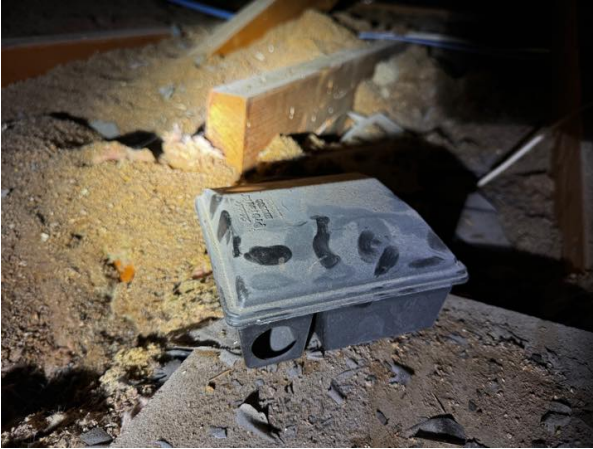
NOTE 57: A rodent trap was observed within the attic - Review.

Example: rodent trap

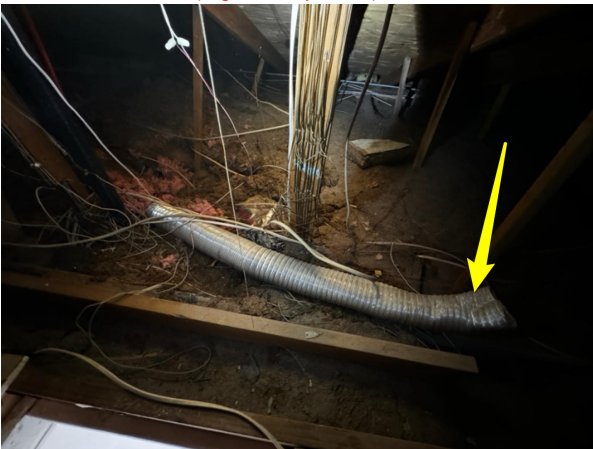
NOTE 59: An exhaust fan duct vents into the attic, which is not permissible. The installation of a proper duct that vents to the exterior is needed - Attention. (e.g. laundry room)

Example: incomplete installation

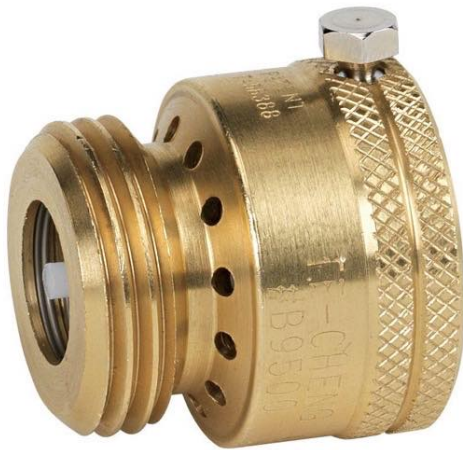
NOTE 70: Hose bibs at the property are missing the required anti-siphon fittings. These fittings are relatively inexpensive and are required by current standards on all hose bibs to prevent backflow contamination (check all) - Attention.

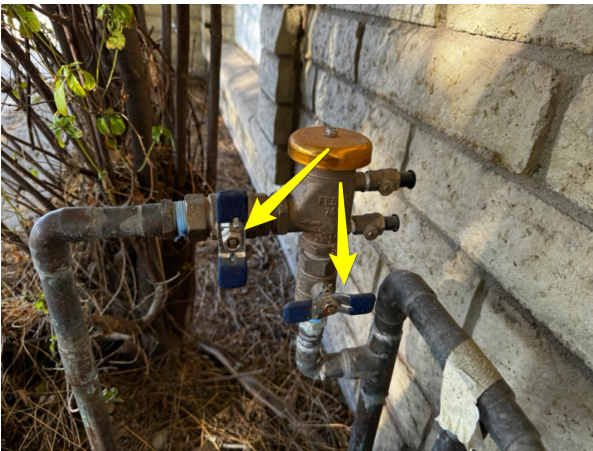
NOTE 91: The water supply to the irrigation system was shut down at the time of the inspection. Further evaluation is needed to assess the system - Review.

Water supply valves shut down

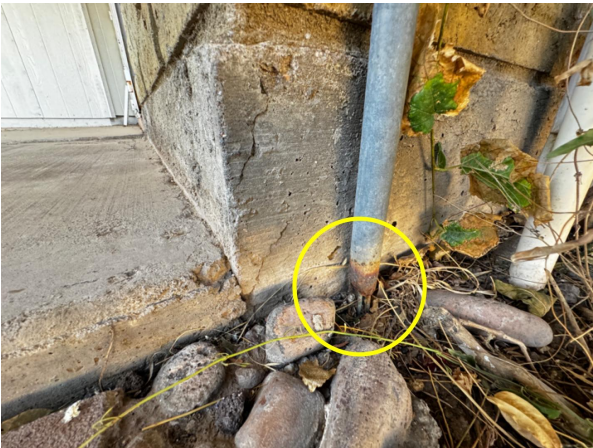
NOTE 92: The electrical conduit below the rear irrigation system timer is rusted/damaged, which has exposed the wiring. Consult a licensed electrician to repair/replace as required - Attention.

Damaged conduit & exposed wiring

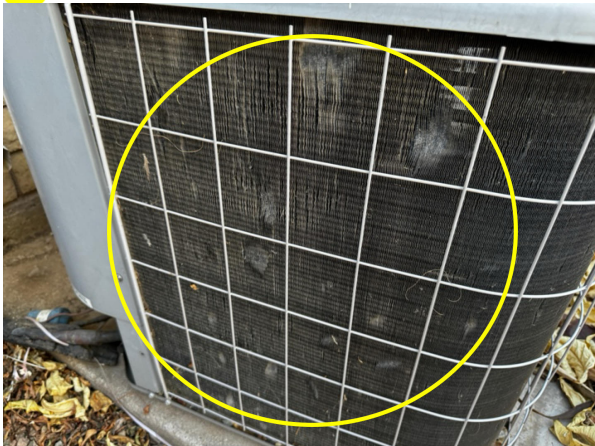
NOTE 104: The fins of the condenser coil have been bent or damaged - Review. (e.g. north unit)

Example: bent fins

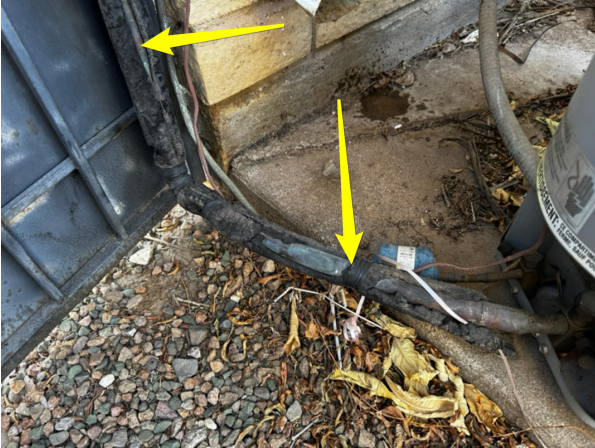
NOTE 105: Damaged/incomplete insulation at the air conditioner refrigerant line should be repaired - Attention. (e.g. north unit)

Example: damaged insulation

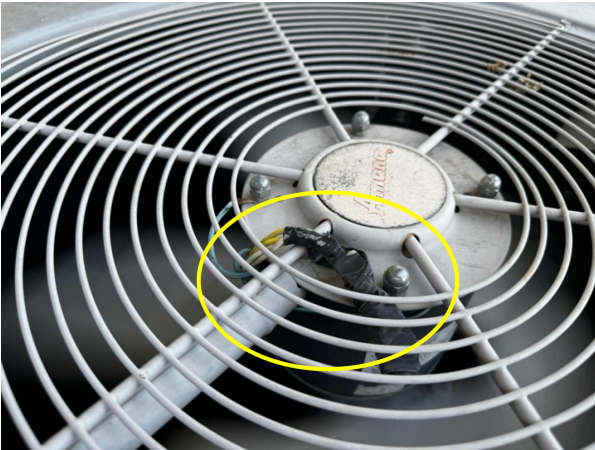
NOTE 106: Exposed electrical connections at the condensing unit indicate past fan motor replacement. These electrical connections are required to be made inside the cabinet for safety and protection of the wiring - Attention. (e.g. north unit)

Improper installation

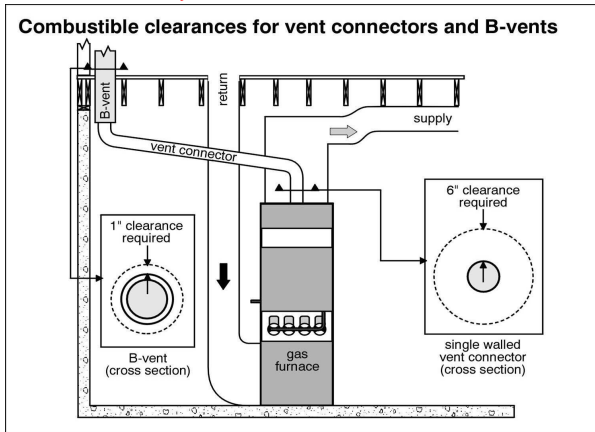
NOTE 115: The furnace vent pipes are improperly in contact with the ceiling surfaces. A double-walled flue requires one inch of clearance between it and any combustible material - Attention.

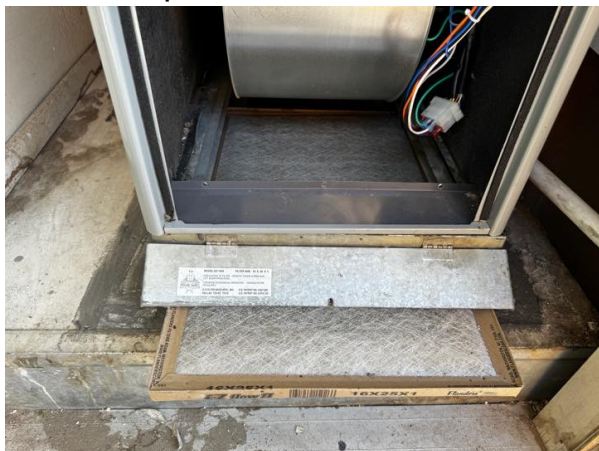
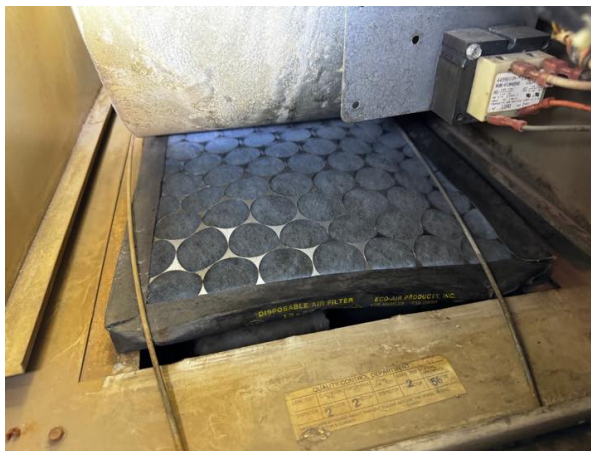
NOTE 121: The heating/cooling system filter is improperly sized and should be replaced - Attention. (e.g. north unit)

NOTE 122: A fastener is missing at the filter compartment door and should be replaced - Attention. (e.g. south unit)

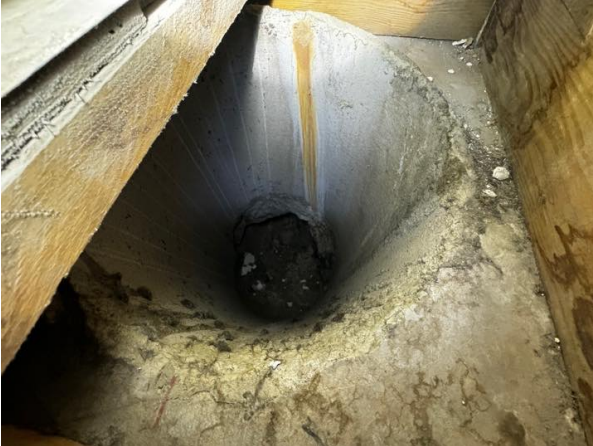
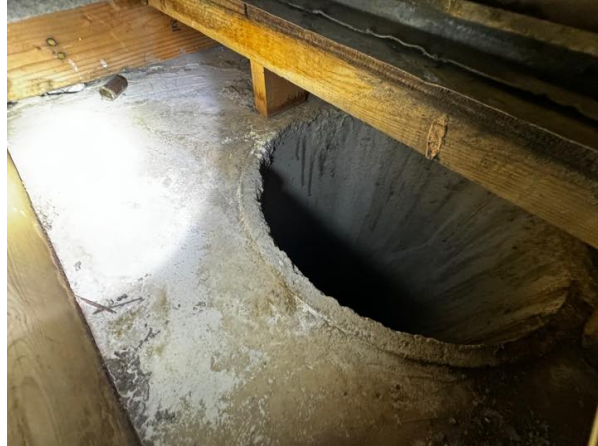
NOTE 126: Underground return ducts at the property are not fully visible during a standard inspection. Consider having a video scan performed during your inspection to determine if latent defects exist - Review.

Example: underground return

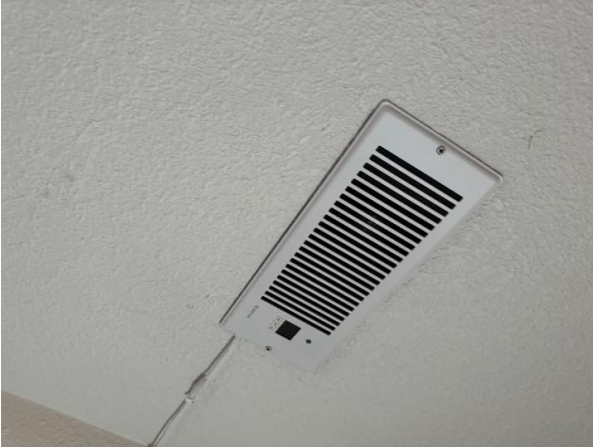
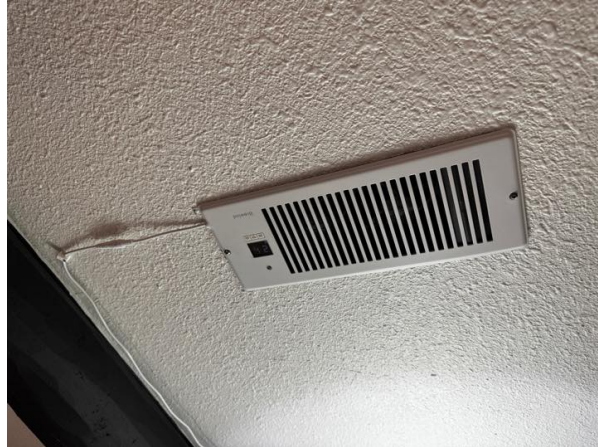
NOTE 127: Booster fans are installed at the supply ducts. These components are outside the scope of this inspection and were not evaluated. Consider further evaluation of the air flow to these area - Review. (e.g. rear bedrooms)

Example: booster fan

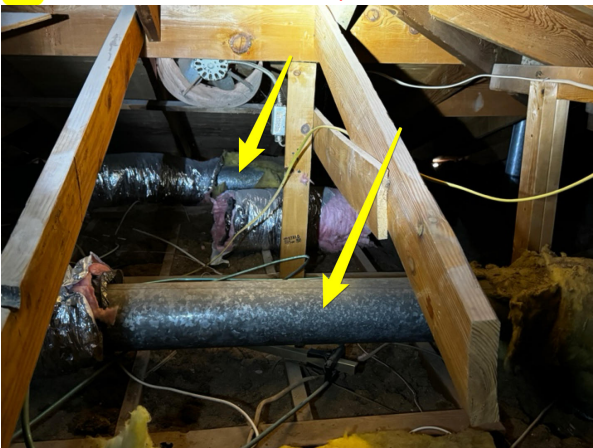
NOTE 128: Duct insulation is incomplete and should be corrected - Attention. (e.g. south side attic)

Example: incomplete insulation

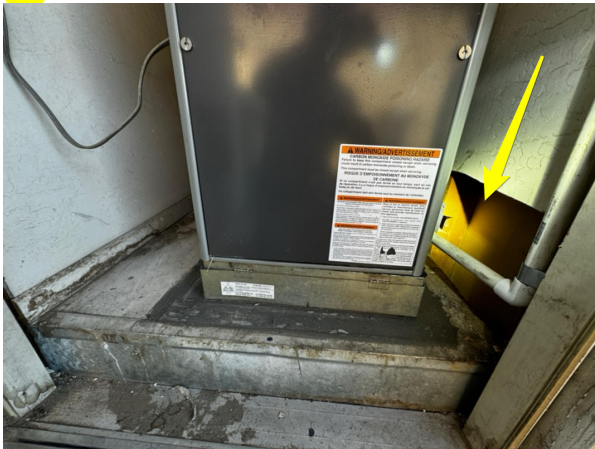
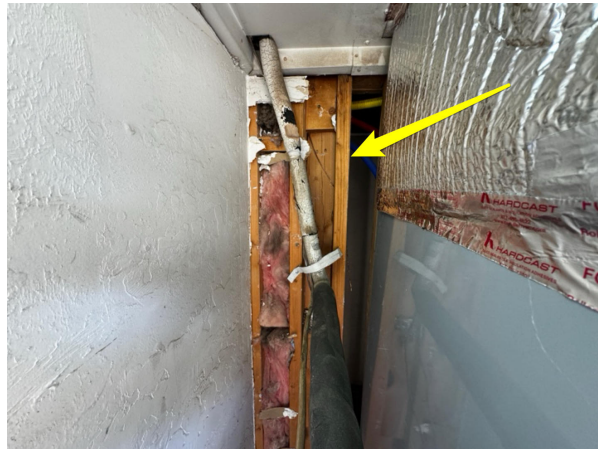
NOTE 132: Stains/damage were observed within the furnace closets - Review.

Example: wall cut open

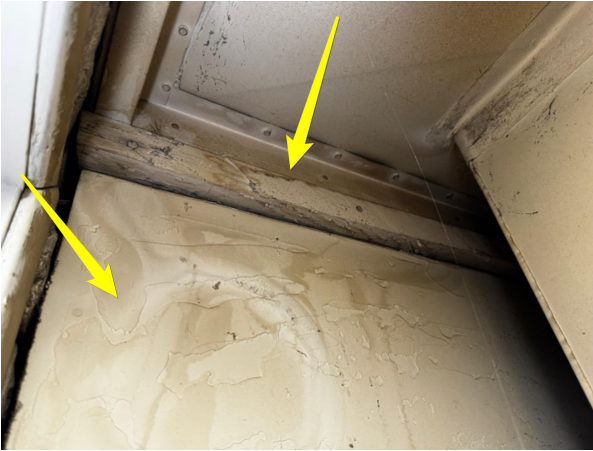
Example: moisture staining

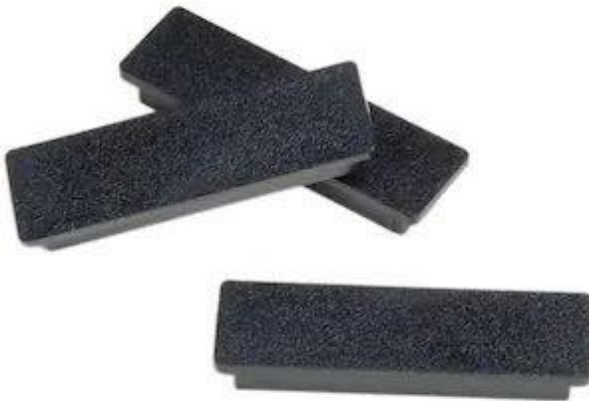
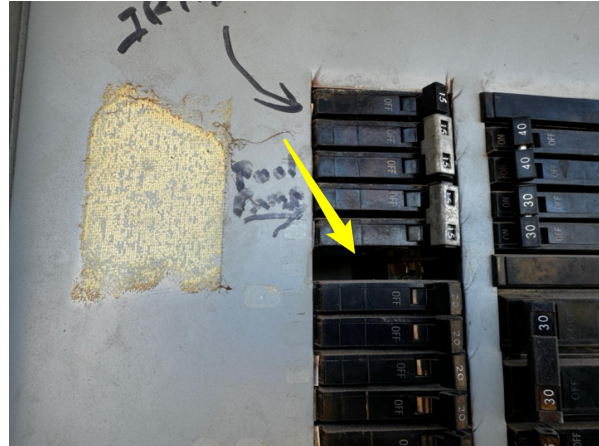
NOTE 142: There is an opening at the interior cover of the electrical panel that needs to be capped for safety - Attention.

Knockout cap needed

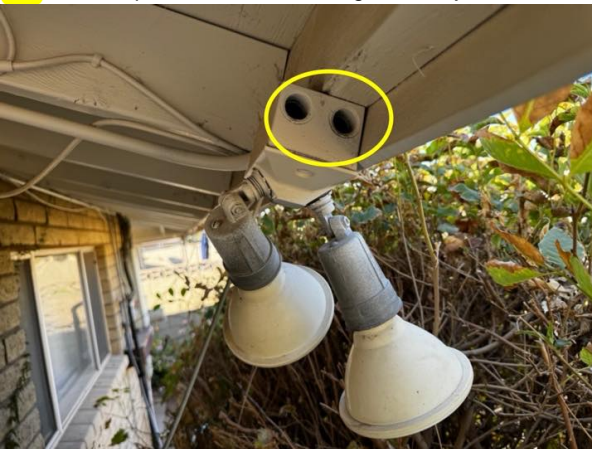
NOTE 148: Caps are needed at the light fixture junction box - Attention. (e.g. rear patio)

Plugs needed

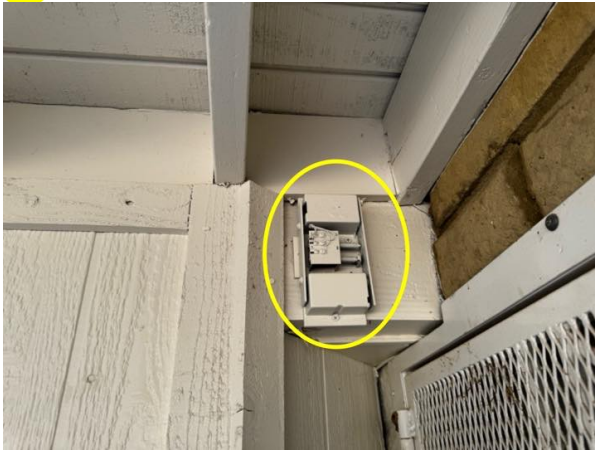
NOTE 152: The doorbell chime cover is missing - Attention.

Cover missing
