CONFIDENTIAL INSPECTION REPORT

Mogul 1046 Wedgewood LLC

*1046 N Wedgewood Dr
Mesa, AZ 85203*

Tuesday, October 1, 2024

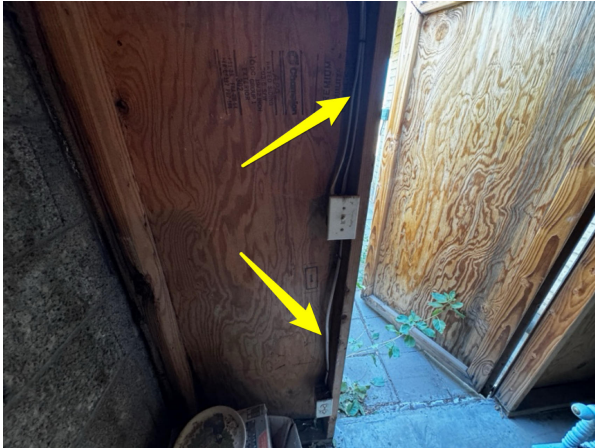
NOTE 153: Exposed electrical wiring should be placed inside a conduit or otherwise protected where subject to damage - Attention. (e.g. storage room, kitchen exhaust hood)

Example: exposed wiring

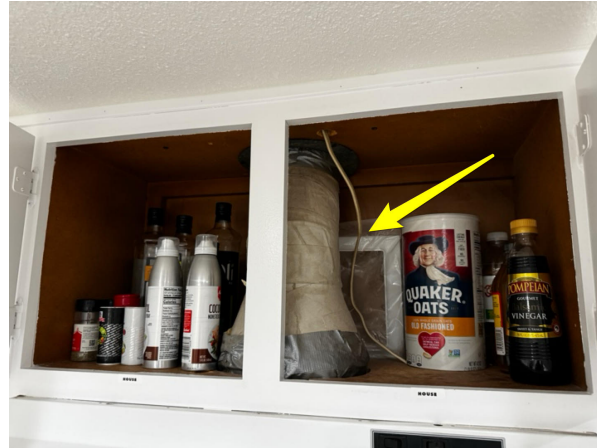
Example: exposed wiring

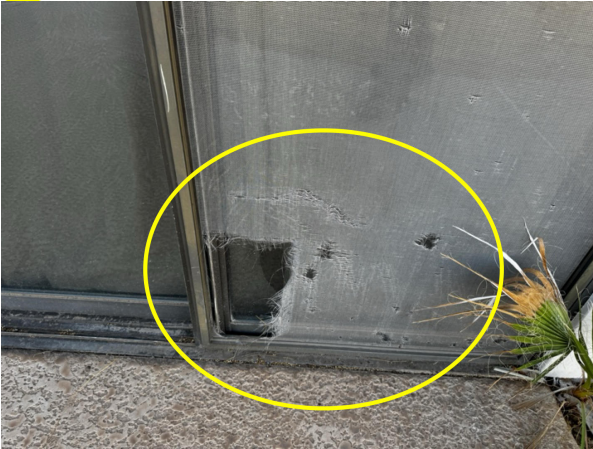
NOTE 157: Damage/defects were observed at the exterior doors - Review.

Example: damaged screen at rear patio door

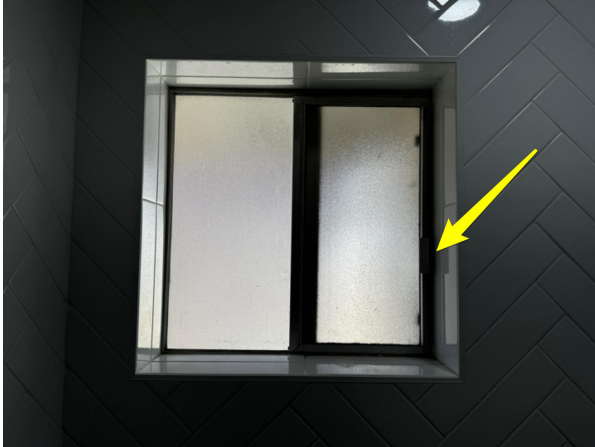
NOTE 159: Windows do not latch properly. Repair/replace as required - Attention. (e.g. south hallway bathroom, Room #6)

Example: window does not latch due to tile installation

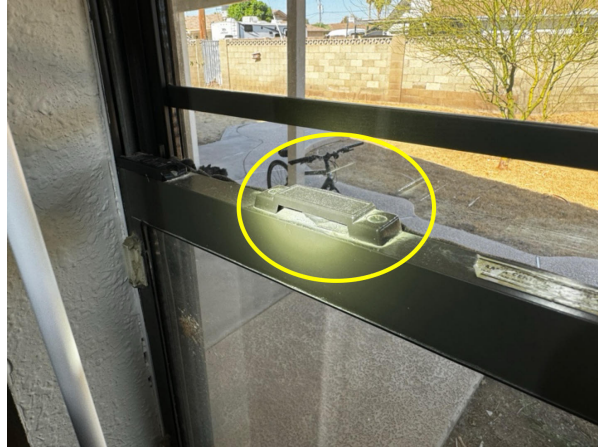
Example: damaged latch handle

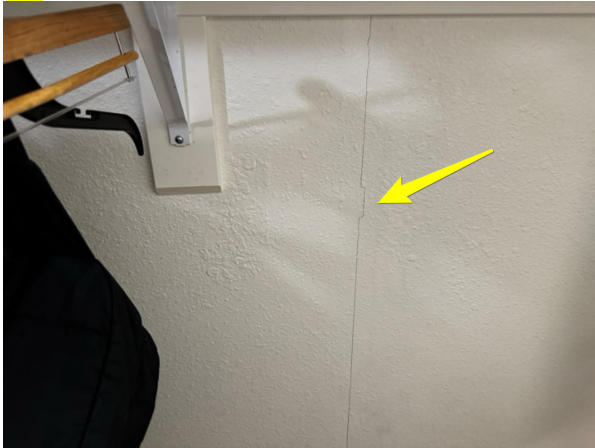
NOTE 162: Typical cracks and minor damage were observed at the interior surfaces - Review.

Example: crack in south bedroom closet

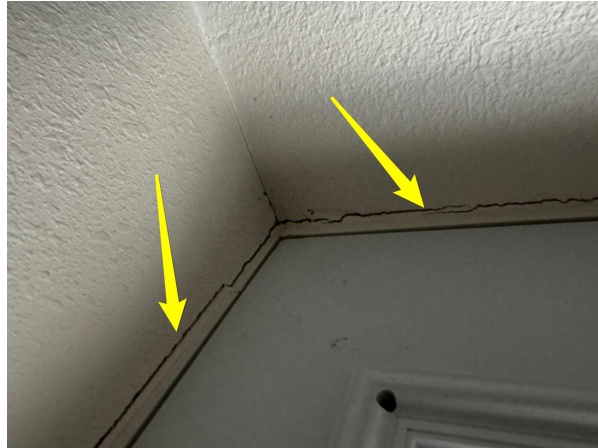
Example: separations at door & window perimeters

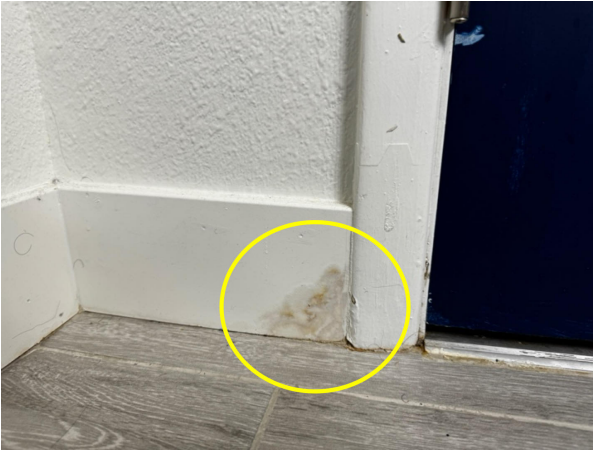
Example: staining at north hallway bathroom base trim

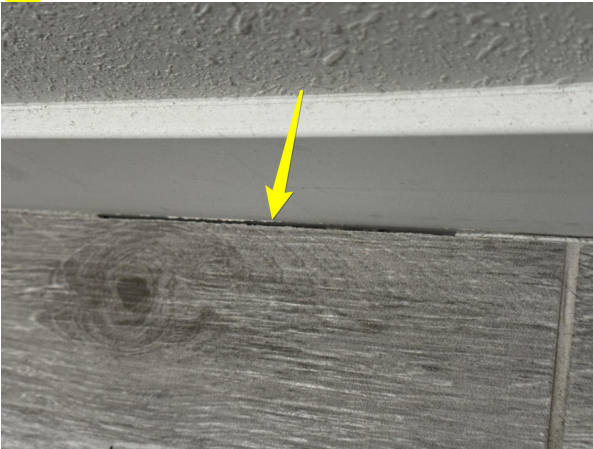
NOTE 164: Typical grout damage was observed at the tiled floor perimeter - Review.

Example: damaged/incomplete grout

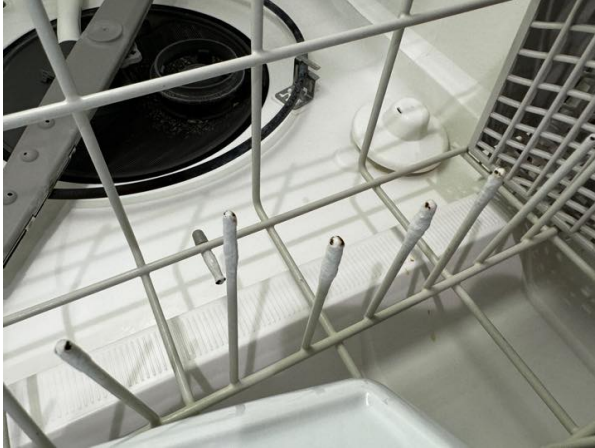
NOTE 177: The dishwasher racks are rusted/damaged - Review.

Example: rust/damage

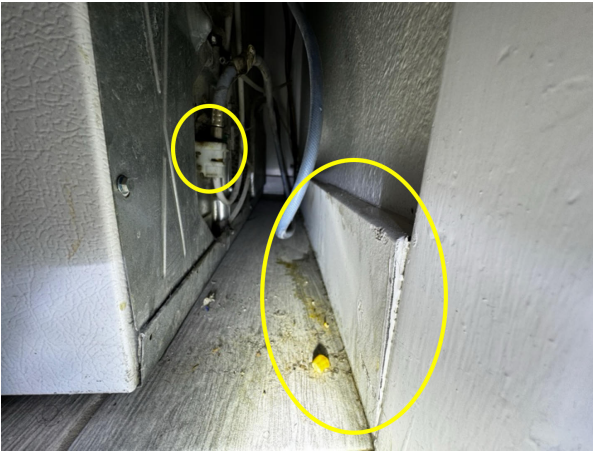
NOTE 184: There is a leak at the refrigerator water supply line that needs repair. Damage was observed at the base of the adjacent wall - Attention.

Leak & water damage

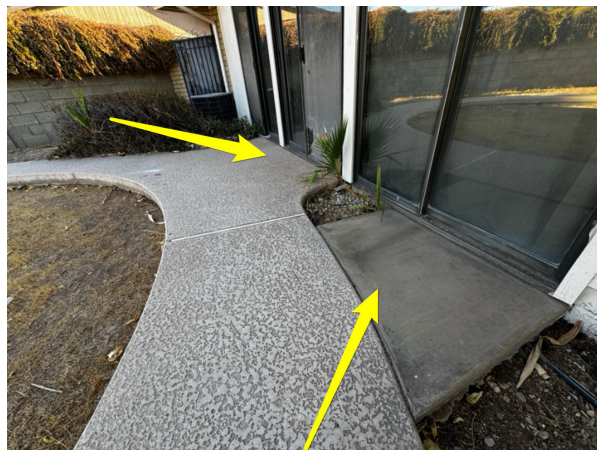
Example: surfaces slope toward structure

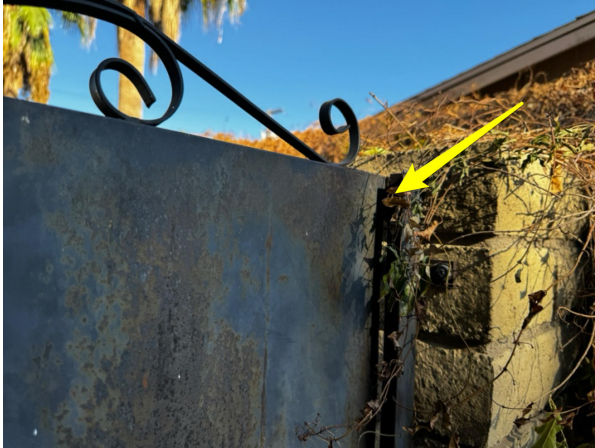
NOTE s-15: The gate does not operate properly and needs repair - Attention. (e.g. north side)

Example: gate does not close

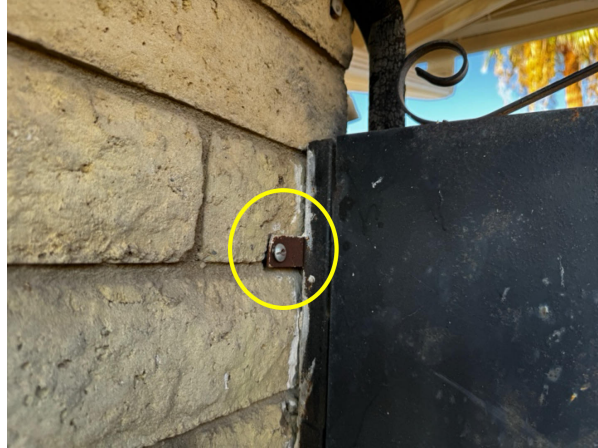
Example: loose anchor

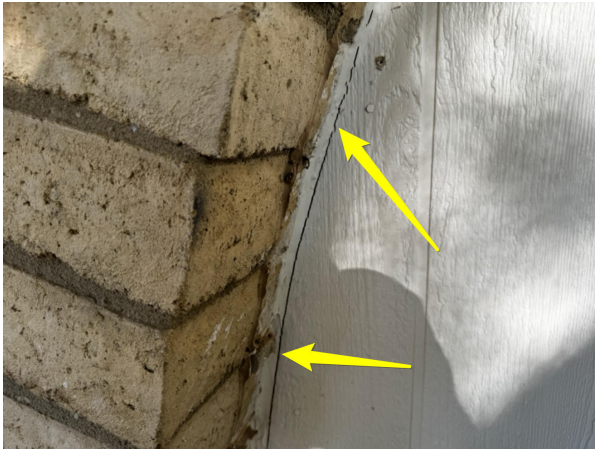
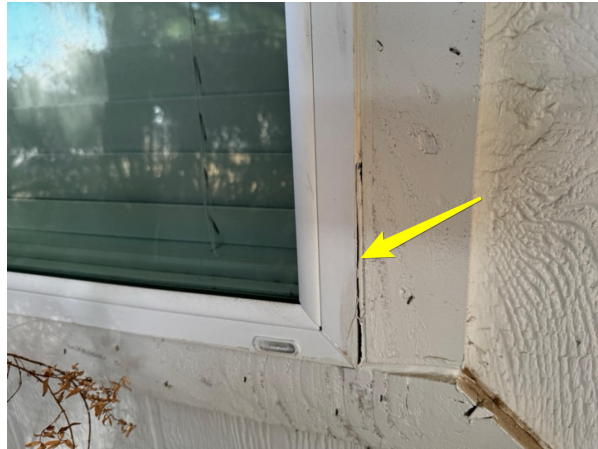
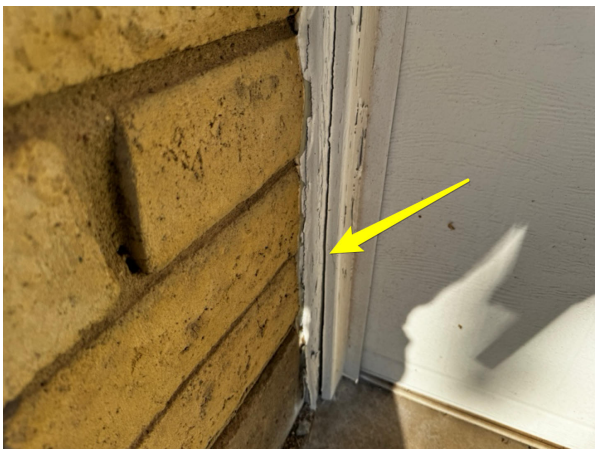
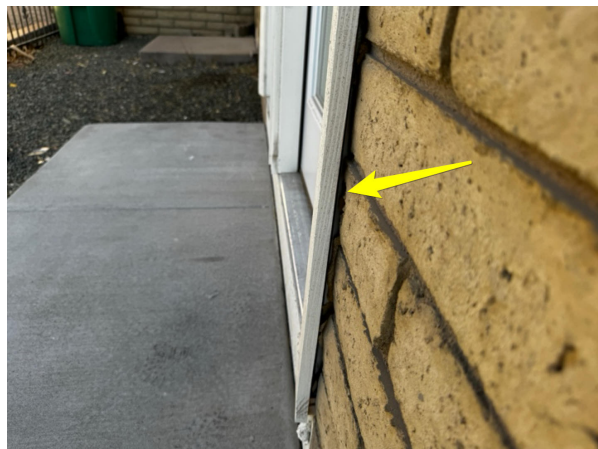
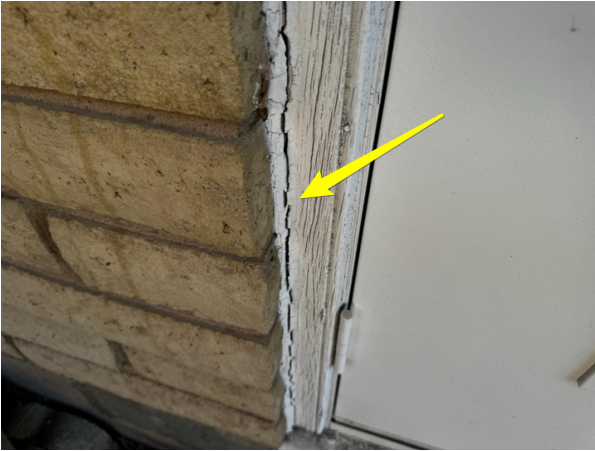
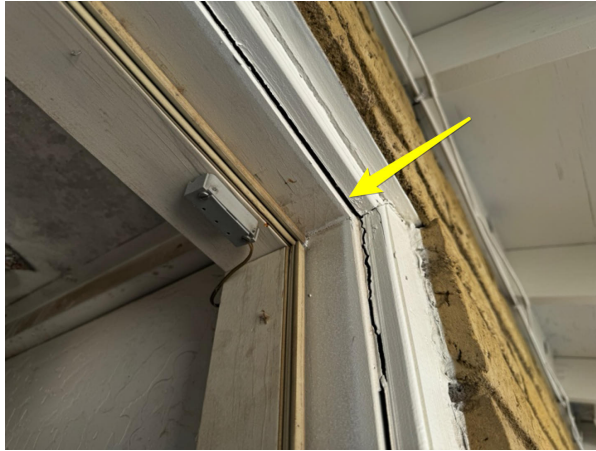
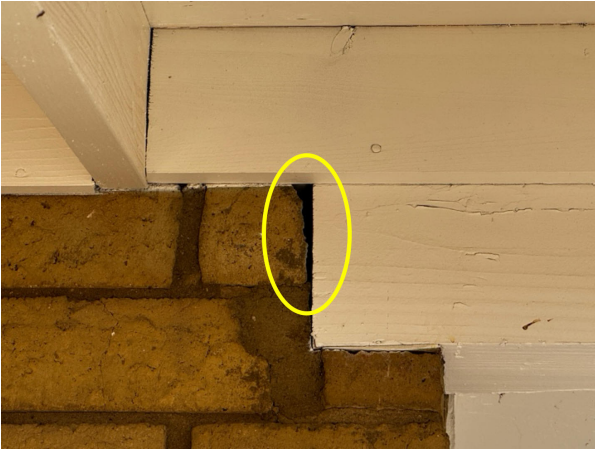
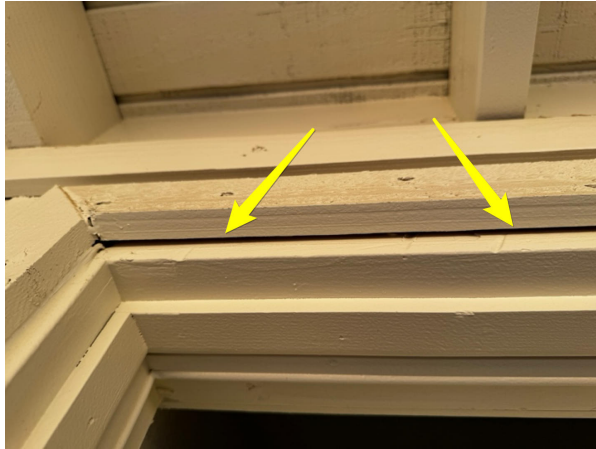
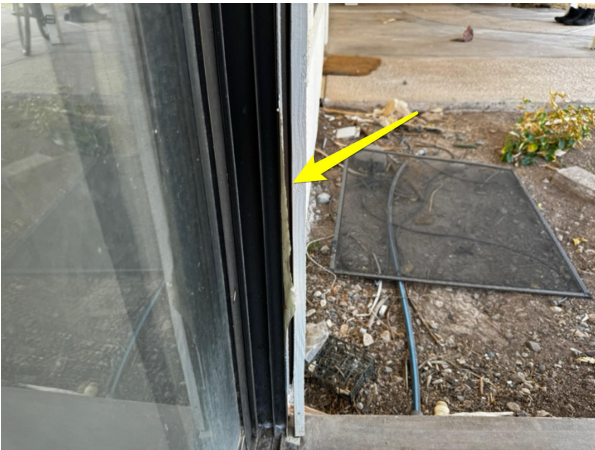
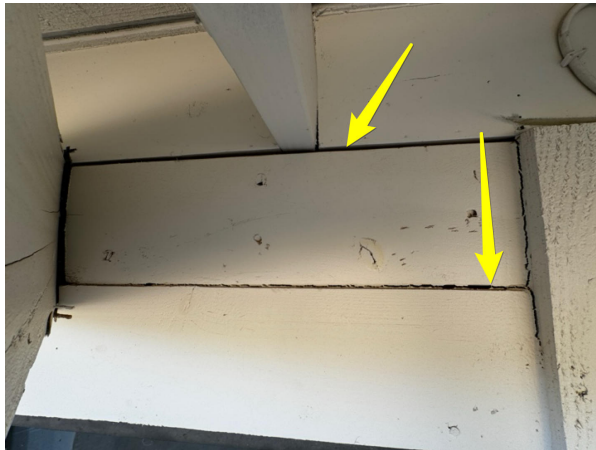
NOTE s-21: There are various gaps/openings/separations at the exterior siding and trim that need to be sealed/repaired to prevent water entry (often found at perimeters of windows, doors, light fixtures, electrical outlets, various penetrations and transition areas) - Attention.

Example: various gaps/openings/separations

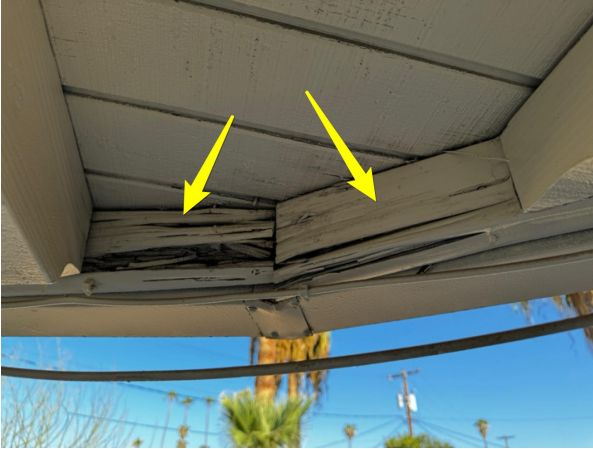
NOTE s-26: There is moisture staining/damage at the eave areas that likely indicates past roof leaks - Review. (e.g. rear patio cover)

Example: rotted wood

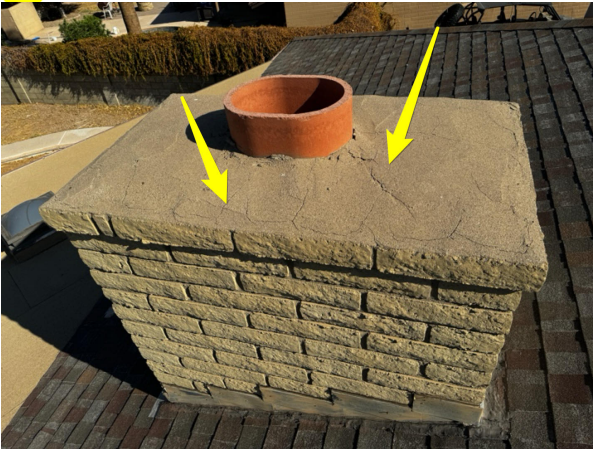
NOTE s-28: The chimney crown (designed to seal the chimney top and shed rainwater) is cracked and should be sealed/repared -Attention.

Example: cracks at crown

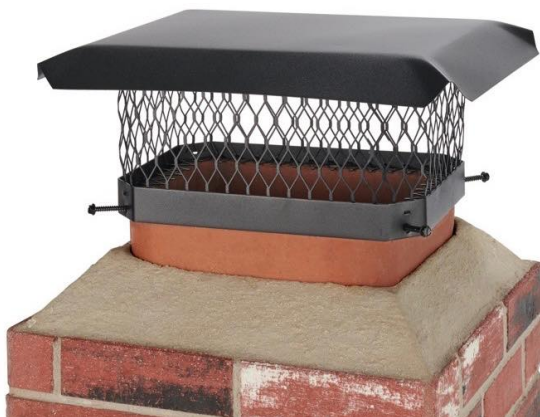
NOTE s-29: The installation of a spark arrestor/rain cap is recommended at the chimney top -Attention.

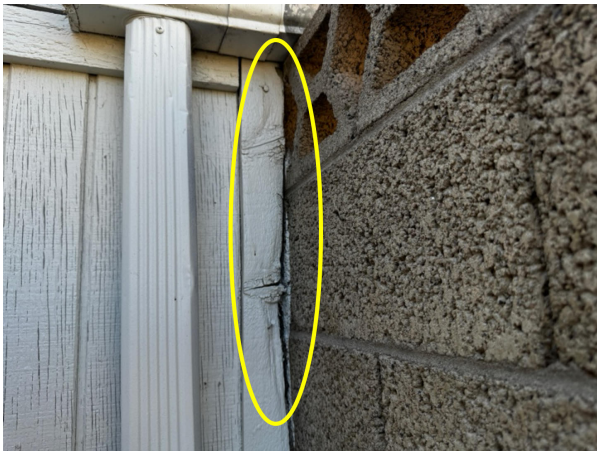
NOTE s-31: Damage/deterioration and evidence of past roof leaks were observed at the storage room - Review.

Example: rotted wood

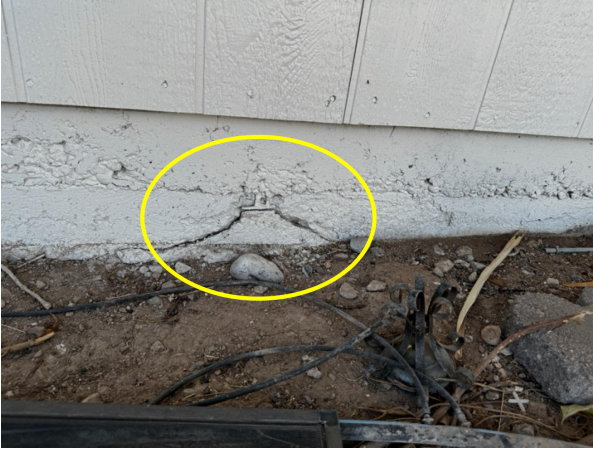
NOTE s-33: Damage was observed at wall anchor areas of the foundation wall. Consult a specialist for further evaluation to determine the options for repair - Review. (e.g. rear addition)

Example: damage

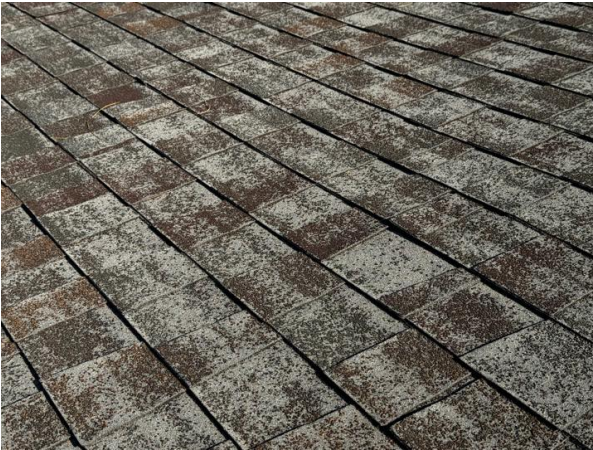
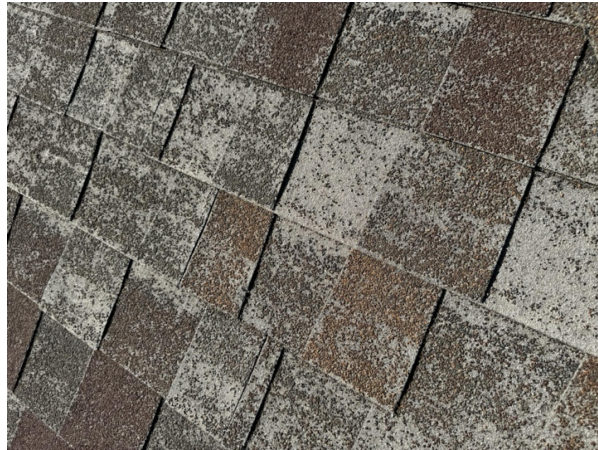
NOTE s-37: The composition shingle roof appears to be at or near the end of its service life. Significant granule loss and material deterioration were observed. It should be further evaluated by a licensed roofer to determine options and cost of replacement - Review.

Example: significant granule loss

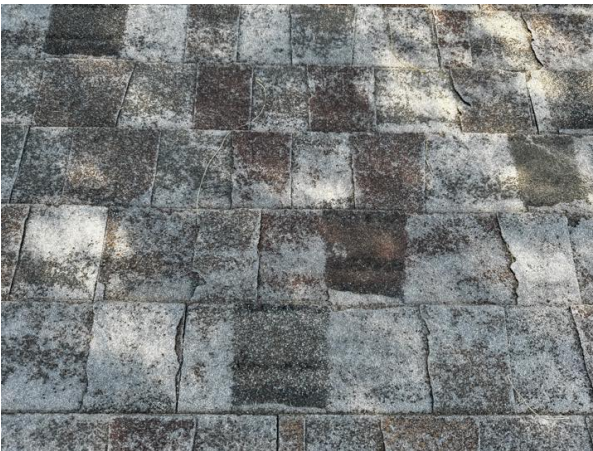
Example: deterioration/damage

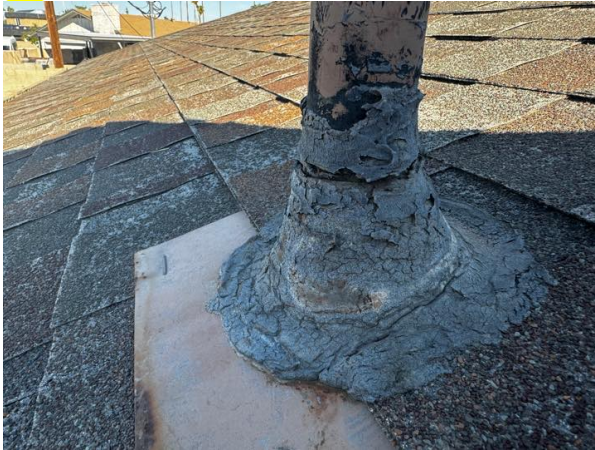
NOTE s-39: Separations at roof flashings need to be sealed to prevent water entry - Attention (e.g. plumbing vents)

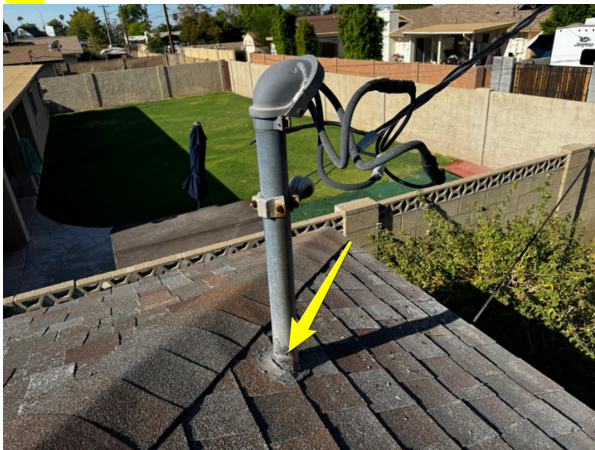
NOTE s-40: Roof flashing detail at penetrations is improper. Further evaluation by a licensed roofer is needed for repair - Attention.

Example: no roof jack installed at electrical mast penetration

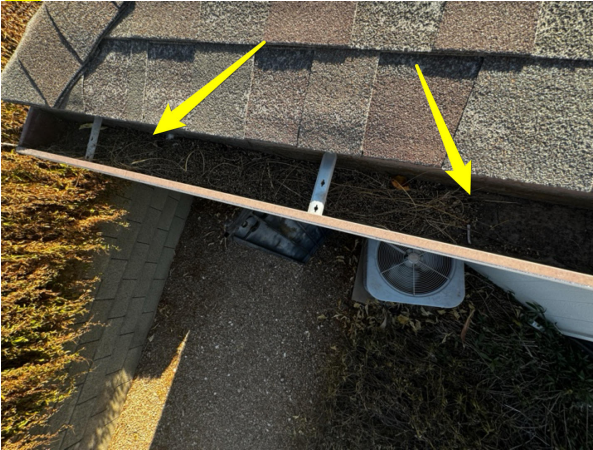
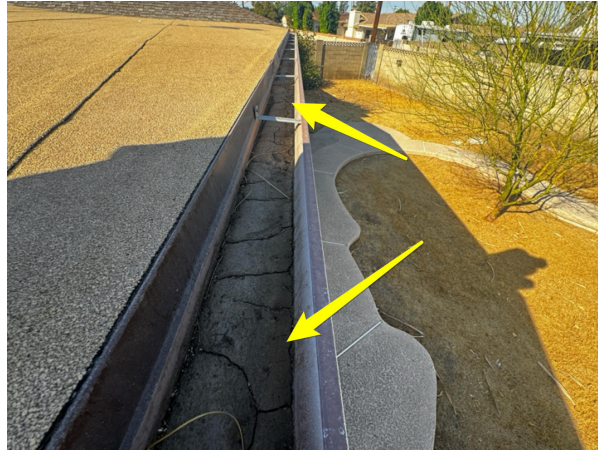
NOTE s-46: The roof gutters need service (i.e. cleaning, sealing seams, securing as needed and aligning them to drain properly) - Attention.

Example: gutter full of debris

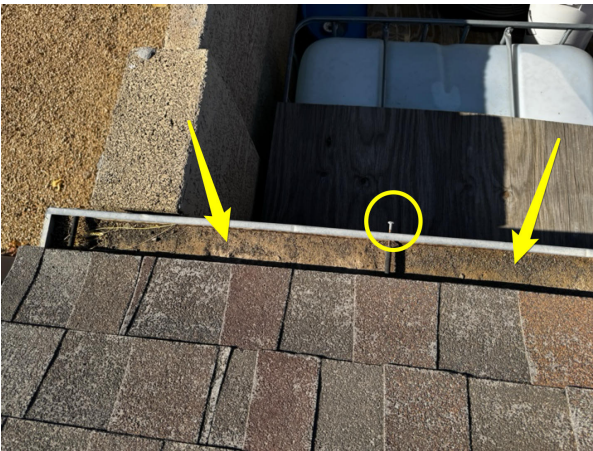
Example: gutter full of debris & loose anchor

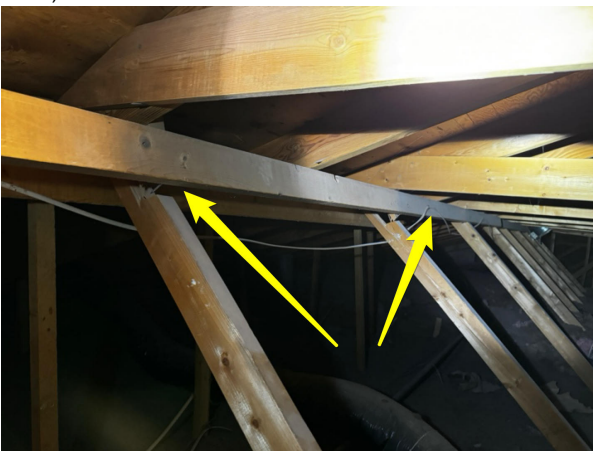
Location

NOTE s-50: A purlin within the attic is damaged/loose. Consult a licensed contractor to repair/repair as required - Attention. (e.g. above living room)

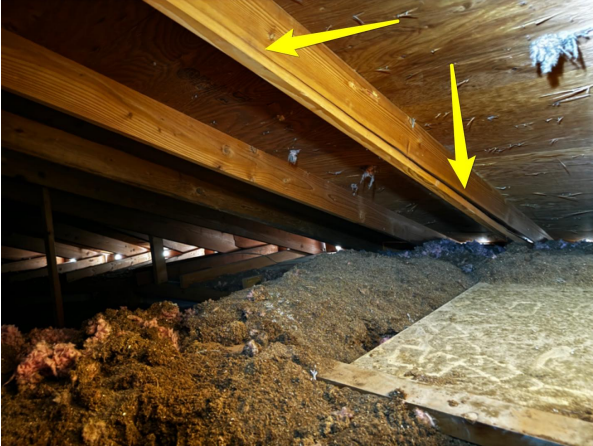
Location

NOTE s-51: A rafter within the attic is cracked/damaged. Consult a licensed contractor to repair/repair as required - Attention. (e.g. near front entry)

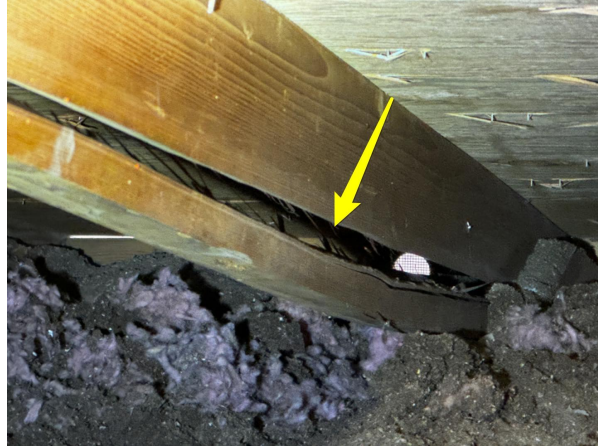
Example: cracked rafter

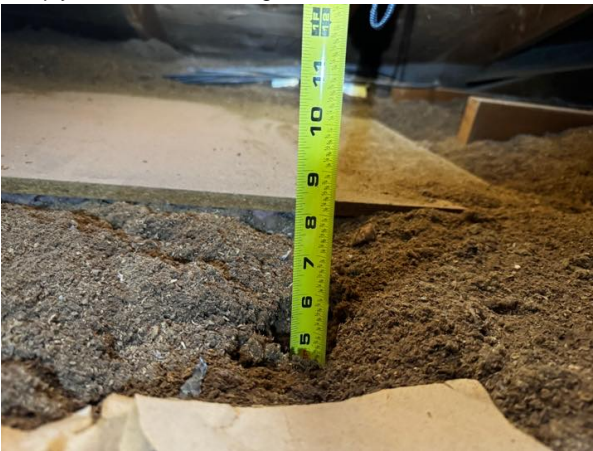
NOTE s-56: Insulation within the attic is low and missing/displaced in areas. Additional material is needed for energy efficiency reasons and to comply with current building standards - Attention.

Example: low insulation

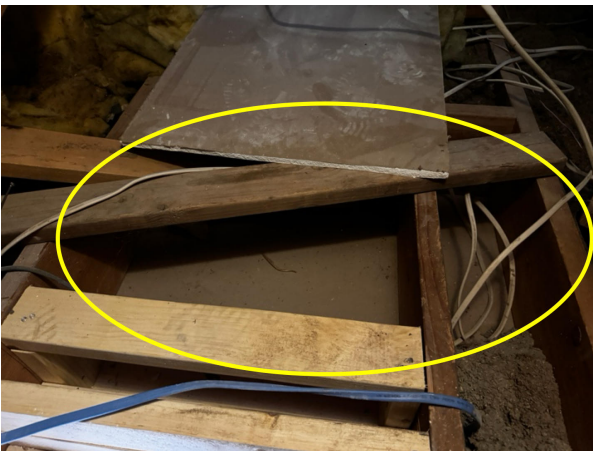
Example: missing insulation

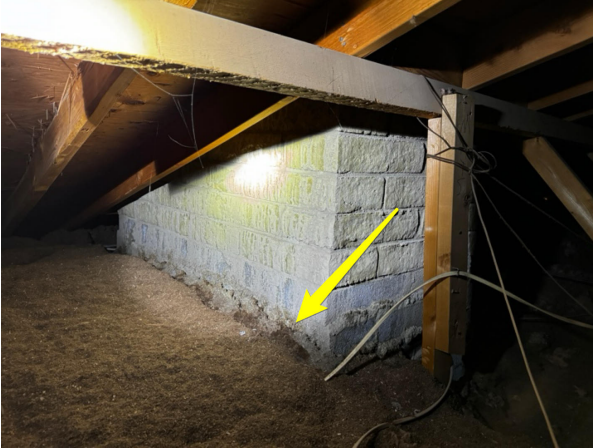
NOTE s-58: There is moisture staining within the attic. You should obtain roof leak history/repair documents or have a licensed roofer evaluate the condition further - Review. (e.g. chimney penetration)

Example: moisture staining

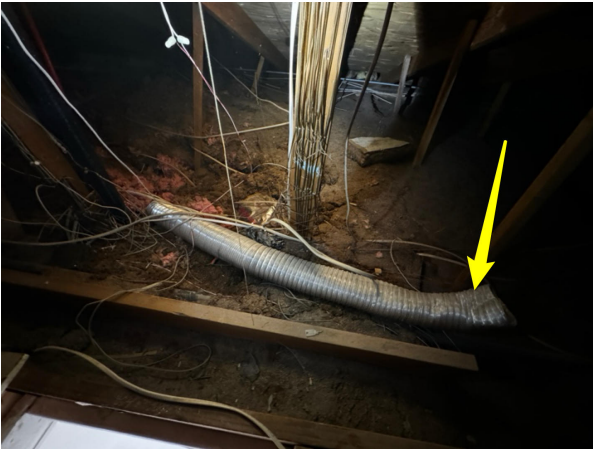
NOTE s-59: An exhaust fan duct vents into the attic, which is not permissible. The installation of a proper duct that vents to the exterior is needed - Attention. (e.g. laundry room)

Example: incomplete installation

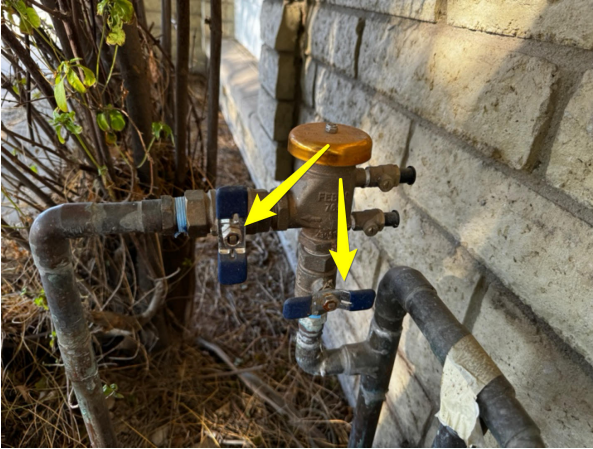
NOTE s-91: The water supply to the irrigation system was shut down at the time of the inspection. Further evaluation is needed to assess the system - Review.

Water supply valves shut down

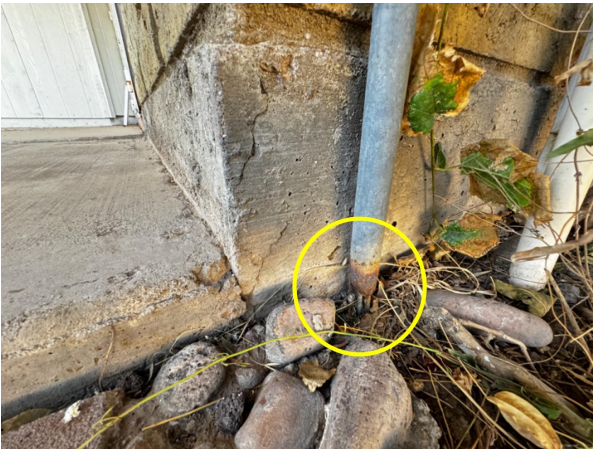
NOTE s-92: The electrical conduit below the rear irrigation system timer is rusted/damaged, which has exposed the wiring. Consult a licensed electrician to repair/replace as required - Attention.

Damaged conduit & exposed wiring

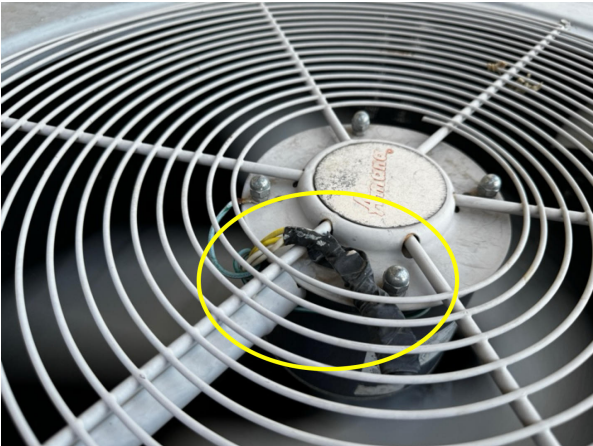
NOTE s-106: Exposed electrical connections at the condensing unit indicate past fan motor replacement. These electrical connections are required to be made inside the cabinet for safety and protection of the wiring - Attention. (e.g. north unit)

Improper installation

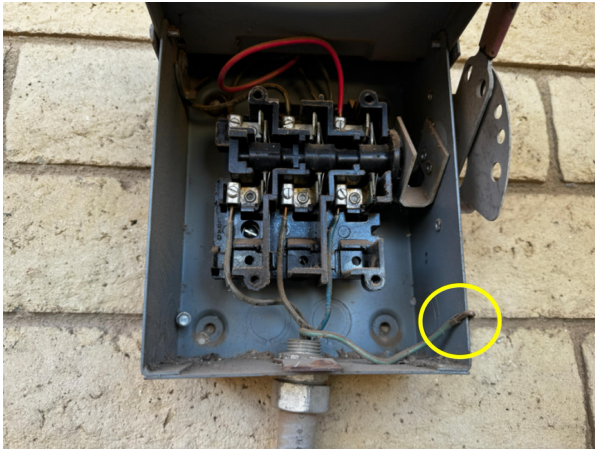
NOTE s-107: A ground wire is not properly attached to the air conditioner electrical disconnect enclosure and should be corrected - Attention. (e.g. north unit)

Improper installation

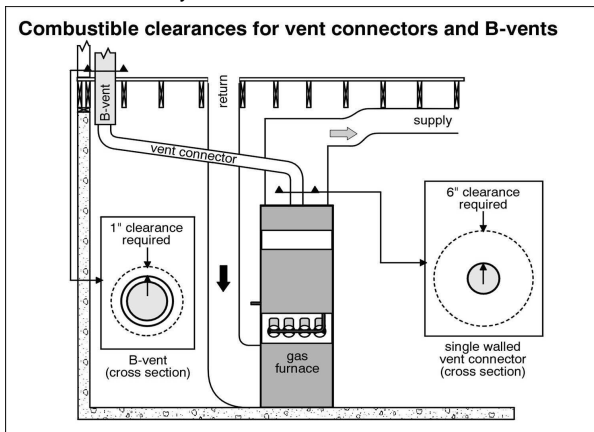
NOTE s-115: The furnace vent pipes are improperly in contact with the ceiling surfaces. A double-walled flue requires one inch of clearance between it and any combustible material - Attention.

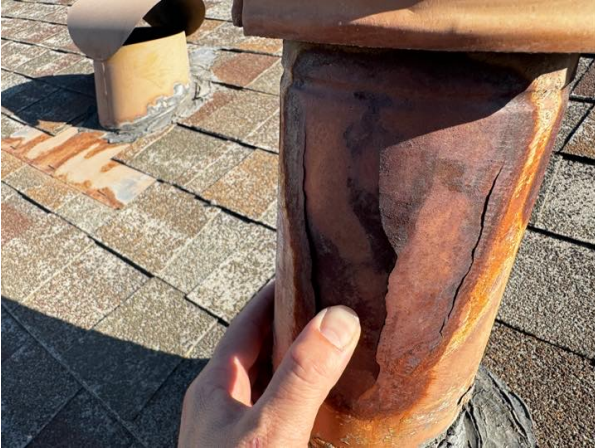
NOTE s-116: The furnace vent pipes are rusted at the roof level. The south side flue is damaged and needs to be replaced - Attention.

Example: rusted/damaged flue

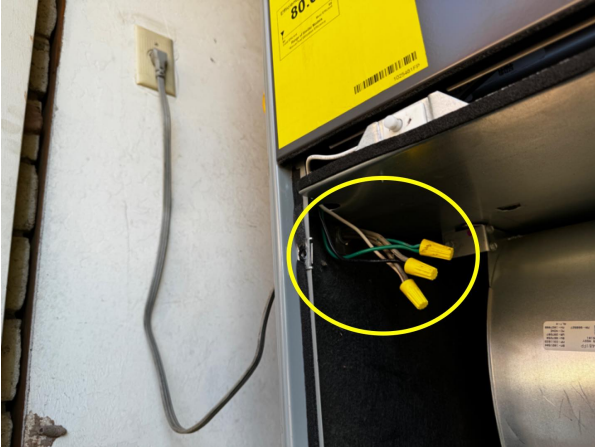
NOTE s-118: The electrical connections at the furnace have been improperly made outside of an enclosed junction box. Consult a licensed HVAC technician to correct as required - Attention. (e.g. south unit)

Exposed wiring connections

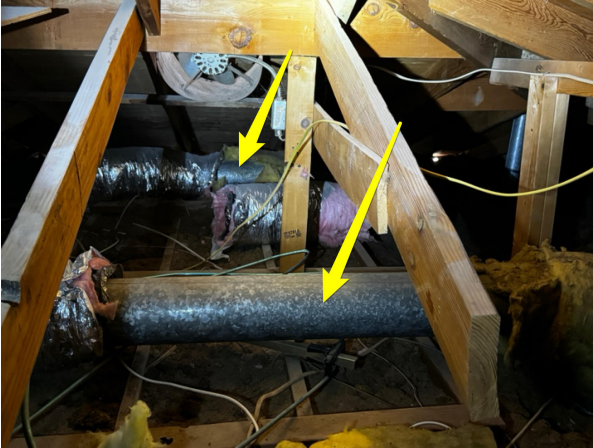
NOTE s-128: Duct insulation is incomplete and should be corrected - Attention. (e.g. south side attic)

Example: incomplete insulation

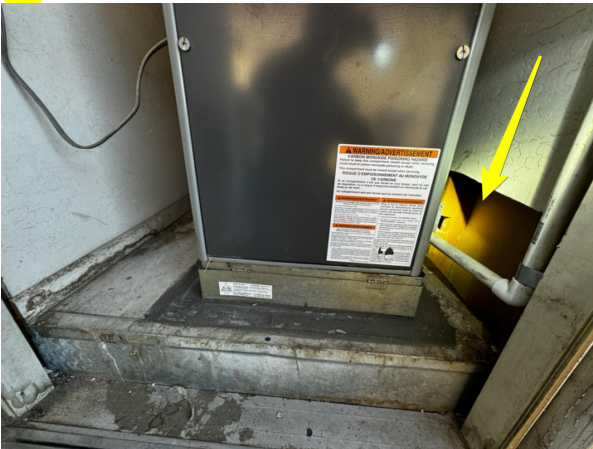
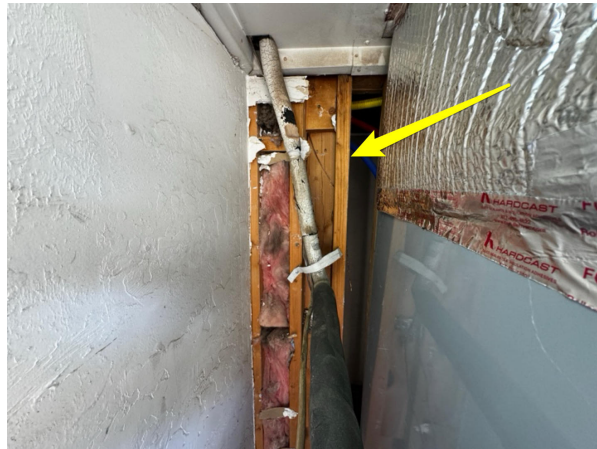
NOTE s-132: Stains/damage were observed within the furnace closets - Review.

Example: wall cut open

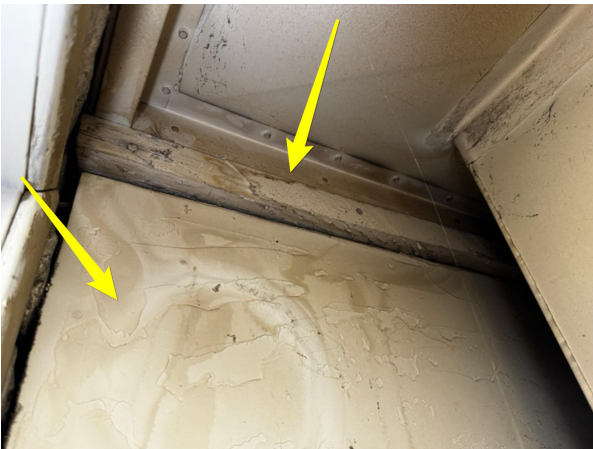
Example: moisture staining

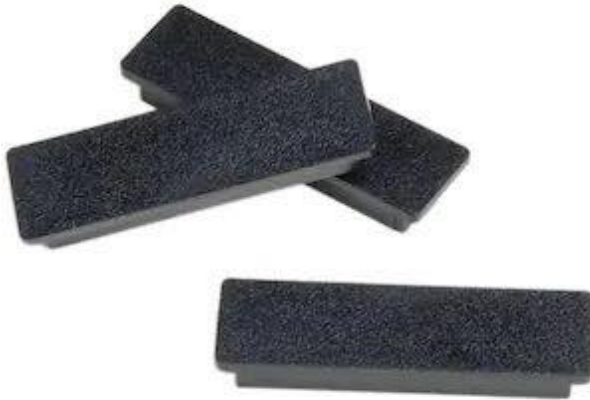
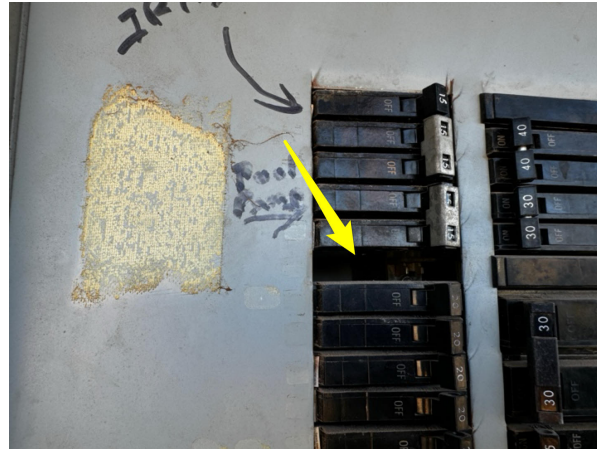
NOTE s-142: There is an opening at the interior cover of the electrical panel that needs to be capped for safety - Attention.

Knockout cap needed

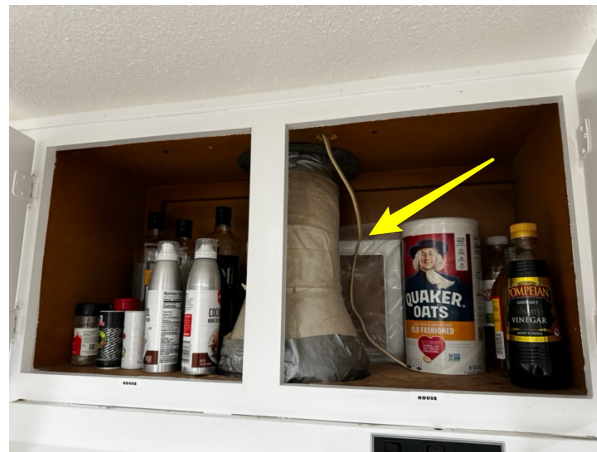
NOTE s-153: Exposed electrical wiring should be placed inside a conduit or otherwise protected where subject to damage - Attention. (e.g. storage room, kitchen exhaust hood)

Example: exposed wiring

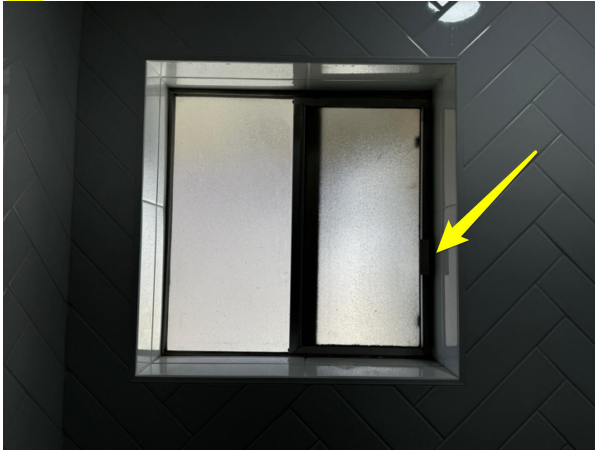
NOTE s-159: Windows do not latch properly. Repair/replace as required - Attention. (e.g. south hallway bathroom, Room #6)

Example: window does not latch due to tile installation
