4604 Feagan Street Houston, Texas 77007

Client	Humberto Marquez
Type	Home Inspection Report - 4604 Feagan Street
Inspected by	Rio Bravo - Inspectify Pro - Houston
State license	TREC 22388
InterNACHI	17031522
Scheduled	January 24, 2025, 4:00 PM
Completed	January 24, 2025, 5:50 PM

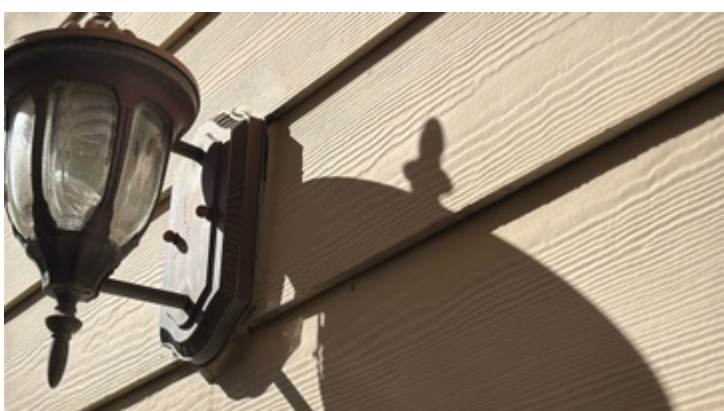
Missing Exterior Caulk

**Repair deficiency**

One or more exterior areas need caulking.

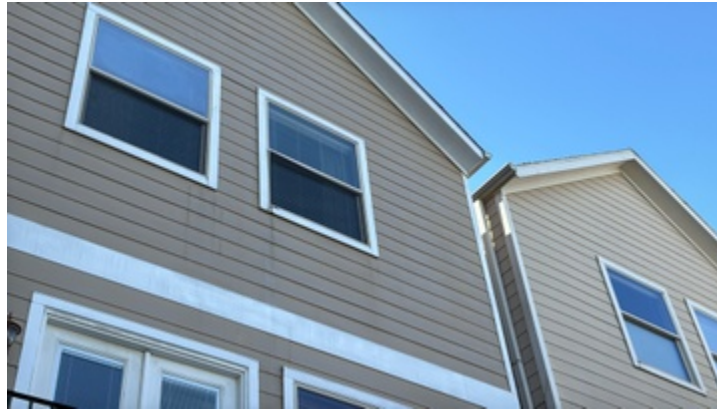
Damaged Trim

**Repair deficiency**

There are signs of damage to the trim.

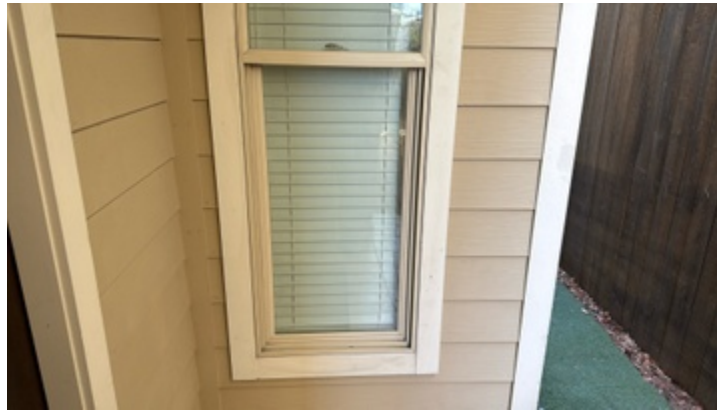
Missing Window Screen

Monitor deficiency

One or more windows are missing a screen.

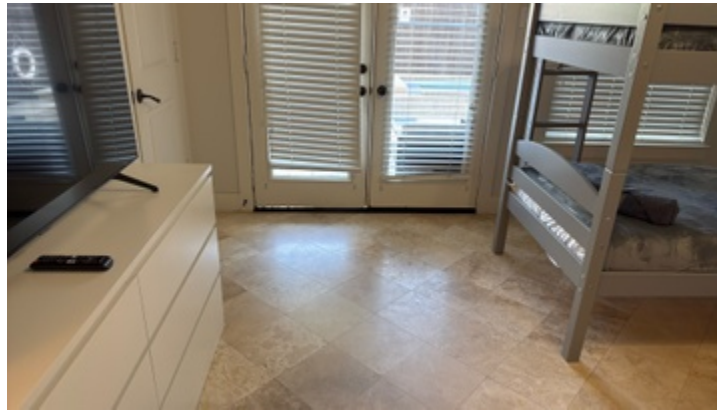
Damaged Weatherstripping on Exterior Door

**Repair deficiency**

The weatherstripping on an exterior door is damaged or deteriorated.

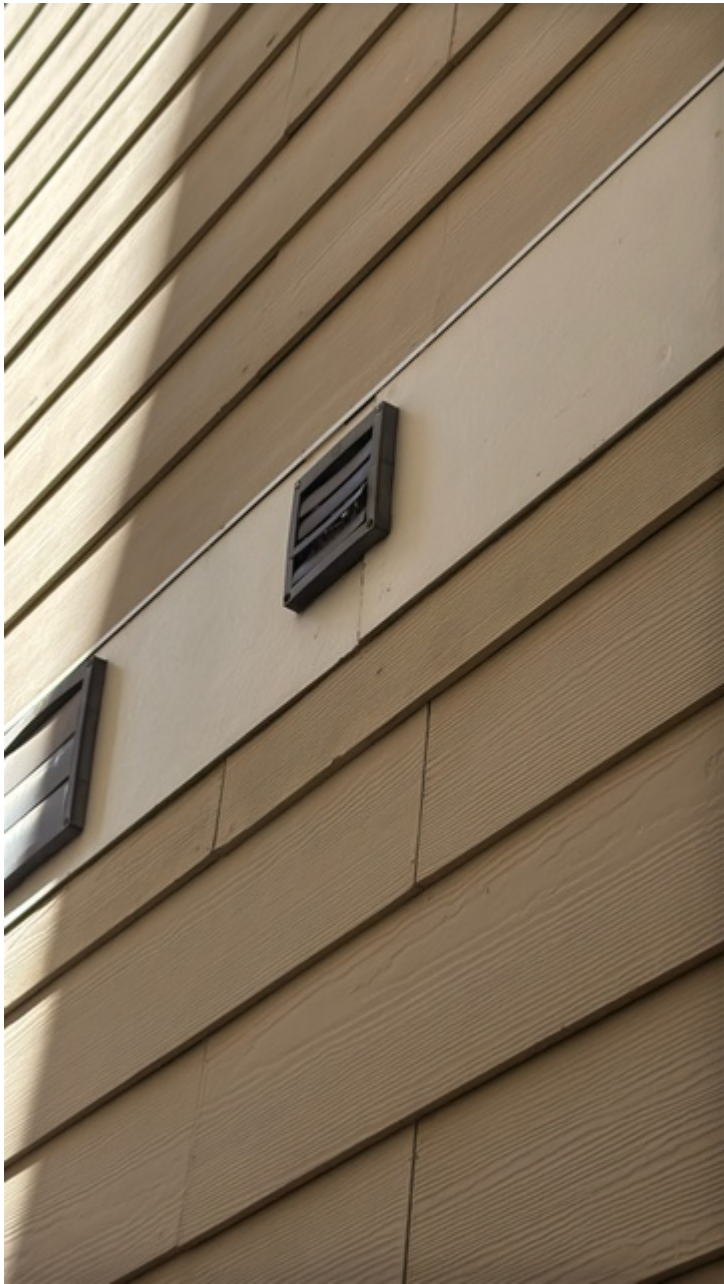
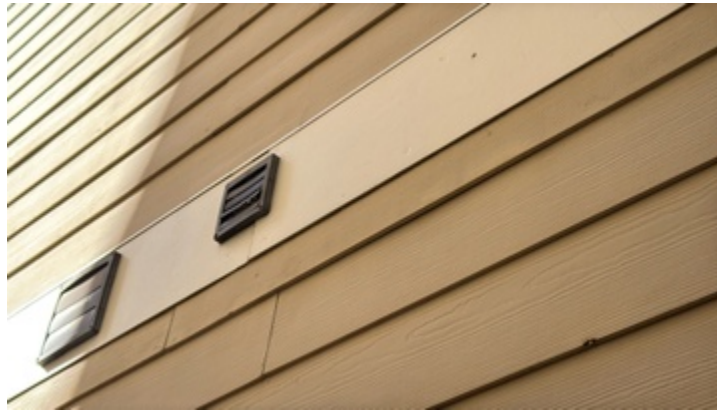
**Repair deficiency**

The dryer vent needs to be cleaned.

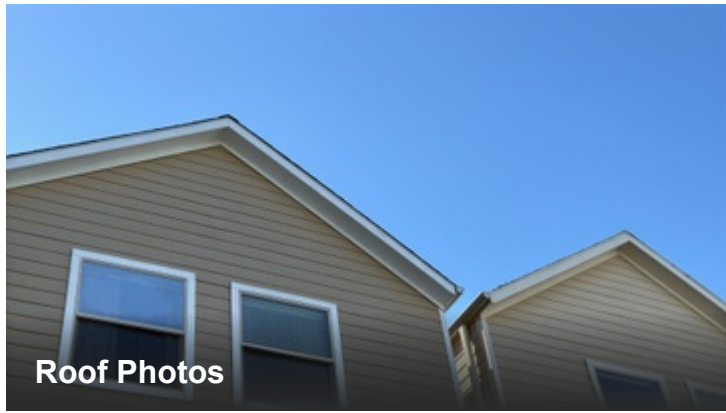
Coverings photos / videos

Roof Covering Condition: No Access

Previous / Partial Roof Repairs Observed: No Access

There was snow covering the roof surface. I was unable to observe everything that I needed to see because of the snow. Recommend further evaluation at a later date when the snow has melted.

There are components of the roof that are not visible or accessible, including the underlayment, decking, fastening, flashing, age, shingle quality, manufacturer installation recommendations, etc.

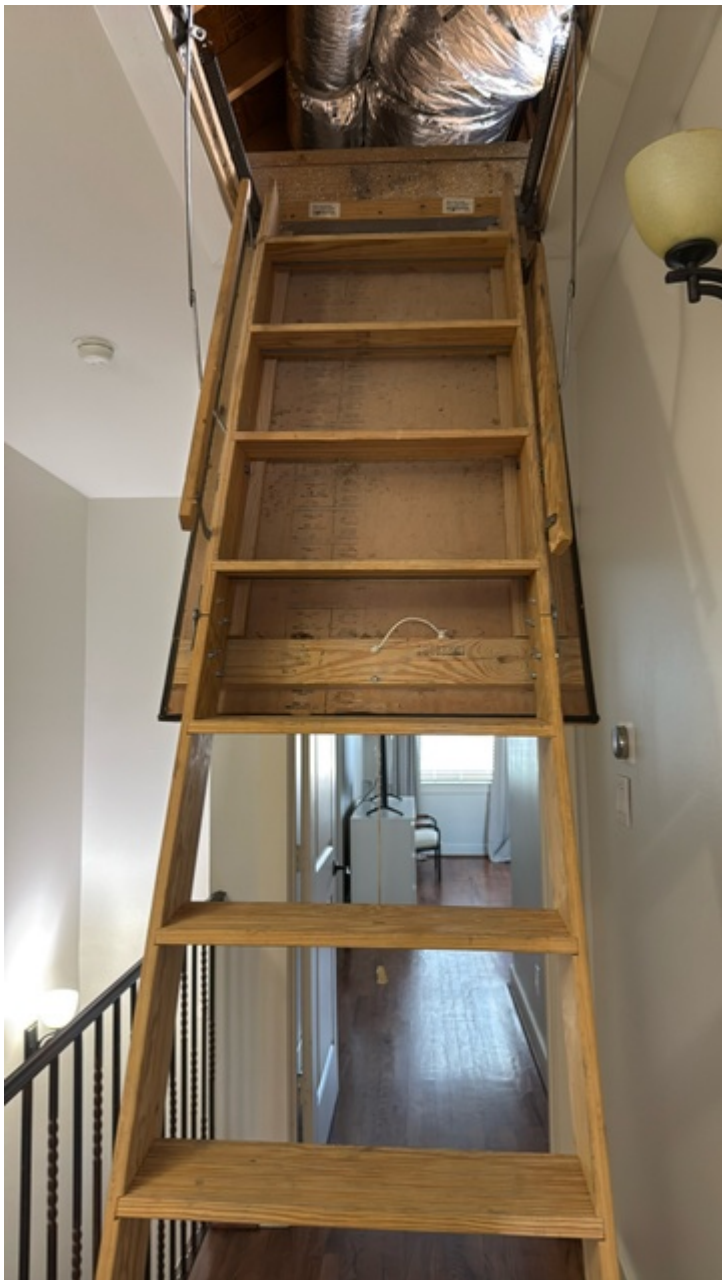
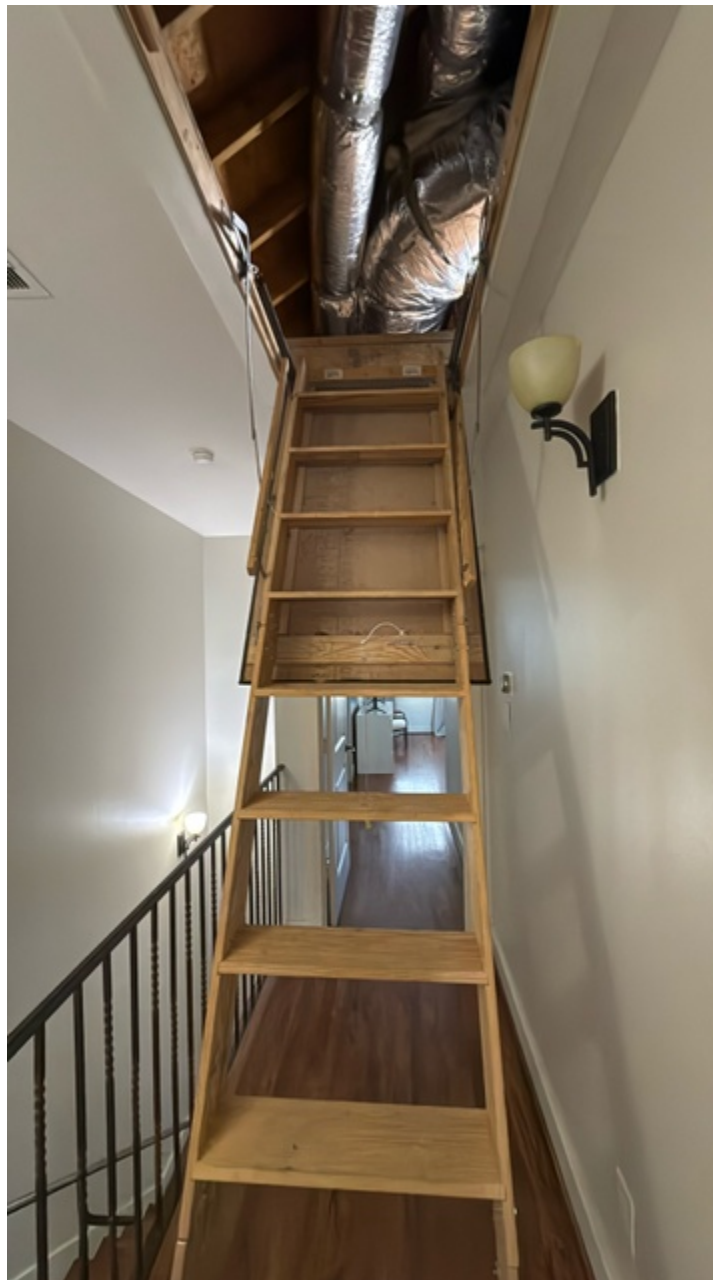
Attic photos / videos

**Repair deficiency**

Missing Attic Hatch Insulation

There is no insulation for the attic access hatches.

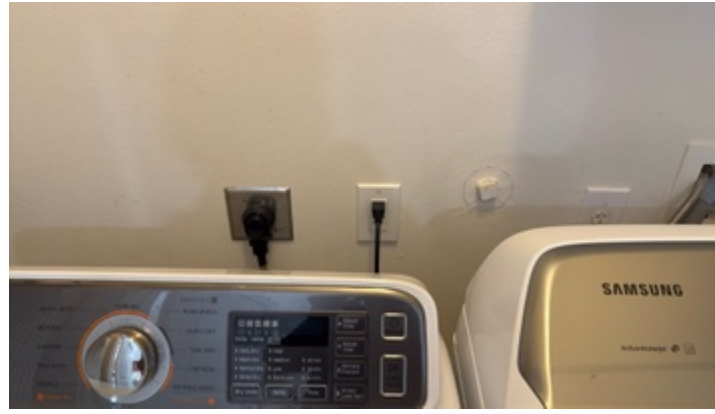
Missing GFCI

There is no GFCI (Ground-Fault Circuit Interrupter) protection.

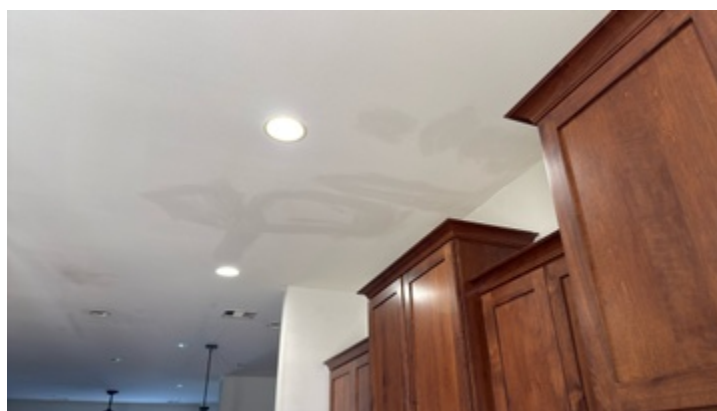
Signs of a Leak are Present

There are signs of a leak present.

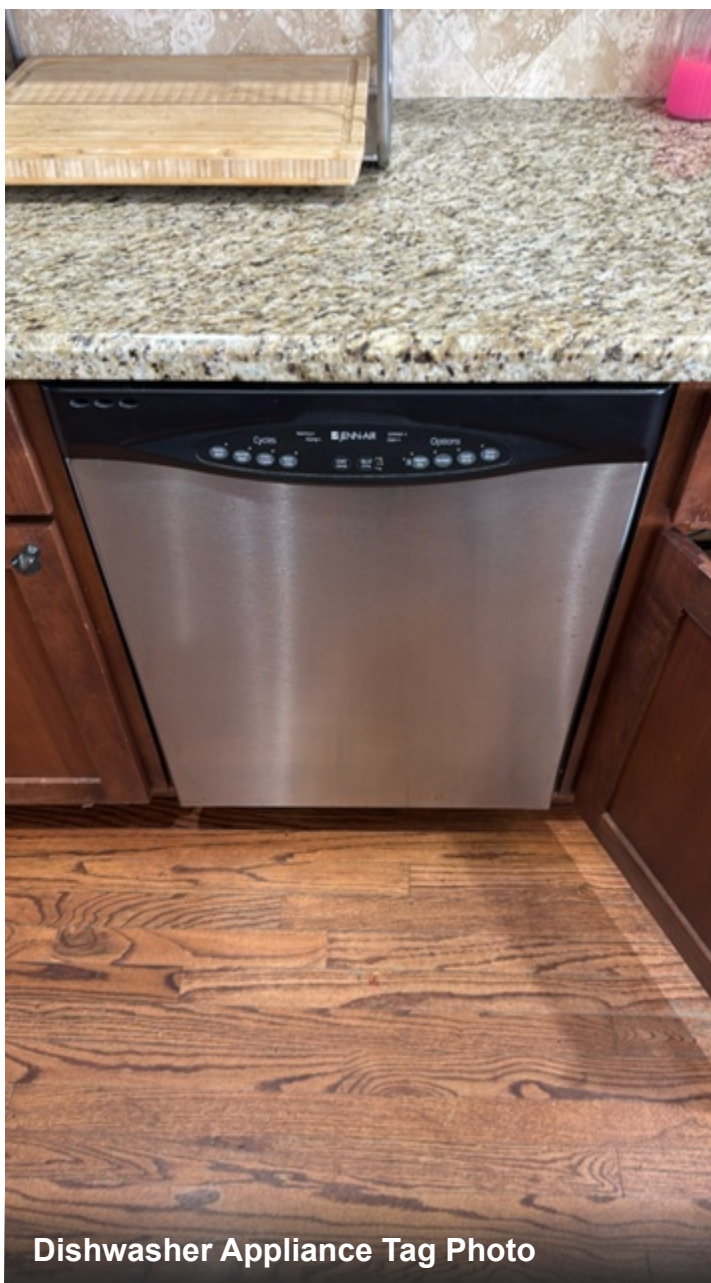
Dishwasher Appliance Tag Photo

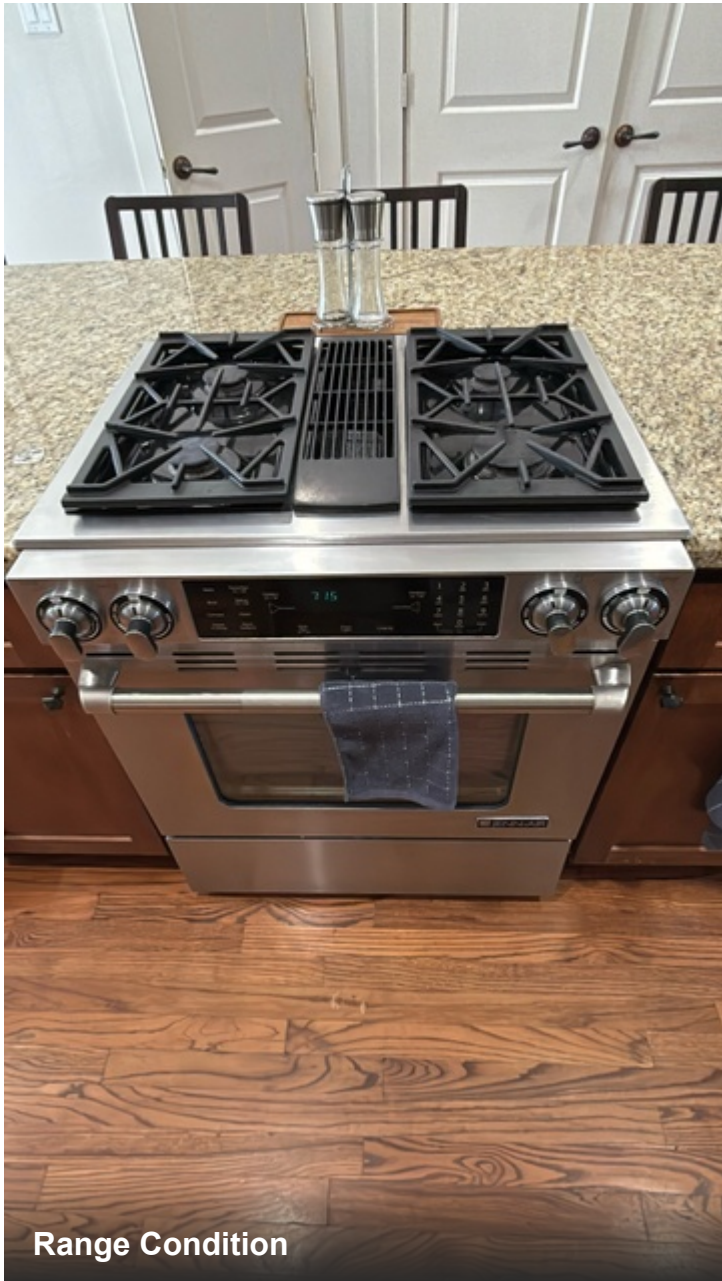
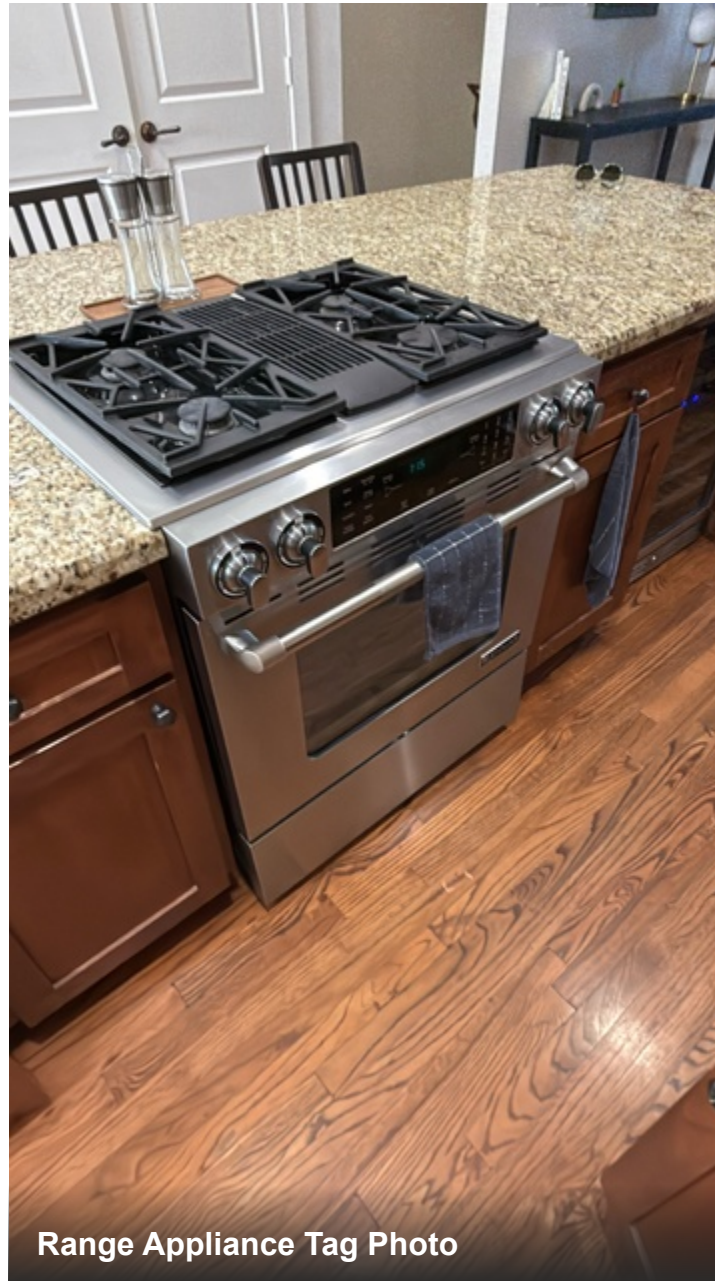
Range photos / videos

Limitation

Range Appliance Tag Photo: Not Present

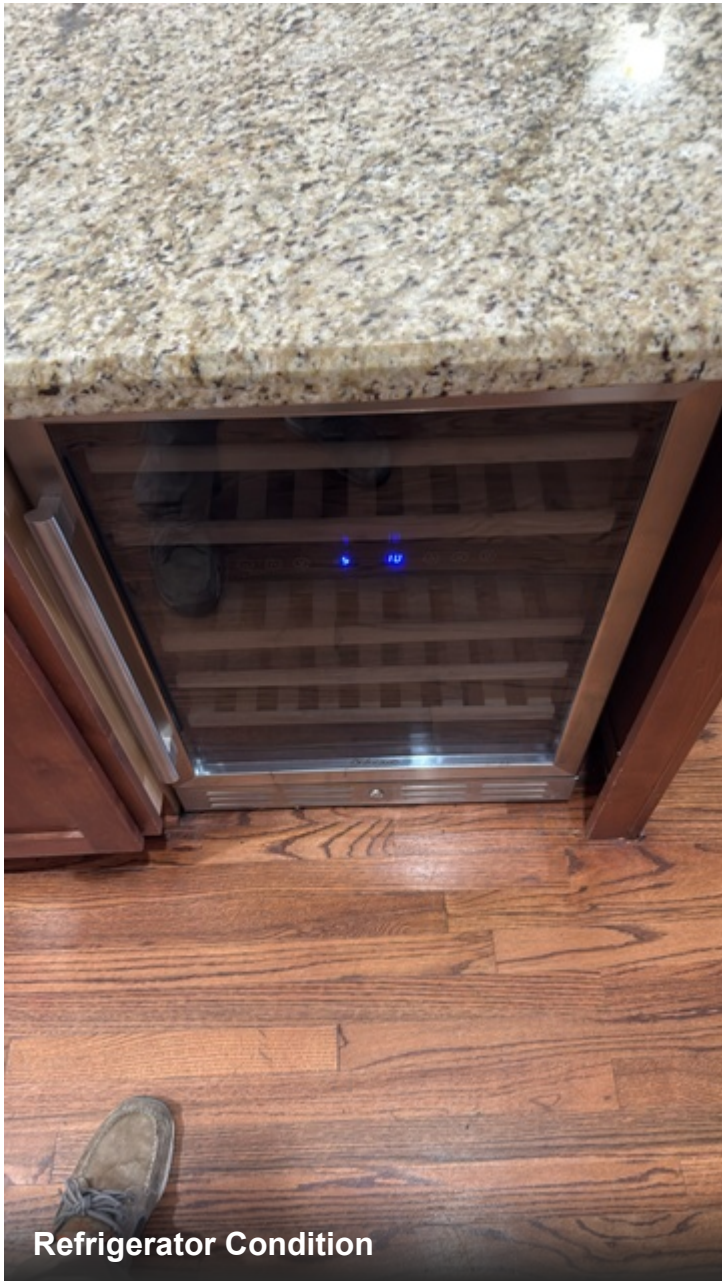
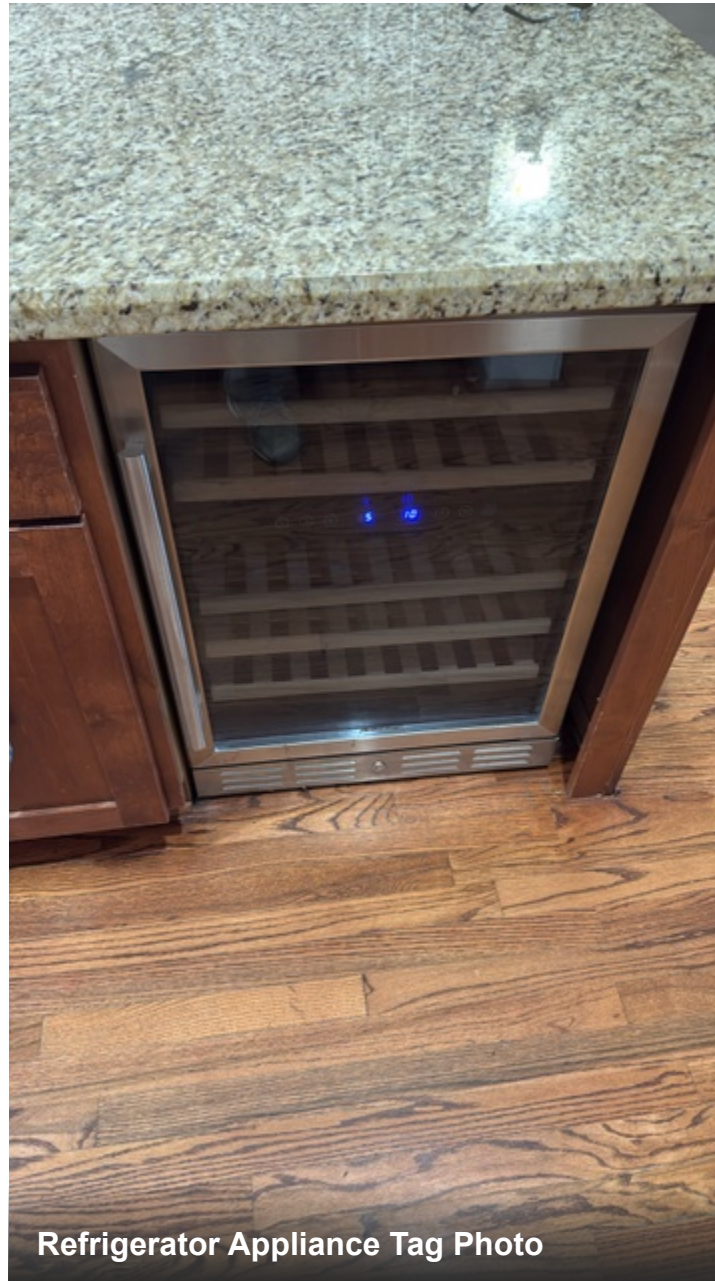
Refrigerator 2 photos / videos

⚠ Limitation

Refrigerator Appliance Tag Photo: Not Present

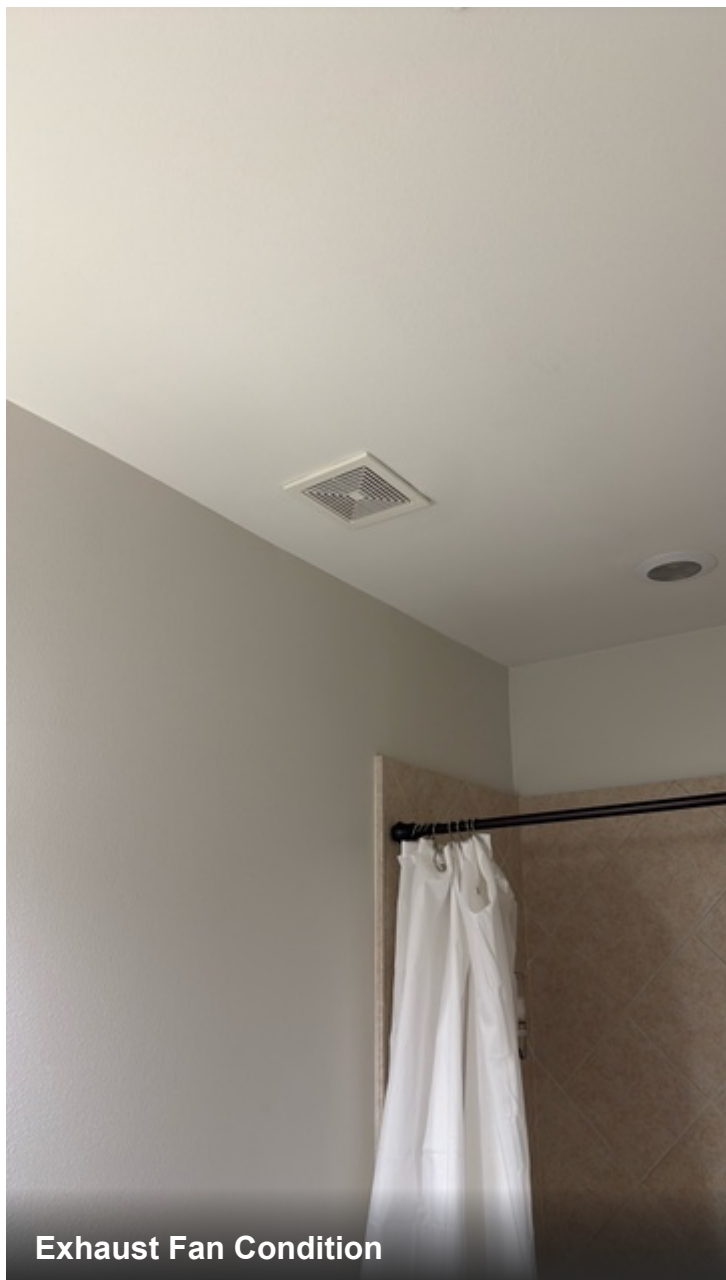
Damaged or Missing Tile

One or more tiles are damaged or missing.

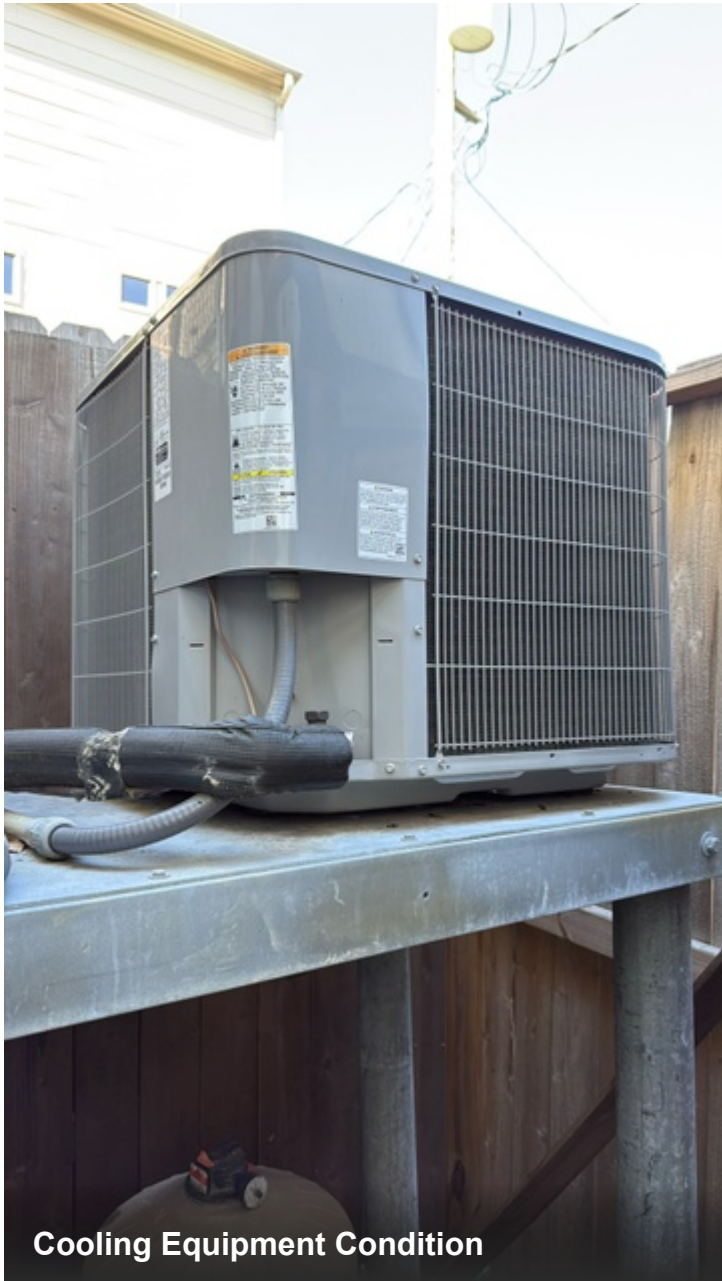
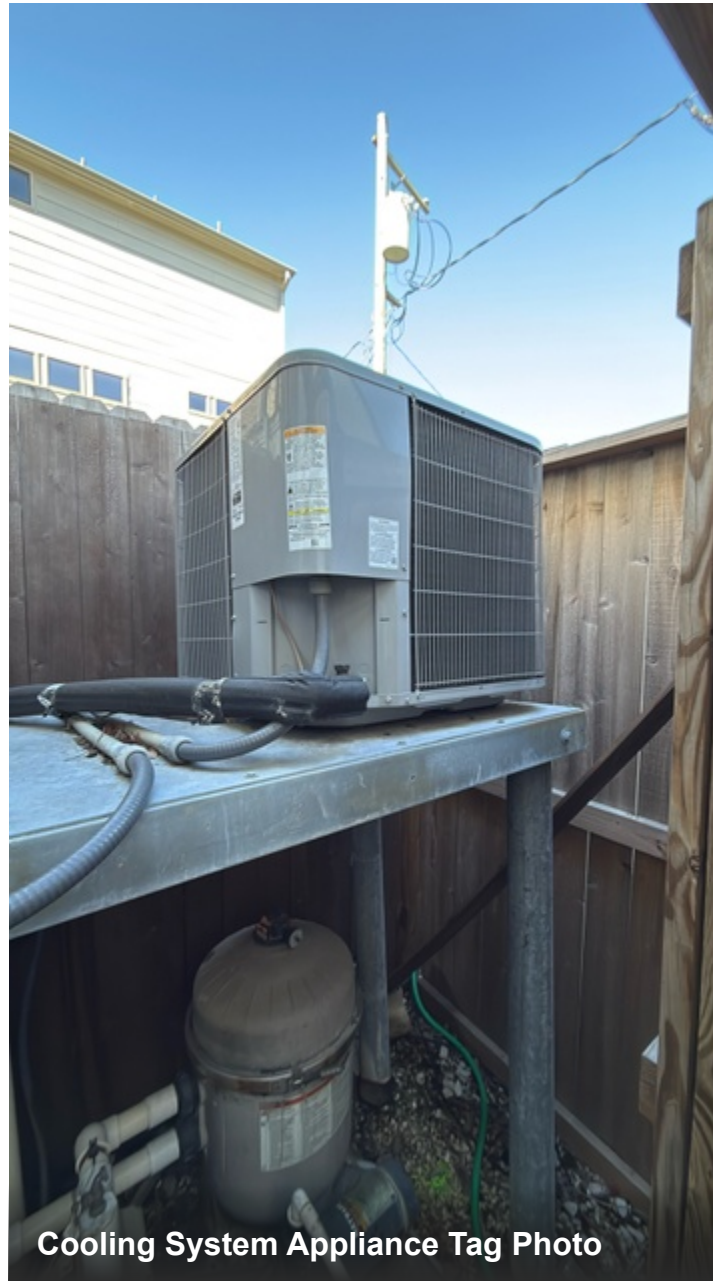
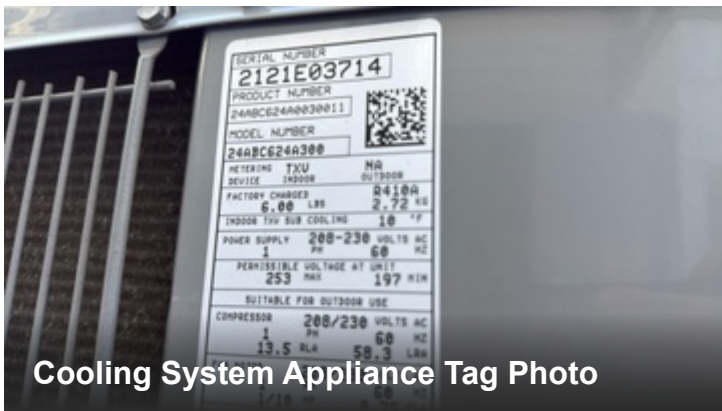
Cooling 2 photos / videos

Cool Temperature Restriction

Because the outside temperature was too cool to operate the air conditioner without the possibility of damaging the system, I did not operate the cooling system.

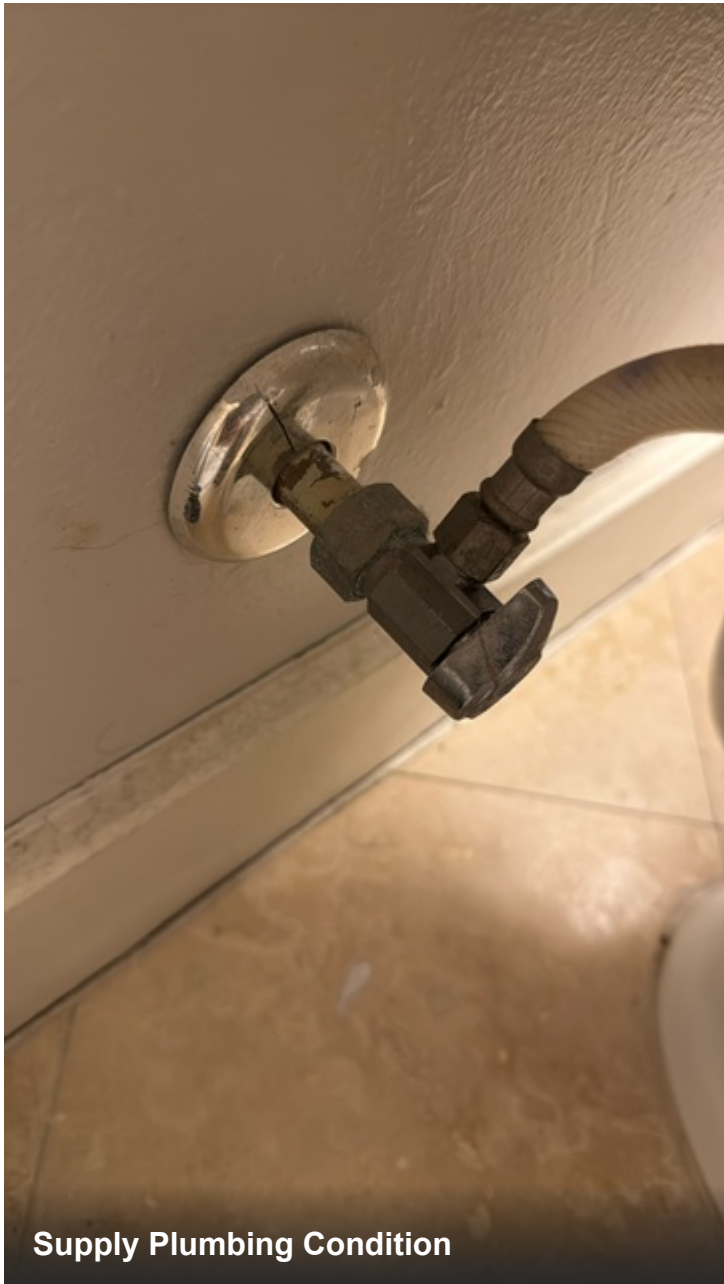
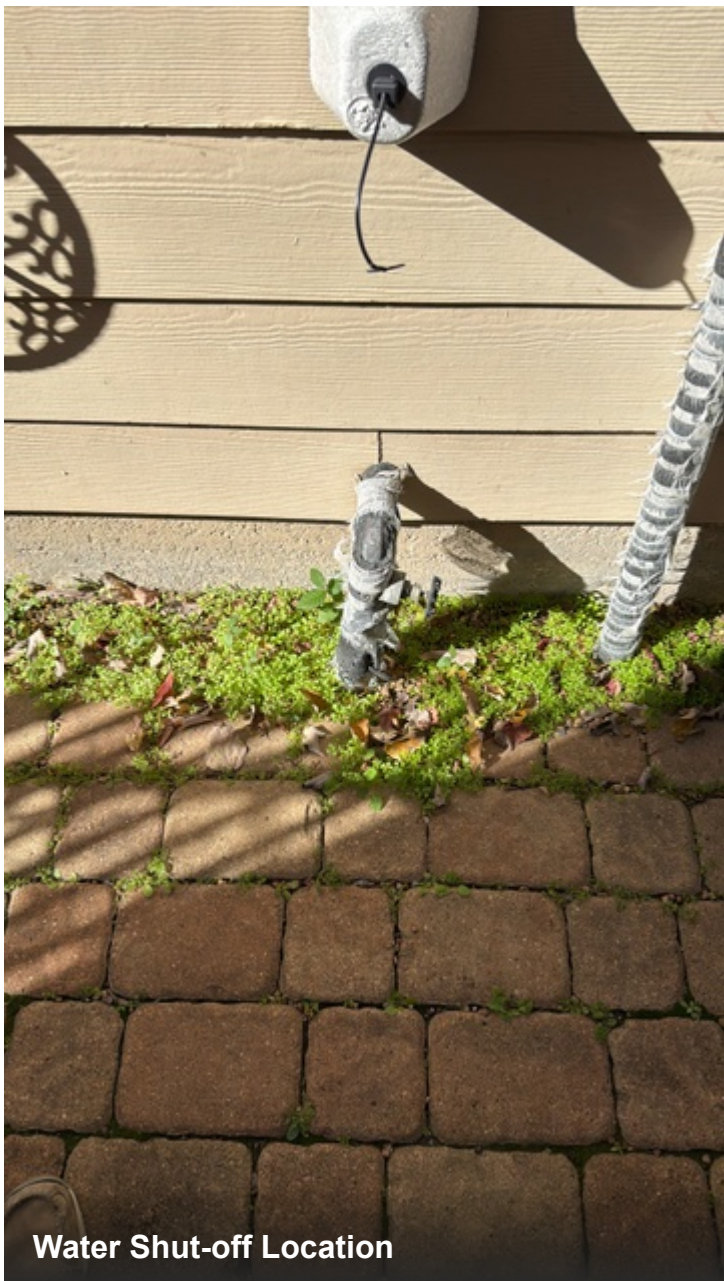
Main Water Supply photos / videos

Plumbing Not Fully Visible

The inspection was restricted because not all of the water supply pipes were exposed, readily accessible, and observed. For example, most of the water distribution pipes, valves and connections were hidden within the walls.

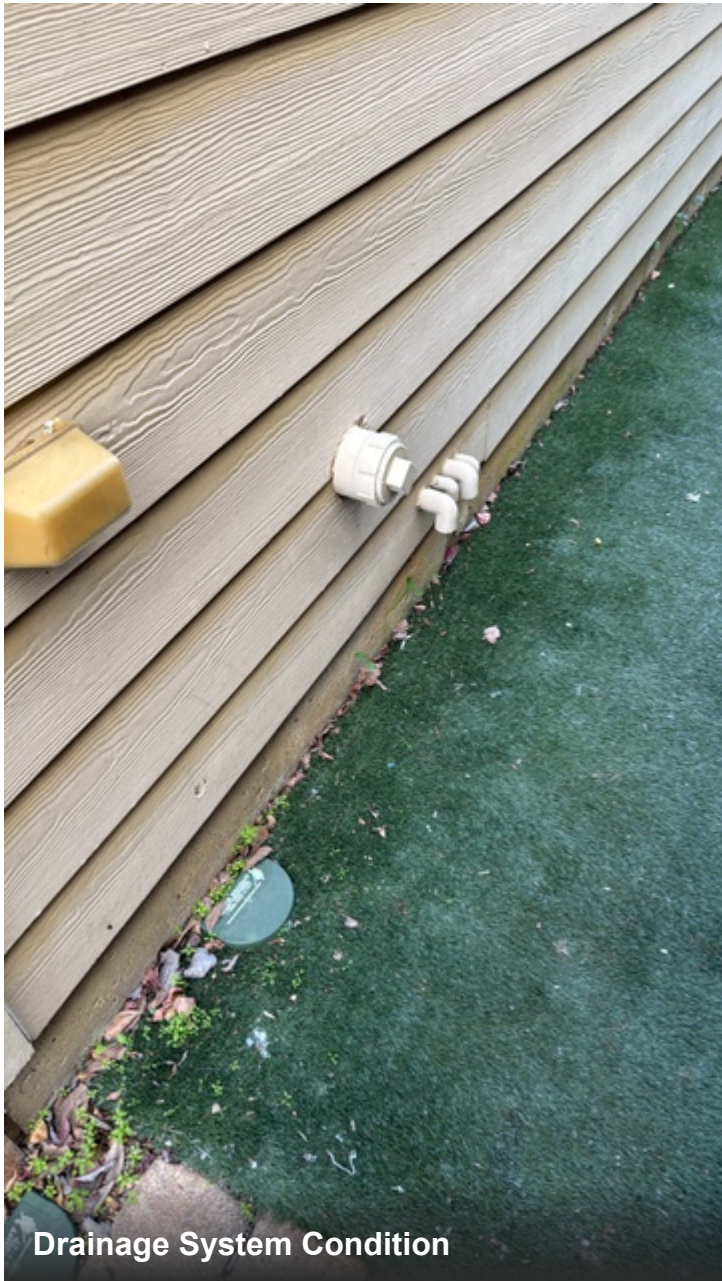
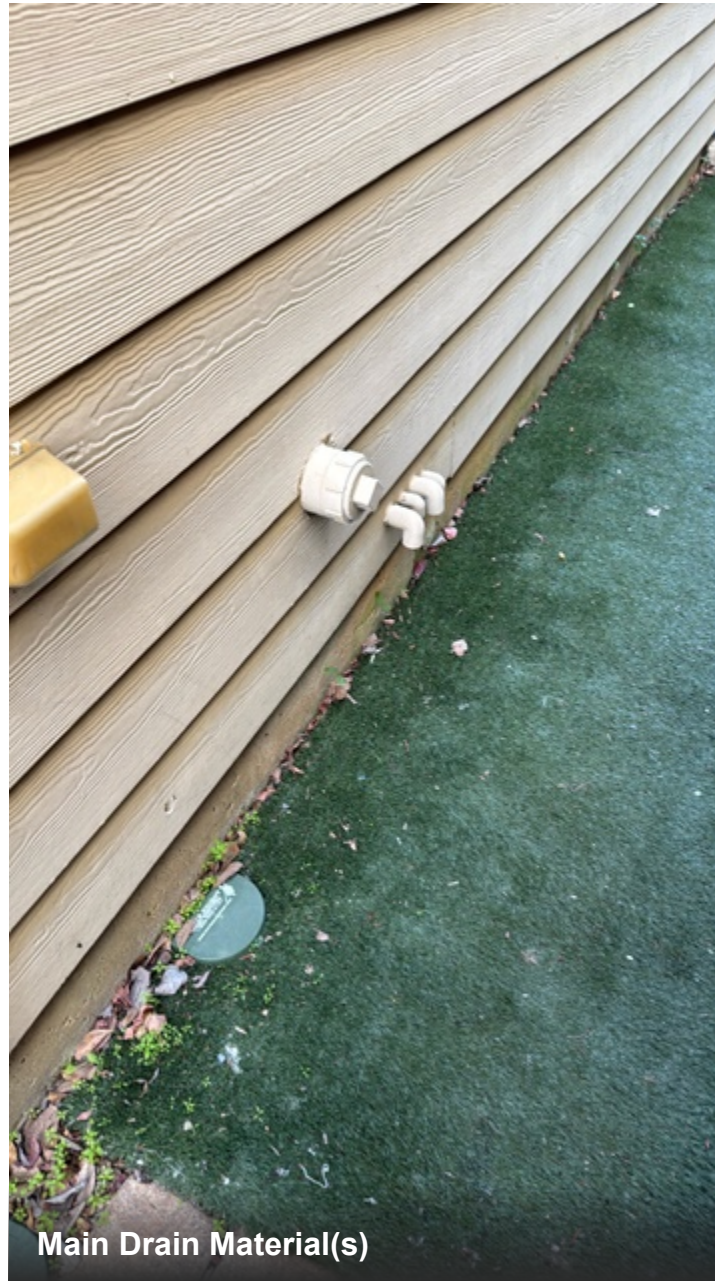
Drainage photos / videos

Plumbing Not Fully Visible

The inspection was restricted because not all of the water supply pipes were exposed, readily accessible, and observed. For example, most of the water distribution pipes, valves and connections were hidden within the walls.

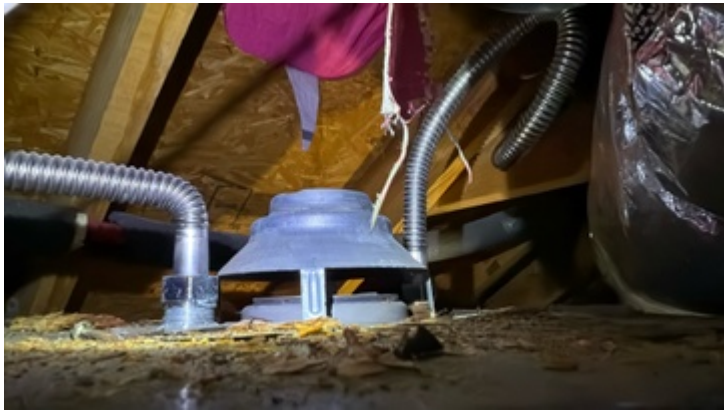
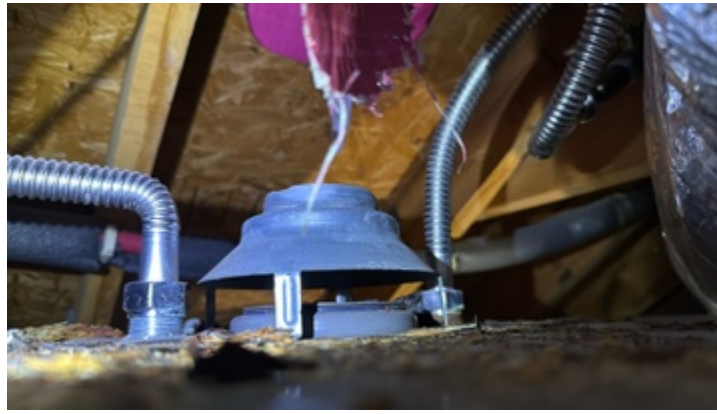
Water Heater photos / videos

+ Safety deficiency

Vent not Attached to Water Heater

The vent is not properly attached to the water heater.

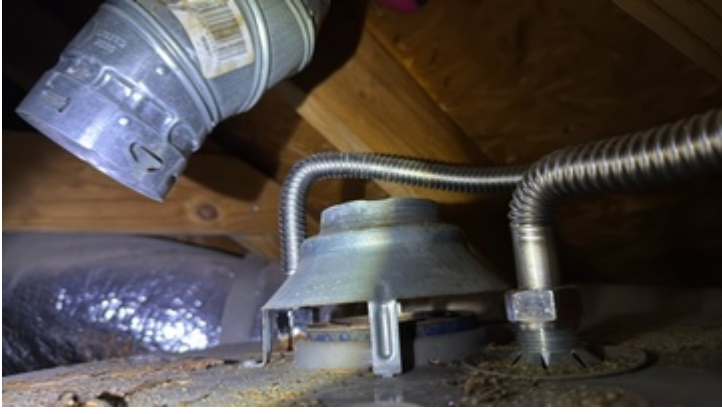
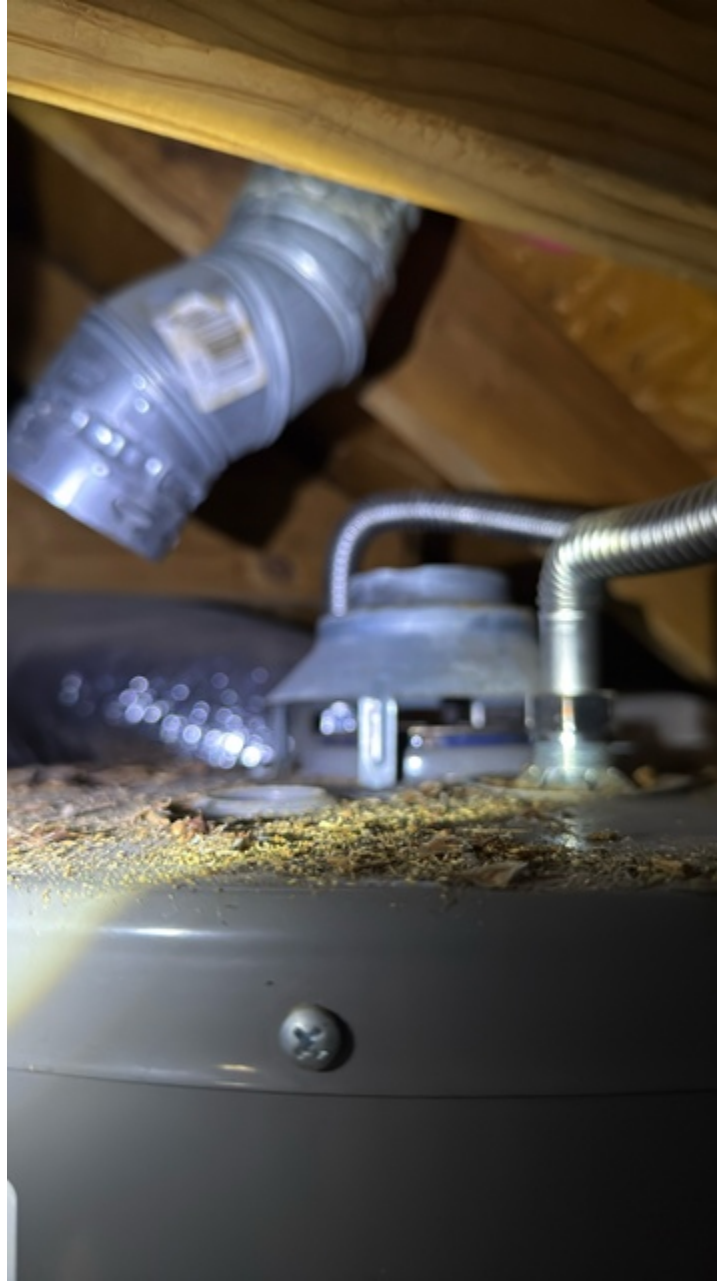
Water Heater 2 photos / videos

**Safety deficiency**

The vent is not properly attached to the water heater.

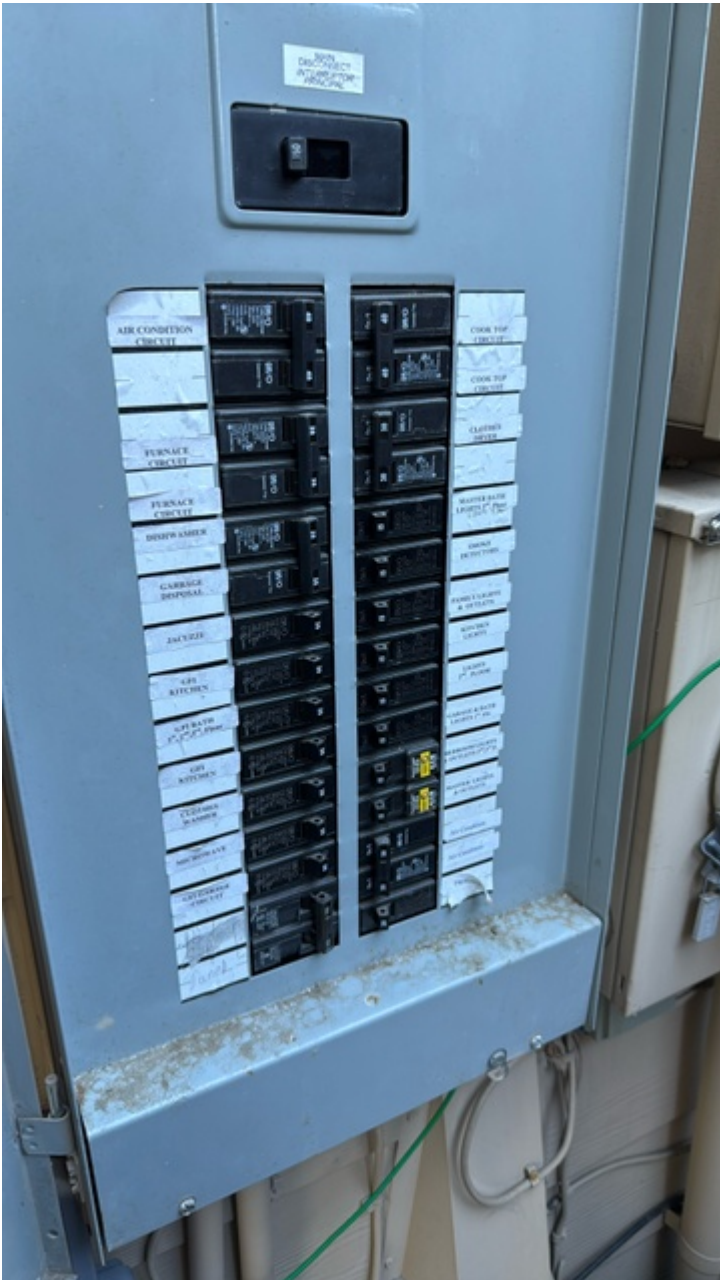
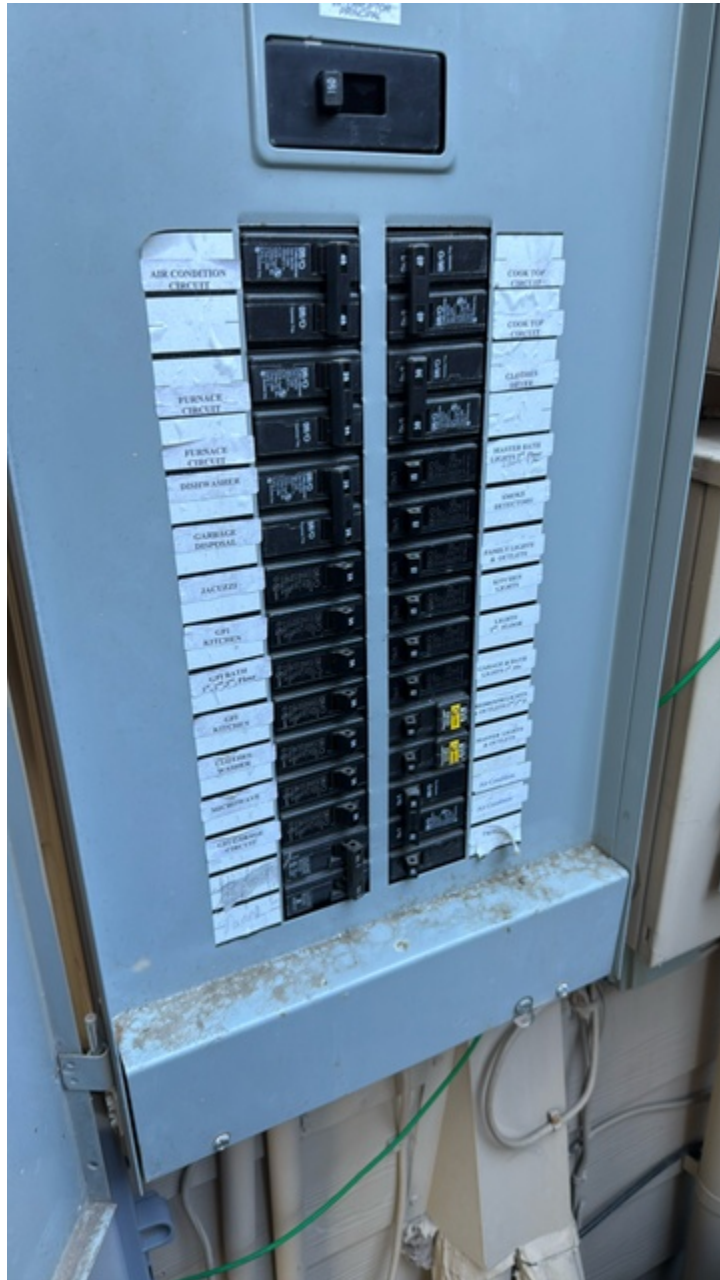
Electrical Panels, Grounding, Main Overcurrent Device photos

**Repair deficiency**

Missing AFCI Breaker

A required Arc-Fault Circuit Interrupter is missing.

Missing Surge Protection

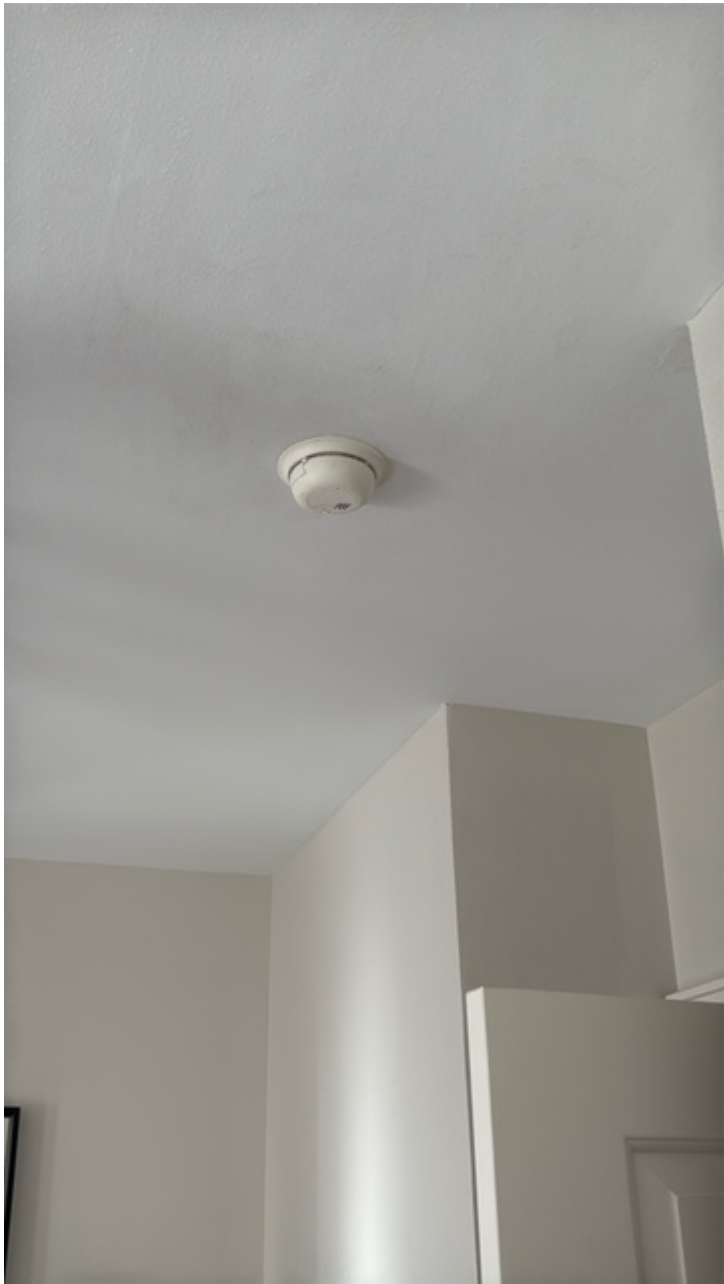
Smoke / Carbon Monoxide Detectors photos / videos

Monitor deficiency

The smoke detector is working, but it is old.
